Visual investigation of possible degradation in GEM foil under test

Abstract

Visual investigation of a Single Mask (SM) Gas Electron Multiplier (GEM) foil, showing small resistance ($\sim 40 \text{ k}\Omega$), is performed manually using an optical microscope. The GEM foil is scanned and the different imperfections in the foil are identified. Different techniques are used to clean the GEM foil to remove the short paths created between the GEM electrodes. The details of the method used for cleaning the GEM foil and the result of leakage current measurement after the cleaning of the foil are discussed in this article.

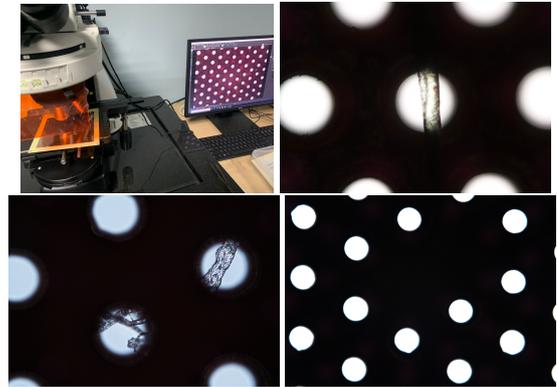
Figure 1: Microscope setup for scanning the GEM foil (top left). Imperfections in the GEM foil at different magnifications (40X: top right, bottom left; 20X: bottom right)

under scanning. The visual inspection revealed several imperfections in the foil and they are shown in Fig. 1. The pitch and diameter of the GEM holes are also measured using the microscope and their distributions are shown in Fig. 2. The average hole diameter is found to be $69.57 \pm 0.09 \mu\text{m}$ and the average pitch is found to be $140.20 \pm 0.80 \mu\text{m}$.

After doing the visual scanning, the GEM foil is cleaned using millipore water and also using an ultrasonic ($\sim 20 \text{ kHz}$) bath with millipore water as the medium.

First, the GEM foil is immersed in the millipore water bath for ~ 60 minutes and then the foil is removed and kept for drying under continuous hot air flow for ~ 30 minutes. After that, the foil resistance is measured and still, it is found that the resistance of the foil is low ($\sim 1 \text{ M}\Omega$). The foil is kept for another 24 hours in a closed box and then again the foil resistance is measured but still, the resistance is found to be $\sim 1 \text{ M}\Omega$. Fig. 3 shows the GEM foil in the millipore water bath.

After the water bath, the foil is put in the ultrasonic ($\sim 20 \text{ kHz}$) bath with millipore water as the medium. The foil is kept in the ultrasonic bath for ~ 5 minutes. After removing the foil from the ultrasonic bath, the foil is dried for ~ 30

minutes under continuous hot air flow. After that, the foil resistance is measured and it is found to be very high, which implies that the short paths are removed. Fig. 4 shows the GEM foil in the ultrasonic bath with millipore water as the medium.

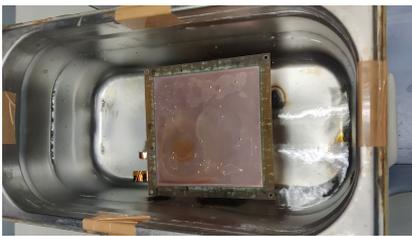
Figure 4: Ultrasonic bath of the GEM foil with millipore water as the medium.

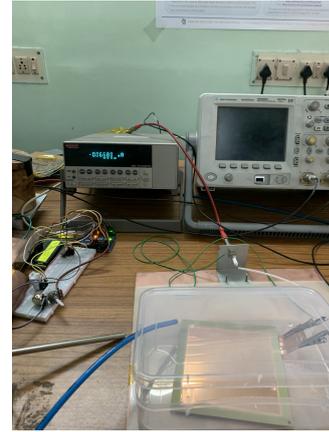
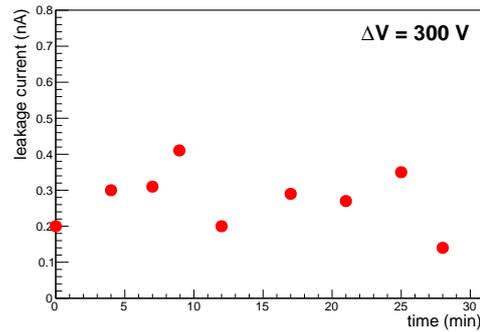
After cleaning with the ultrasonic bath, the leakage current of the foil is measured under a continuous flow of Ar/CO₂ gas mixture. The voltage is applied across the GEM foil by connecting the two leads of the foil to the external High Voltage module. The current is measured using a Keithley picoammeter (Mod No.: 6485). The setup of the leakage current measurement is shown in Fig. 5 (top). The voltage across the GEM foil is kept at $\Delta V \sim 300$ V and the leakage current of the foil is measured for 30 minutes. The leakage current is found to be ~ 0.3 nA at a relative humidity (RH) of ~ 50 %. The measured

Figure 5: Setup for leakage current measurement of the GEM foil (top). Leakage current as a function of time (bottom).

leakage current as a function of time is shown in Fig. 5 (bottom).
