Multiaxial Fatigue Behaviour of A356-T6

Aluminum alloy A356-T6 was subjected to fully reversed cyclic loading under tension, torsion and combined loading. Results indicate that endurance limits are governed by maximum principal stress. Fractography demonstrates long shear mode III propagation with multiple initiation sites under torsion. Under other loadings, fracture surfaces show unique initiation sites coincidental to defects and mode I crack propagation. Using the replica technique, it has been shown that the initiation life is negligible for fatigue lives close to 10^6 cycles for combined loading. The natural crack growth rate has also been shown to be comparable to long cracks in similar materials.

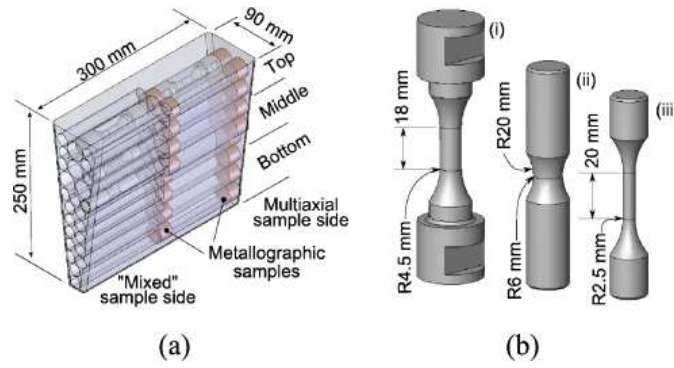
Figure 1: Wedge casting dimensions and specimen locations (a) and (b) the different types of fatigue specimens employed: tension-torsion (i), torsion (ii) and tension (iii) type.

The motivation for using a wedge-shaped casting (Fig 1a) was to create a cooling rate gradient during solidification that varied with height in the casting. A more refined microstructure was expected at the base of the casting where the cooling rate was the highest and a coarser microstructure occurred at the top where the cooling rate was the lowest. One half of the wedge was sectioned to produce tension-torsion fatigue specimens, while the other half was used to produce a mixture of solid tension, torsion and tension-torsion fatigue specimens (Fig 1b). Solid specimens were employed as opposed to tubular specimens in order to retain sampling within specific microstructural regions of the wedge. Metallographic specimens were taken such that there was at least two samples per height where fatigue specimens were cut in the wedge (Fig 1a). Additional tension-torsion fatigue and metallographic specimens were sectioned from the spokes of a Low Pressure Die Cast (LPDC) automotive wheel. All specimens were subjected to a T6 heat treatment: solutionized at 538°C for 3 hours, quenched in

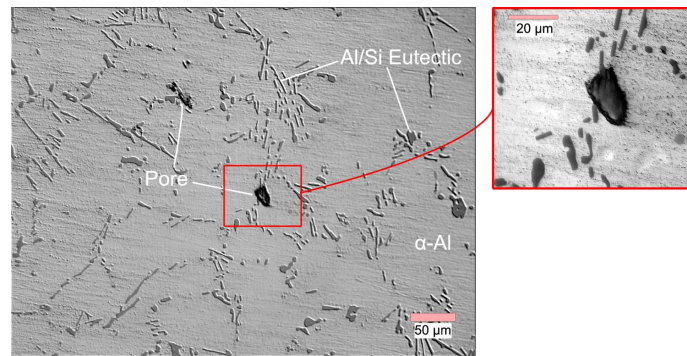
Figure 2: Typical A356-T6 microstructure showing α -Al, Al-Si eutectic phases and porosity.

Aluminum alloy A356 has an as-cast microstructure consisting of a primary dendritic structure, α -Al, filled with Al-Si eutectic phases. As the cooling rates decrease and solidification time increases, the dendritic structure coarsens resulting in larger secondary dendrite arm spacings. The T6 heat treatment serves to modify and refine the Al-Si eutectic structure. Depending on the casting conditions, the as-cast material may contain a variety of defects include gas and shrinkage porosity, and/or oxides which remain after heat treatment. Fig 2 shows optical micrographs of the typical microstructure. Metallographic analysis did not present any evidence of Fe-rich intermetallic phases known to affect fatigue properties.

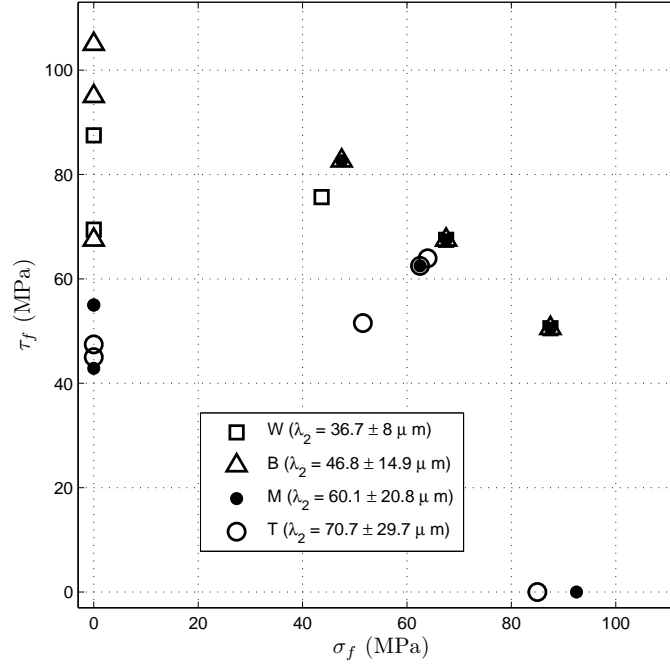
Figure 3: Fatigue limit grouped by material family type.

Grouped according to family, Fig 3 depicts σ_f versus τ_f for each specimen. Following the trend of

decreasing λ_2 from top to bottom of the wedge, the general trend is that specimens with the largest λ_2 exhibit the lowest fatigue limit. The exception was specimens extracted from the wheel, which showed a lower fatigue limit than the wedge material at a tension/torsion ratio slightly below pure torsion. However, this difference is less than the range of results shown by the pure torsion testing of the wheel specimens. Fig 4 depicts σ_a versus τ_a for all of the loading scenarios (Table 3) independent of family type. Considering the maximum fatigue limit for the entire experimental data set independent of specimen type and microstructure, σ_f and τ_f for $R = -1$ are approximately equidistant from the

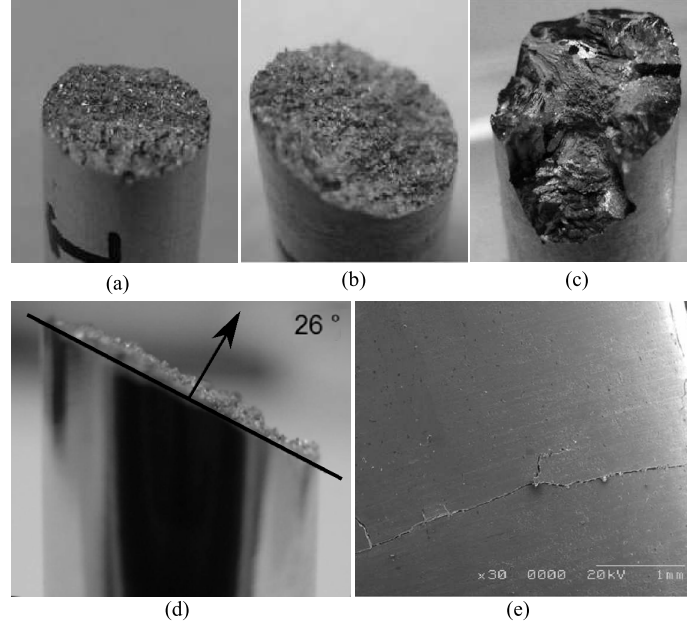
Figure 5: Failure types: (a) pure tension (b) combined tension-torsion ($\sigma_a = \tau_a$) (c) pure torsion (d) Macroscopic crack plane orientation combined tension-torsion ($\sigma_a = \tau_a$) (e) shear crack on the gauge section of the torsion sample far from the fracture surface.

A representative summary of the fracture surfaces formed for each type of loading is presented in Fig 5. Under pure tension (Fig 5a), the fracture plane was found to be always normal to the direction of applied stress and thus, coincident with the maximum principal stress ($\sigma_{1_{\max}}$) plane. Specimens from both the wheel and wedge casting exhibited this behaviour indicating that this observation is

Under combined tension-torsion loading, the fracture surface features are similar to pure tension including regular fracture planes with no bifurcation (Fig 5b) regardless of the sample location. SEM observation of the gage section far from the fracture surface reveals only small secondary cracks less than 50 μm long. The orientation of the fracture surface in Fig 5d is shown by the fracture surface normal. In this combined loading case where $\sigma_a = \tau_a$, the fracture surface normal is oriented 26° from the axis of the specimen. With the maximum principal stress acting at 31° from the specimen axis, the fracture surface normal is close to being parallel. This difference of 5° is the largest discrepancy observed over the 18 multiaxial specimens tested. Thus, the orientation of the macroscopic fracture plane under combined loading conditions correlates to the loading condition and more specifically, to the direction of the maximum principal stress ($\sigma_{1\text{max}}$). Therefore, the tension component of the loading must play a major role in deciding the path of crack propagation.

that of pure tension and combined tension-torsion loading. Fig 5c is an example of the fracture surfaces observed. The tortuous fracture surface has two major crack planes activated: one aligned with the axis of the specimen and the other one perpendicular to this axis. This highlights the difficulty in finding a unique initiation site on the fracture surface. Macroscopic observations confirmed by SEM analysis indicate that there are many different initiation sites over the periphery of the gage section and that different crack planes link together to form the final fracture surface.

The fracture surfaces of the samples tested in pure torsion were much more difficult to analyze than the pure tension samples. As shown in Fig 5c, the macroscopic topology of the surface is very complex with two perpendicular mode III cracks activated and multiple initiation sites. Initiation is spatially distributed and as a result, the fracture surface is a combination of different cracks that have coalesced to cause final failure of the sample. Thus, it was difficult to identify a single initiating feature. However, when the fracture surface was less tortuous, there were features that could be analyzed (Fig 6f). For these samples, it was non-trivial to separate the fatigue zone from final failure zone. Fig 6f shows two features that are presumed fatigue initiation sites. The feature closest to the center of the specimen is clearly shrinkage porosity with an equivalent diameter of 265 μm , located well away from the surface. The second feature is possibly an oxide film, but the features have been

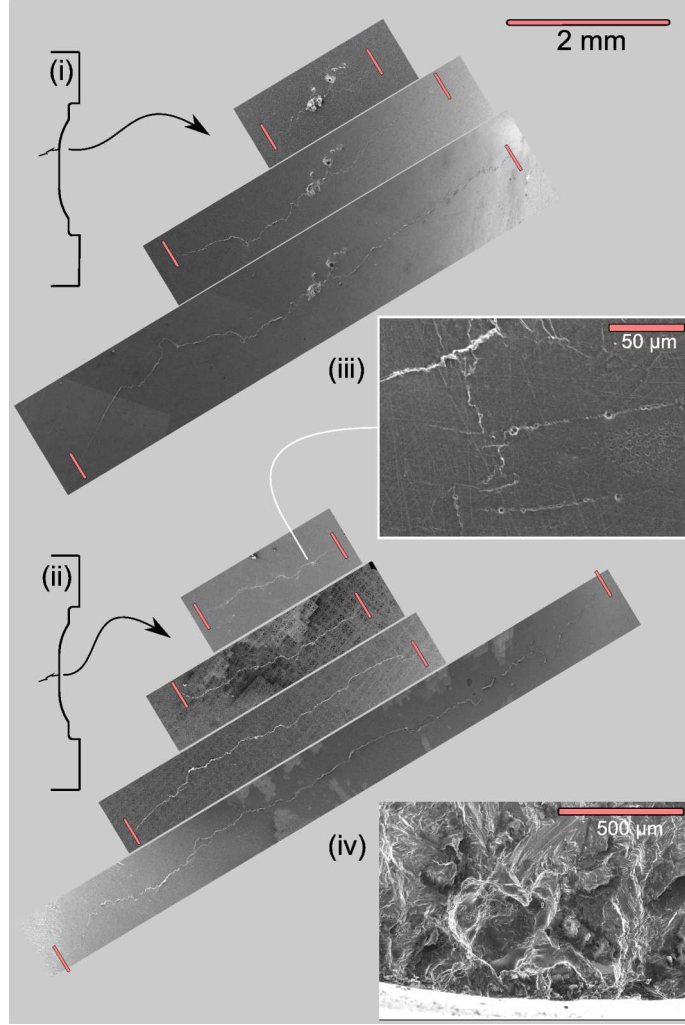
Figure 8: Multi-axial specimen T3, $\sigma_a, \tau_a = 65$ MPa and $N_f = 9.07 \times 10^5$ cycles with the secondary crack (i) at $N = 2.25 \times 10^5$, $N = 6.75 \times 10^5$ and $N = 8.75 \times 10^5$. The primary crack (ii) is shown at $N = 2.25 \times 10^5$, $N = 3.75 \times 10^5$, $N = 6.75 \times 10^5$ and $N = 8.75 \times 10^5$. Damage accumulation (iii) was found to occur at the initiation zone and a 300 μm defect (iv) was found on the fracture surface.

presented in Fig 8. The crack path is regular and the propagation plane normal of both cracks is oriented at 31° from the central axis of the specimen. This is consistent with other tests of the same type (Section 4). Fracture surface analysis revealed a gas pore with an equivalent diameter of 300 μm just below the gage surface. Since this specimen had the same fatigue limit (68 MPa) as a specimen where a defect could not be identified, it is assumed that this pore had minimal effect on the fatigue limit. The secondary crack observed on this sample initiated at a gas pore, visible on the surface of the specimen, near the beginning of loading and grew in the same orientation as the main crack.
