Neutron emission from fracturing of granite blocks: An experimental revisitation

Abstract

A series of experimental tests, such as those of Carpinteri et al. (2013), have been performed. The aim was to check the emission of neutrons in the fracture of Luserna granite blocks under mechanical loading, as reported by the above mentioned authors. No neutrons have been detected and some doubts have emerged on the soundness of the previous measurements.

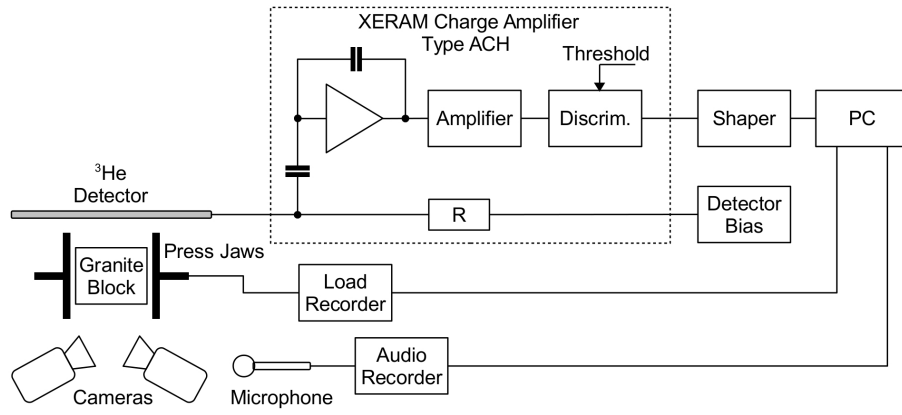
Figure 1: Schematics of the experimental set-up used in the compression tests.

Our experimental set-up is sketched in Fig. 1. The cubic specimens were Luserna granite, the same material used by Carpinteri et al. in their tests, having dimensions either $10 \times 10 \times 10 \text{ cm}^3$ or $10 \times 10 \times 8 \text{ cm}^3$. No differences were observed between them, except the collapsing load. The neutron detector used in the compression tests is a ^3He type 65-NH-45 manufactured by Xeram, (France) with its standard electronics [6, 7]. The detector (25 mm diameter, 450 mm long) is exactly of the same model of that used in [1]. Its thermal neutron sensitivity is 65 cps for a thermal neutron flux of $1 \text{ neutron s}^{-1} \text{ cm}^{-2}$. During the tests the detector was powered at 1.4 kV by means of a high voltage CAEN N126 power supply. The electronics performs an integral-differentiation of the ^3He signal ($1 \mu\text{s}$ integration, $4 \mu\text{s}$ differentiation) followed by a discrimination which supplies output TTL pulses ($10 \mu\text{s}$ width). The time width of these pulses was stretched to 1 ms by means of a Gate Generator (CAEN 2255B), the output of which was directly connected to the input of a PC sound card board used as data-acquisition card allowing the sampling of the input pulses at 10 kSa/s and giving the time of occurrence of each ^3He count with a precision of 0.1 ms. The sensitivity of the ^3He detector was checked before the measurements against a known neutron flux [8]. The press employed is a servo-hydraulic “200 Mp Compression Testing Machine model 200 D 76”, manufactured by Amsler (Switzerland) [9]. The maximum value of the applied loading force is 2000 kN. The adopted instrumentation was integrated with two video cameras and an audio recorder. The acquisition of ^3He pulses, mechanical load, video and audio signals was synchronized at the beginning of each run.

The minimal possible distance between the center of the rock sample and the detector was 26 cm. In comparison with [1], there is a reduction of a factor six in the collected solid angle, nevertheless, according to the data in Table 2 of the same reference, more than one neutron should still be detected in the crash.

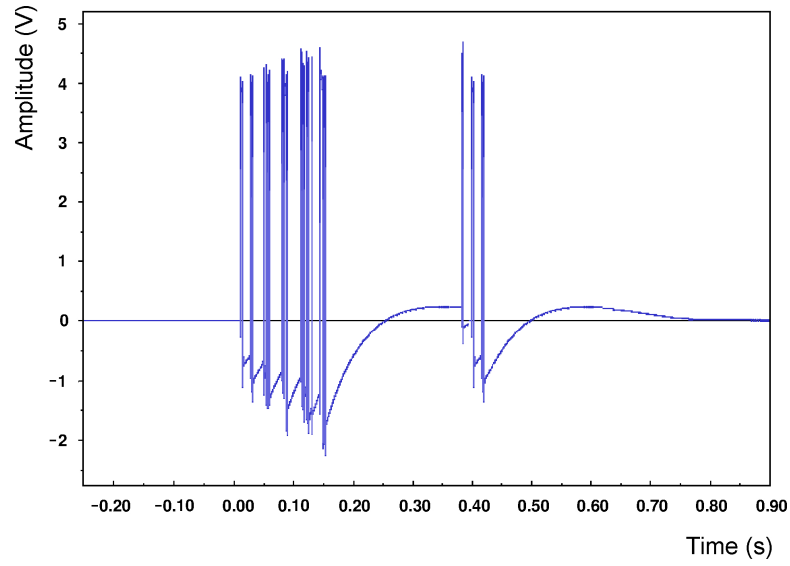
Figure 2: Acquired ^3He signals showing many TTL pulses surfing over a strongly perturbed baseline.

In one of the earliest test, the ^3He detector was accidentally hit by a mechanical component of the hydraulic press. The acquired signal, shown in Fig. 2, presented a complex waveform in which many TTL signals were surfing over a strongly perturbed baseline. The corresponding ^3He counts are shown as black dots in Fig. 3, together with the loading force exerted by the press on the specimen (red line). The vertical blue dashed line in the plots indicates the crashing time. At first glance these signals should have been associated to neutrons detection but, because of the mentioned shock accident and the high number of associated pulses, it was impossible to rule out a mechanical effect on electronics. Furthermore, even an acoustic effect was eligible, as supposed in [3].

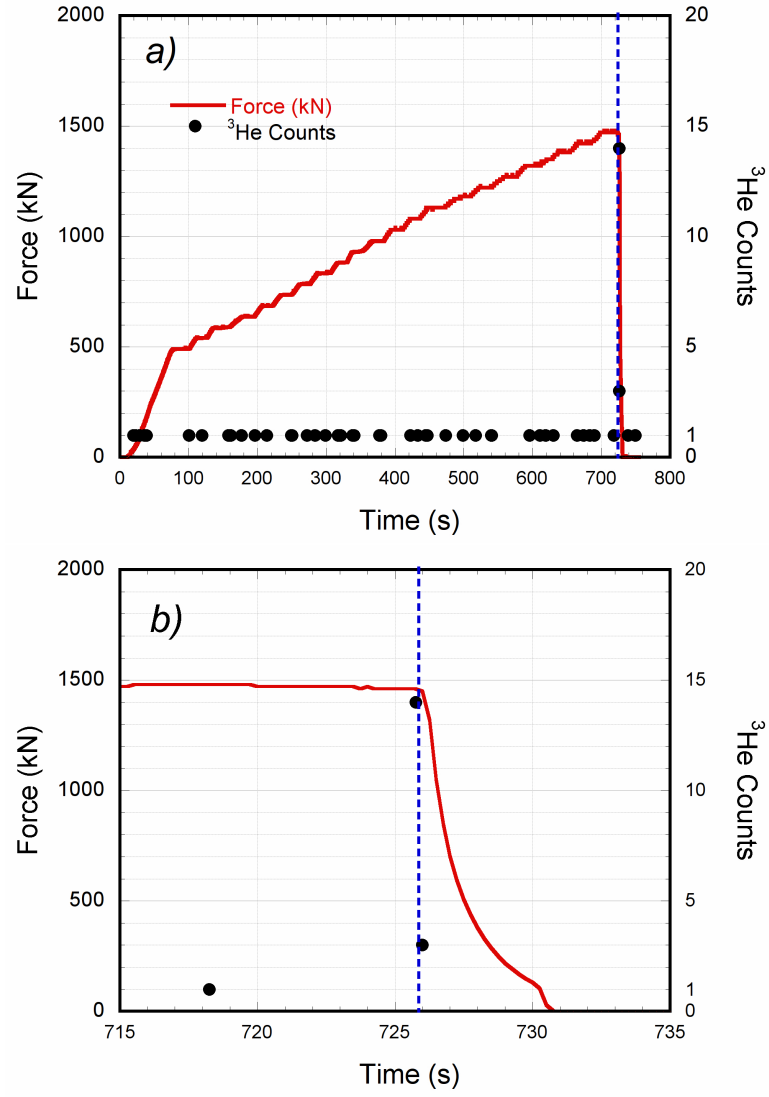
Figure 3: ^3He counts (black dots) together with the loading force on the specimen (red line) in one early test with the unshielded neutron detector. In a) the whole experimental test time is plotted whereas in b) a zoom around the crashing moment is represented. The vertical blue dashed line, in the plots, indicates the crashing time.

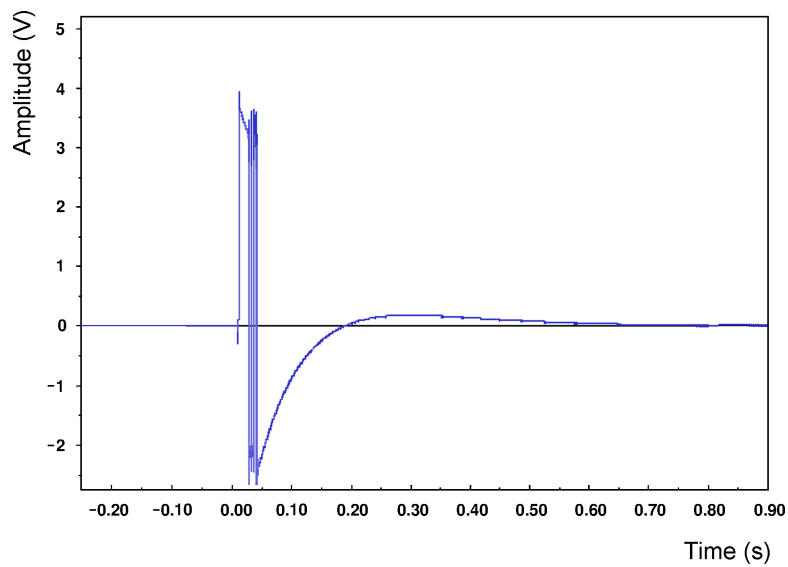
Figure 4: TTL signals acquired when a blank gun was fired near the ^3He detector.

This last hypothesis found a proof when we intentionally fired a blank gun near the ^3He detector: TTL signals were recorded, exactly as in the case of neutron occurrence, as shown in Fig. 4. Following this finding, we started a systematic investigation of this artifact in the detection unit. To this purpose, we repeated the test with the blank gun mentioned above by installing an increasing amount of acoustical shielding material, until we found no additional pulses above the background single ones at all.

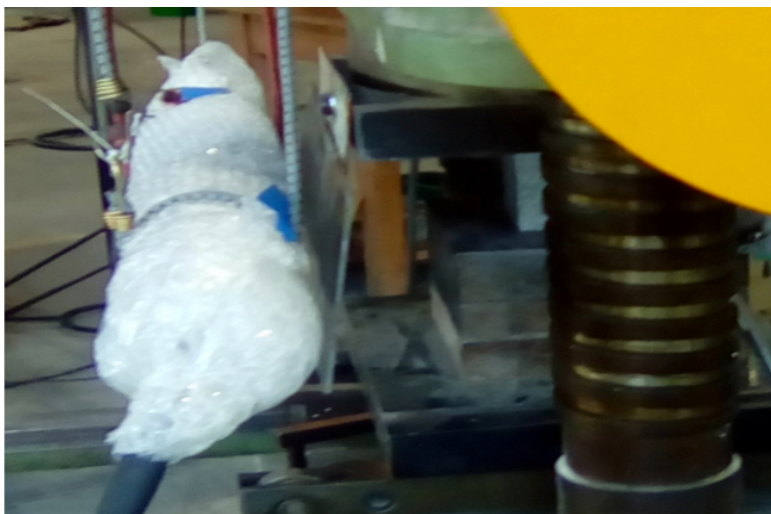
Figure 5: The mechanical press, the granite block inside its jaws and the detector, suspended and wrapped in a white protective plastics. The ^3He detection system was recalibrated against thermal neutrons with this protection in place.

Eventually a suitable protection was achieved, i.e. no pulses observed above the background ones, and test on granite restarted. This protection, as shown

in Fig. 5, was made of tubular foam covering the ^3He tube, its cable and the preamplifier. Furthermore, the detector was wrapped with a pluriball foil. Of course we were aware that the gun shot wasn't necessarily equivalent to that generated in the collapse of the granite specimen, but we considered a success to have at least eliminated this kind of perturbation. As matter of facts, after then we never observed a neutron signal in conjunction with the collapse of granite blocks, except the single pulse background. A record of a typical test is reported in Fig. 6.

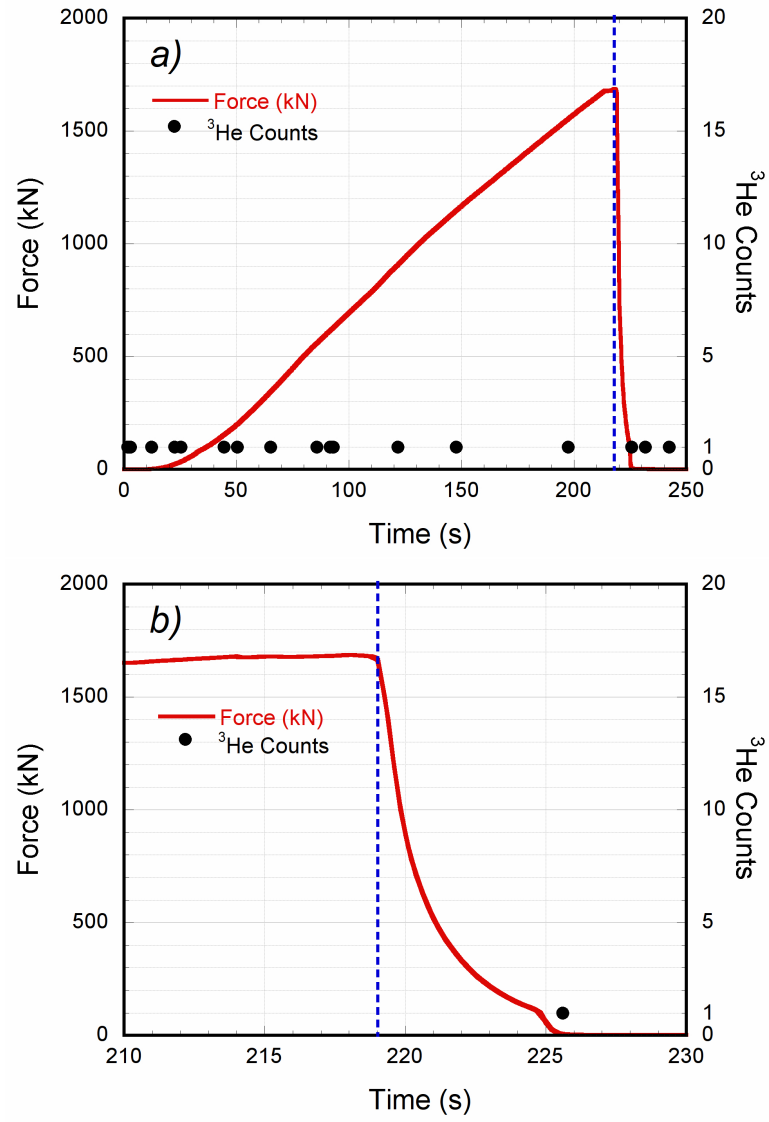
Figure 6: ^3He counts (black dots) together with the loading force on the specimen (red line) for the test with the whole neutron detector protected against acoustic effects. In a) the whole experimental test time is plotted; in b) a zoom around the crashing time is represented. The vertical blue dashed line, in the plots, indicates the crashing time.

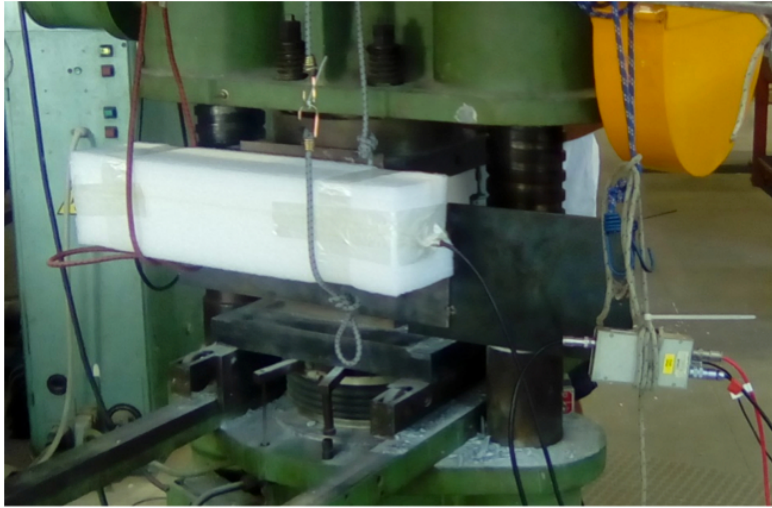
Figure 7: The suspended detector, embedded in polystyrene protection and the preamplifier, now unsheltered.

Once ascertained that with a suitable protection of the detector, at the time of the collapsing of the Luserna granite, no signal occurred, neither from detected neutrons nor from acoustical effects, it was decided to repeat tests without acoustic protection, except for the ^3He tube, where the protection was replaced with a polystyrene shield, as shown in Fig. 7. Apparently this last configuration had also been adopted in the work of Carpinteri et al. [1].

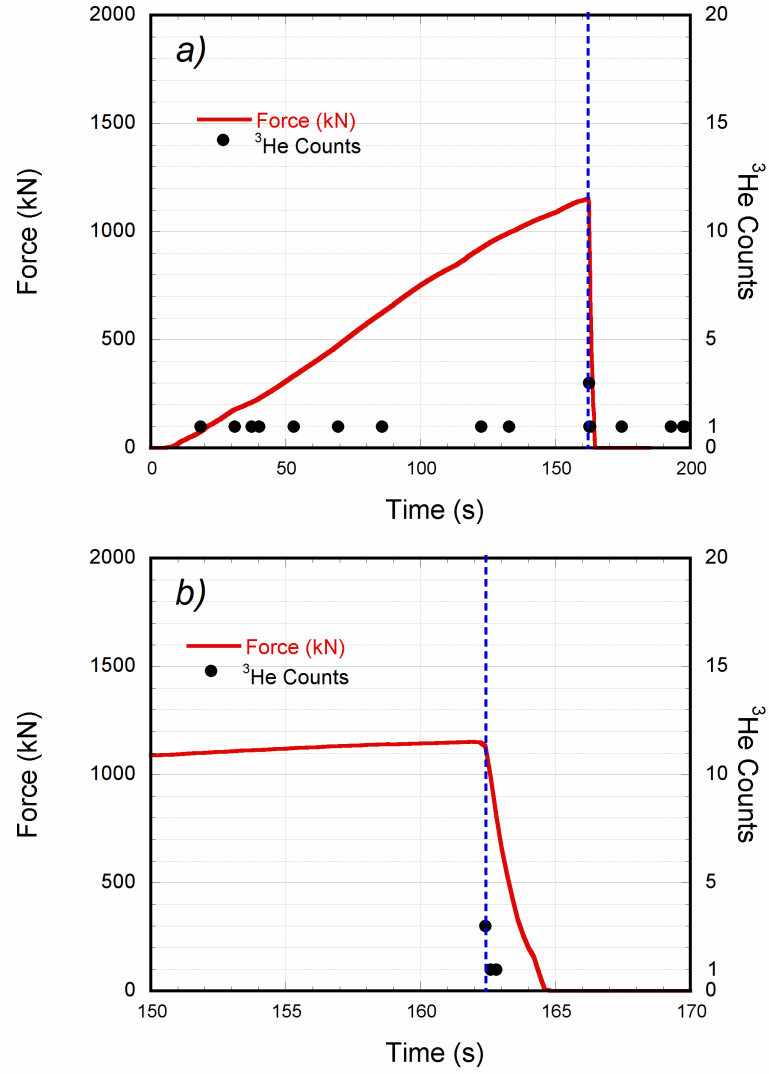
Figure 8: ^3He counts (black dots) together with the loading force on the specimen (red line) when only the ^3He detector is protected by a polystyrene shield, as by a way in [1]. In a) the whole experimental test time is plotted whereas in b) a zoom around the crashing moment is represented. The vertical blue dashed line, in the plots, indicates the crashing time.

Not only the system was now sensitive again to the blank gun but also at the crashing time of a granite block the TTL signals appeared again (Fig. 8) confirming that even the preamplifier/cable are sensitive to the acoustic noise.
