# Rolling contact fatigue deformation mechanisms of nickel-rich nickel-titanium-hafnium alloys

Sean H. Mills<sup>1</sup>, Christopher Dellacorte<sup>2</sup>, Ronald D. Noebe<sup>2</sup>

Behnam Amin-Ahmadi,<sup>1\*</sup> and Aaron P. Stebner<sup>1,3\*</sup>

## ABSTRACT

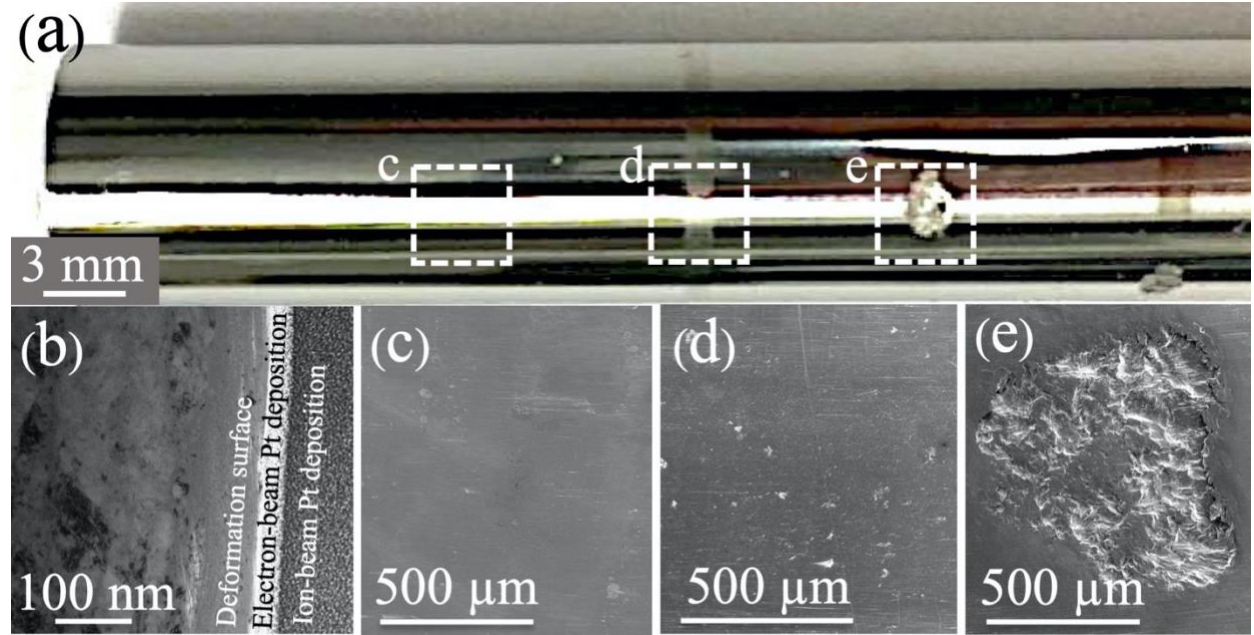
**Fig. 1.** (a) Typical rolling contact fatigue (RCF) test specimen after several tests, with as-polished regions of the surface such as the region labeled c, as well as multiple wear tracks such as the regions labeled d and e. (b) BF-TEM micrograph of a TEM foil prepared by FIB “lift-out” from the untested, super-polished rod surface showing the preserved deformation layer and the two Pt protective layers deposited using the electron-beam (lower energy) and Ga<sup>+</sup> ion-beam (higher energy). SEM micrographs of (c) a super-polished region of the rod surface, (d) a wear track region of the surface after “run-out” was attained at  $1.7 \times 10^8$  cycles, and (e) a spalled region of the surface within the wear track of a test that failed prior to  $1.7 \times 10^8$  cycles.

A Delta Research Corporation three ball-on-rod RCF test rig was used for evaluation of the longevity of the three alloys under complex RCF conditions by simulating types of loading and fatigue conditions that bearing components experience while in service [ref Olver 2005 and Ringsberg 2001]. A more in-depth description of the setup and functionality of this particular RCF tester is provided by Glover [36]. The NiTi and NiTiHf rod specimens were tested in contact with three polished and hardened steel balls rotated at 3600 rpm. The balls used in the rolling contact fatigue study were grade-ten, standard 12.7 mm diameter bearing balls made from hardened (700 – 800 HV) AISI 52100 type tool steel and were replaced after every test [1]. The balls were evenly spaced around the circumference of each rod by a bronze retainer and eight to ten drops of Mil-J-7808-J turbine oil drip feed lubrication per minute was provided lubrication between contacting parts, while effectively removing debris, regulating temperature, and preventing corrosion throughout the duration of the test [35]. A piezoelectric accelerometer was set close to ambient vibration (low sensitivity setting  $\sim 250 \mu\text{m/s}^2$ ) to monitor surface damage,

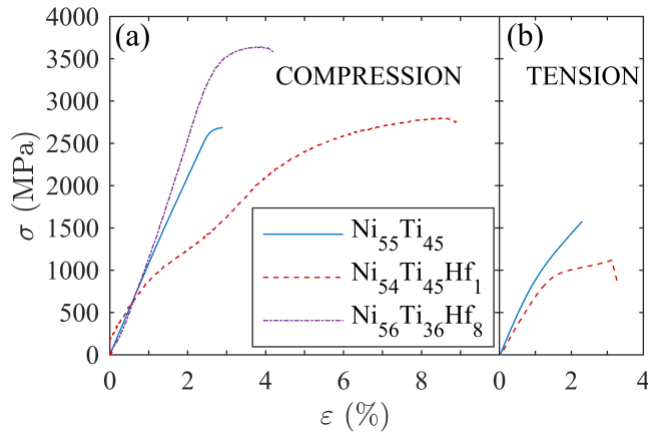
**Fig. 2.** (a) Compression and (b) Tension stress-strain behaviors of each alloy aged in the same condition as the RCF tests were performed. The Ni<sub>56</sub>Ti<sub>36</sub>Hf<sub>8</sub> tensile sample broke when gripped, and more material was not available to make more samples. The Ni<sub>55</sub>Ti<sub>45</sub> data is replotted from [24].

The compressive stress – strain responses are plotted in Fig. 2(a). The Ni<sub>56</sub>Ti<sub>36</sub>Hf<sub>8</sub> alloy exhibited superior uniaxial compression strength (3.4 GPa yield stress) and moderate strain (4.2%) before failure by fracturing into several pieces. As previously reported [24], the Ni<sub>55</sub>Ti<sub>45</sub> alloy yielded at ~2.7 GPa and exhibited a compressive strain of 3.2 % prior to failing by buckling. The Ni<sub>54</sub>Ti<sub>45</sub>Hf<sub>1</sub> alloy exhibited superelastic-like behavior at a stress level of ~ 1 GPa that is consistent with the stress-induced transformation behavior reported by Casalena et al. [25], and achieved a maximum compressive stress of ~2.8 GPa and strain of 8.8% prior to failure by fracturing cleanly into 2 pieces about a plane 45° to the loading axis; i.e., a plane of maximum shear stress.

The tensile stress-strain responses (Fig. 2(b)) show that the Ni<sub>55</sub>Ti<sub>45</sub> alloy tested by Benafan et al. [24] achieved an ultimate tensile strength of 1.6 GPa prior and 2.3 % elongation to failure. The Ni<sub>54</sub>Ti<sub>45</sub>Hf<sub>1</sub> alloy exhibited a tensile elastic limit of ~ 800 MPa. It is unclear if the inelastic deformation is due to phase transformation or plasticity or both, as the sample fractured at a maximum tensile stress of 1.1 GPa and 3.1 % elongation to failure, and the mechanical response to this point did not show any hardening or other signatures typical of separated phase transformation vs. plastic deformation responses. As previously noted, the tensile behavior of the Ni<sub>56</sub>Ti<sub>36</sub>Hf<sub>8</sub> alloy was not determined due to samples breaking before testing.

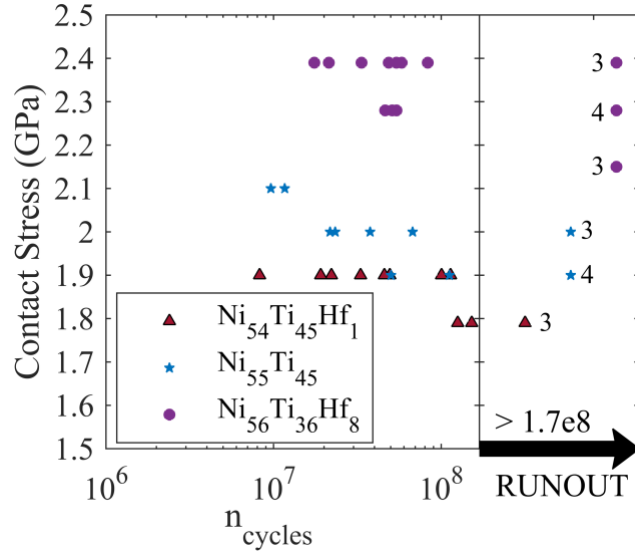
**Fig. 3.** Rolling contact fatigue results are plotted as a function of Hertzian contact stress (GPa) vs. cycles to failure ( $\log_{10}$ ). The number of successful runout samples at each stress level are indicated next to the respective markers on the right-hand side.

The RCF results for all three alloys are plotted in Fig. 3. The corresponding contact stress limit exhibited by the Ni<sub>56</sub>Ti<sub>36</sub>Hf<sub>8</sub> alloy (2.2 – 2.3 GPa) is about 25% and 15% higher than the stress limits exhibited by the Ni<sub>55</sub>Ti<sub>45</sub> and Ni<sub>54</sub>Ti<sub>45</sub>Hf<sub>1</sub> alloys of 1.8 and 2.0 GPa, respectively. As previously reported [], this improvement in sustained contact stress corresponds with both increased hardness (769 HV vs. 688 and 677) and stiffness ( $E = 130$  GPa vs. 104 GPa, 72 GPa, see Fig. 2a). However, the microstructural origins of the increased compressive and RCF strengths, hardness, and stiffness are unknown, hence we proceed to examine the microstructures before and after RCF testing in detail.

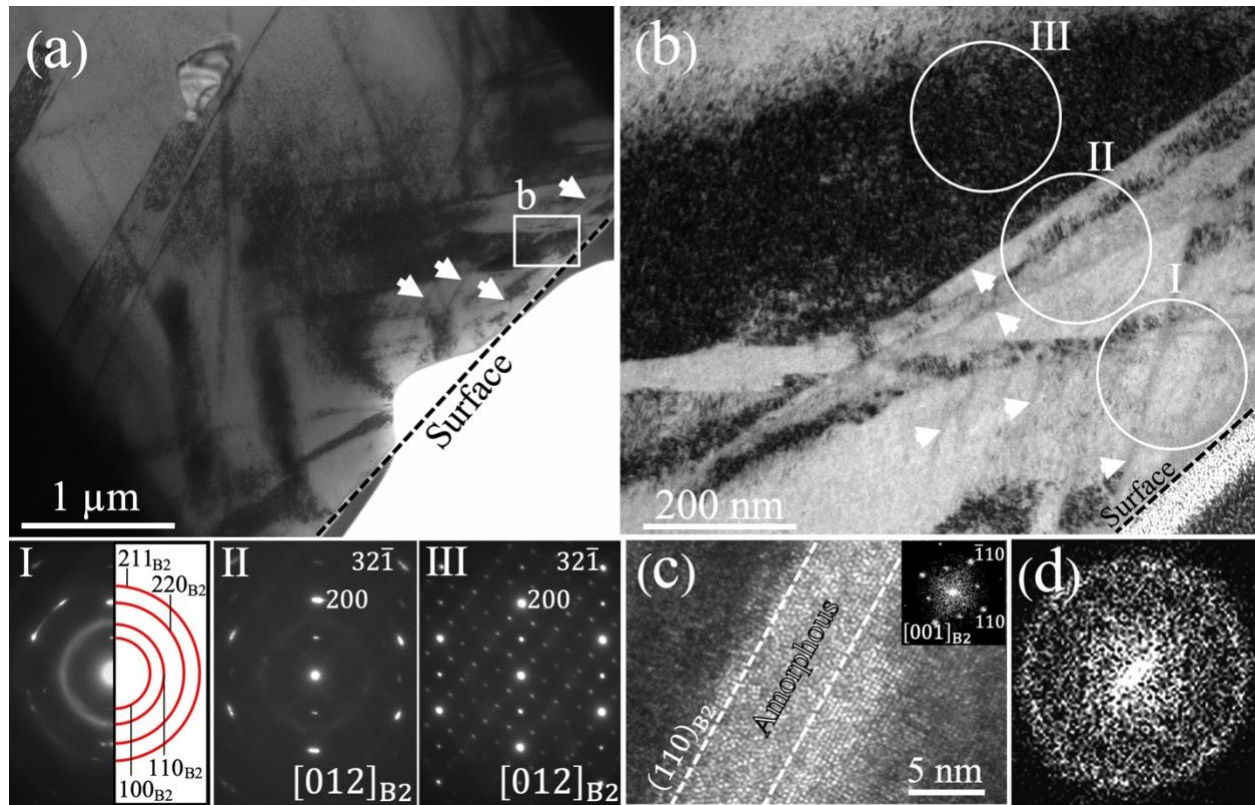
**Fig. 4.** (a) BF-TEM micrograph near the surface of the super-polished Ni<sub>55</sub>Ti<sub>45</sub> showing narrow deformation bands (e.g., those marked with white arrows). (b) Magnified BF-TEM micrograph of the region indicated by the white box in (a) showing closely spaced deformation bands (e.g., those marked with white arrows) located close to the surface. (I) SAED pattern taken from an area within 200 nm of the polished surface, showing both strong diffuse rings and distinct B2 spots that correspond to amorphous phase and several B2 nanocrystals being contained within the diffracting volume, respectively, as supported by the schematic overlay of the indexed B2 structure diffraction rings on the right side. (II) SAED pattern taken along the  $[012]_{B2}$  zone of a B2 grain within the region 200 – 400 nm below the polished surface, also showing faint diffuse rings from the presence of some amorphous phase and faint Ni<sub>4</sub>Ti<sub>3</sub> superlattice reflections. (III) SAED pattern taken along the  $[012]_{B2}$  zone from a single B2 grain within the region 400 – 600 nm beneath the polished surface, including strong superlattice reflections of Ni<sub>4</sub>Ti<sub>3</sub> precipitates along  $\frac{1}{7}\langle 321 \rangle$ . (c) HRTEM micrograph of a deformation band close to surface with interface that lies on  $(110)_{B2}$  plane (orientation confirmed by FFT (inset)) and (d) corresponding FFT showing the amorphous structure of the band.

Fig. 4 depicts the microstructure of the super-polished Ni<sub>55</sub>Ti<sub>45</sub> sample at and below the surface of the rod. Analysis of these data indicates that there was a layer of damaged material near the surface due to machining and/or polishing of the rods. Considering the mechanics of the sample preparation steps, it is most likely that the majority of this damage occurred during the centerless grinding operation that preceded the super-polishing. Deformation bands with average width of  $43 \pm 24$  nm and average spacing of  $221 \pm 114$  nm (Table 1) are observed through

The magnified BF-TEM micrograph (Fig. 4(b)) shows that the material nearest to the surface is the most heavily damaged; the density of deformation bands increases close to the surface. SAED patterns taken from several regions with a diameter of approximately 200 nm (indicated by white circles in Fig. 4(b)) are presented in Fig. 4 (I–III). The SAED pattern taken nearest to the surface (Fig. 4(I)) is composed of diffuse ring and spotty patterns, which correspond to the existence of amorphous phase and B2 nanocrystals, respectively. The existence of  $\text{Ni}_4\text{Ti}_3$  phase throughout the undeformed, aged microstructure is expected based upon previous studies of the  $\text{Ni}_{55}\text{Ti}_{45}$  alloy [24,39]. However, typical  $\text{Ni}_4\text{Ti}_3$  superlattice reflections were not observed within this region, indicating that they have been dissolved during sample fabrication processes. The HRTEM micrograph and corresponding diffuse circular FFT pattern taken from a deformation band (Fig. 4(c,d)) confirms that the deformation bands close to the surface are amorphous. The HRTEM image, Fig. 4(c), shows that the interfaces of the deformation bands lie along  $(110)_{\text{B2}}$  planes. Analysis of the HRTEM image also indicated that the dislocation density of the B2 matrix within 200 nm of the surface is  $6.2 \pm 0.3 \times 10^{16}/\text{m}^2$  (Table 1).

reflections along  $\frac{1}{7}\langle 321 \rangle$  are also observed, confirming the existence of some  $\text{Ni}_4\text{Ti}_3$  precipitates 200 – 400 nm beneath the surface, though not in the expected morphologies, indicating that some precipitate dissolution has occurred.

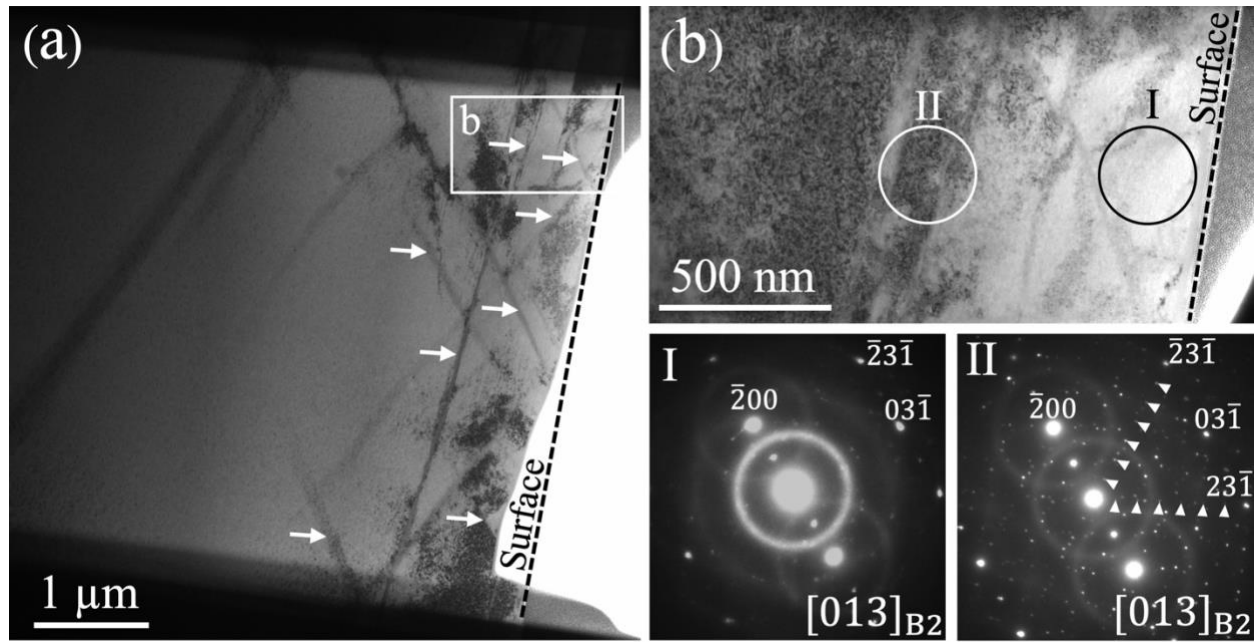
**Fig. 5.** (a) Low magnification BF-TEM of the material beneath the surface of a Ni<sub>55</sub>Ti<sub>45</sub> wear track that achieved the runout condition shows deformation bands (e.g., those marked with white arrows). (b) Higher magnification BF-TEM micrograph taken from the region indicated by white box in (a). (I) SAED pattern taken from the material just beneath the wear surface showing clear spot pattern of a single grain along the  $[013]_{B2}$  zone, diffuse rings from amorphous bands, and weak superlattice reflections, possibly from nanocrystals and/or Ni<sub>4</sub>Ti<sub>3</sub> precipitates. (II) SAED pattern taken from a region 800 nm beneath the wear surface shows a B2 grain oriented along the  $[013]_{B2}$  zone, and includes intense superlattice reflections from two variants of Ni<sub>4</sub>Ti<sub>3</sub> precipitates (white arrowheads) and weak diffuse rings (from amorphous bands).

The lowest magnification BF-TEM micrograph of worn, passed  $\text{Ni}_{55}\text{Ti}_{45}$  material (Fig. 5(a)) appears similar to the unworn material (Fig. 4(a)). However, analysis of the deformation bands shows that they coarsened due to the wear to  $63 \pm 37$  nm wide and average spacings of  $153 \pm 97$  nm (Table 1). Also, the deformation bands appear more prevalent at depths 2  $\mu\text{m}$  to 3  $\mu\text{m}$  beneath the surface than they were in the untested material.

[013]<sub>B2</sub> zone (Fig. 5(I)) together with a strong diffuse ring pattern originating from amorphized material. HR-TEM analysis (not shown) indicated that the material within 100 nm of the surface was mostly amorphized. Weak random superlattice reflections in this pattern can be attributed to a low volume fraction of retained Ni<sub>4</sub>Ti<sub>3</sub> precipitates, though most of them have dissolved. Furthermore, the measured dislocation density of the B2 matrix increased to  $11 \pm 0.2 \times 10^{16}/\text{m}^2$  (Table 1), nearly double that observed near the surface in the super-polished condition.

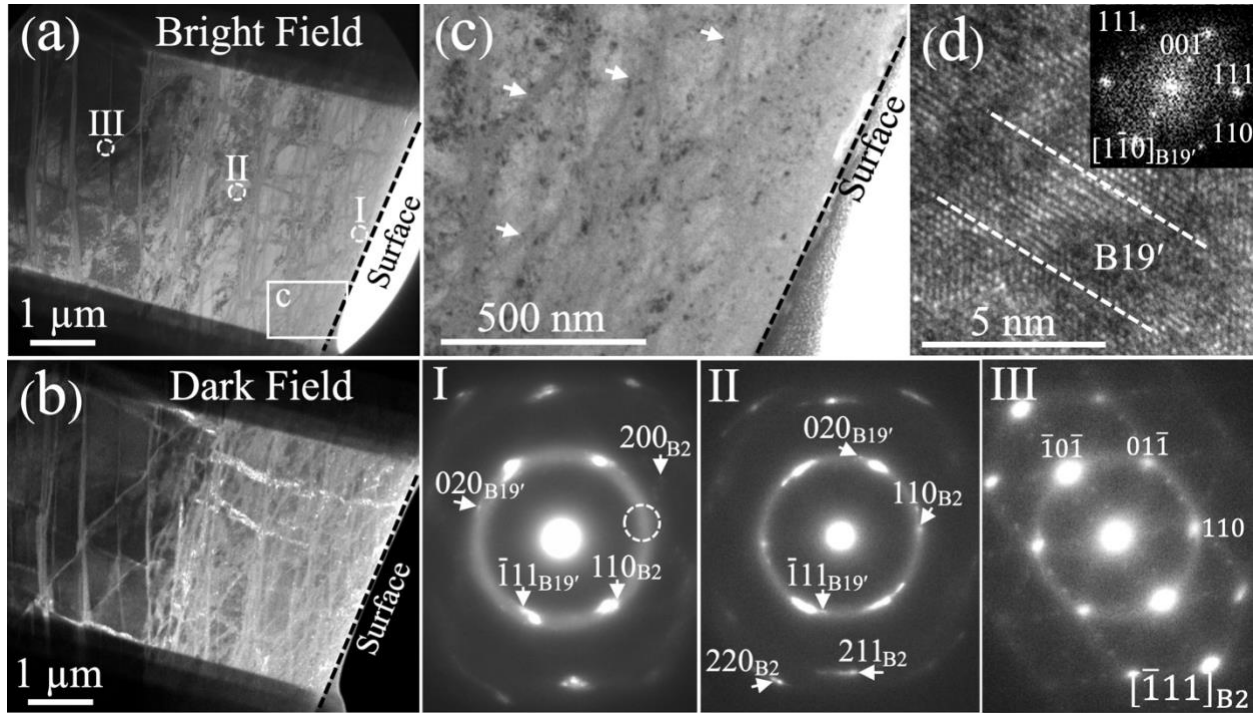
**Fig. 6.** (a) BF-TEM and (b) corresponding DF-TEM micrograph of  $\text{Ni}_{55}\text{Ti}_{45}$  beneath a spalled region of a failed wear track surface. The DF micrograph was imaged using the part of ring pattern marked by the dashed circle on the SAED pattern of (I). (c) Magnified BF-TEM image taken from the region indicated by the white box in (a) contains high density of deformation bands (e.g., those marked with white arrows). (I) SAED pattern taken near the surface (the region within the dashed circle labeled (I) in (a)) contains a diffuse ring and spots that correspond to amorphous bands and B2/B19' nanocrystals, respectively. (II) SAED pattern taken 2.1 – 2.5  $\mu\text{m}$  from surface (the region within the dashed circle labeled (II) in (a)) exhibits a weaker diffuse ring pattern, which suggests less amorphization than at the surface. B2/B19' nanocrystals are also still observed; precipitates were not observed up to 4.5  $\mu\text{m}$  into the sample. (III) SAED pattern taken 4.1 – 4.5  $\mu\text{m}$  from the surface (the region within the dashed circle labeled (III) in (a)) shows a spot pattern of a single B2 grain along the  $[\bar{1}11]_{\text{B2}}$  zone containing  $\text{Ni}_4\text{Ti}_3$  precipitates, evident from the superlattice reflections. (d) HRTEM micrograph and corresponding FFT pattern (inset) taken close to the surface confirm the B19' structure of some of the nanocrystals.

The BF-TEM micrograph taken of material extracted underneath a spalled region of a failed wear track of the Ni<sub>55</sub>Ti<sub>45</sub> alloy shown in Fig. 6(a) clearly shows much greater damage than Figs. 4(a) and 5(a). The SAED pattern taken near the surface (Fig. 6(I)) consists of a diffuse ring pattern (indicative of amorphous phase) and spot ring patterns from nanocrystalline grains of B2 and B19' structure. A part of the diffuse ring (indicated by dashed circle in Fig. 6(I)) was used to image the DF-TEM micrograph shown in Fig. 6(b). In this case, most of the microstructure under the spalled surface, to a depth of 3  $\mu\text{m}$ , was amorphized; however, some

dark contrast from nanocrystals was also observed within this region. Moreover, it is clear from the DF-TEM micrograph, Fig. 6(b), that the deformation bands far into the sample were amorphous. The RCF damaged penetrated more than 6  $\mu\text{m}$  into the sample (limitation of FIB sample size). The average width of the amorphous deformation bands was  $92 \pm 34$  nm and average spacing was  $112 \pm 75$  nm (Table 1) – they have coarsened substantially compared with the worn, but passed material. The magnified BF-TEM micrograph (Fig. 6(c)) taken from the region indicated by the white box in Fig. 6(a) and the SAED pattern taken close to the surface (Fig. 6(I)) indicates that the structure was mostly amorphous 300 nm into the sample, together with some nanocrystals. The HRTEM micrograph taken close to the surface and corresponding FFT shown in Fig. 6(d) confirm that some of the nanocrystals are of B19' martensite structure. Further HRTEM analysis of the B2 matrix near the surface showed that the dislocation density increased to  $13.1 \pm 0.2 \times 10^{16}/\text{m}^2$  (Table 1), which seems to be the limit that the matrix can tolerate before amorphization occurs.

A high density of deformation bands is still observed deeper into the sample than the mostly amorphized region, as indicated by white arrows in Fig. 6(c). In fact, the SAED pattern taken 2.1 – 2.6  $\mu\text{m}$  from the surface (Fig. 6(II)) contains a weak diffuse ring and intense spot ring patterns, indicating that even several microns below the surface, the material is mostly B2 and B19' nanocrystals in between amorphous deformation bands. Superlattice reflections from  $\text{Ni}_4\text{Ti}_3$  precipitates were not detected in SAED patterns acquired up to 4.5  $\mu\text{m}$  into sample. The SAED pattern (Fig. 6(III)) taken 4.1 – 4.5  $\mu\text{m}$  from the surface, however, shows an intense spot pattern oriented along the  $[\bar{1}11]_{\text{B2}}$  zone containing a weak diffuse ring pattern and superlattice reflections from  $\text{Ni}_4\text{Ti}_3$  precipitates. Thus, the severe damage under the spall penetrated to 4  $\mu\text{m}$  depths. Below 4  $\mu\text{m}$  depths, the material is mostly polycrystalline B2 matrix phase with the

expected  $\text{Ni}_4\text{Ti}_3$  precipitates, except for dispersed deformation bands of amorphous material (Fig. 6(b)). Since the microstructure was heavily distorted throughout the region where HRTEM was taken, measurements were taken directly from B2 structure nanocrystalline grains.

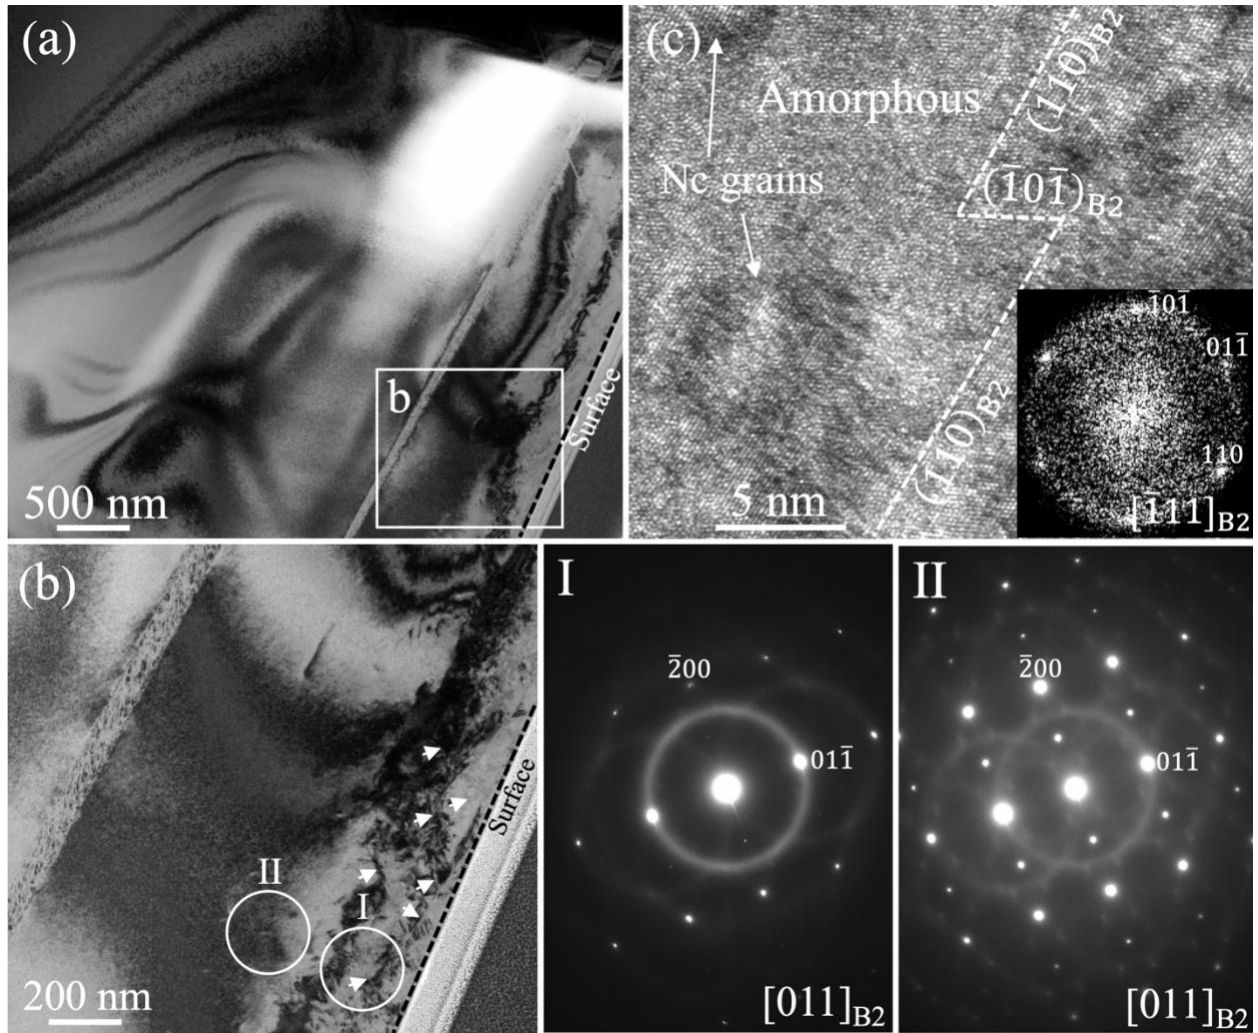
**Fig. 7.** (a) Low and (b) high magnification BF-TEM micrographs of the material beneath the surface of a  $\text{Ni}_{54}\text{Ti}_{45}\text{Hf}_1$  super-polished sample show deformation bands (e.g., those marked with white arrows in (b)) close to the surface. (I) SAED pattern taken close to the surface indicated by the white circle in (b), shows spots of a single B2 grain along  $[011]_{B2}$  zone, together with a diffuse rings corresponding to amorphous bands. Precipitates were not observed up to 350 nm into the sample. (II) SAED pattern taken 350 – 550 nm from the polished surface (per the ring labeled II in (b)) indicate a B2 grain oriented along the  $[011]_{B2}$  zone axis, together with a weak diffuse ring pattern of amorphous bands and  $\text{Ni}_4\text{Ti}_3$  superlattice reflections corresponding to  $\text{Ni}_4\text{Ti}_3$  precipitates. (c) HRTEM micrograph and corresponding FFT (inset) taken close to the surface shows an amorphous deformation band that contains B2 structured nanocrystalline (Nc) grains. The zig-zagged interface of the deformation band follows  $(110)_{B2}$  and  $(\bar{1}0\bar{1})_{B2}$  planes.

The super-polished  $\text{Ni}_{54}\text{Ti}_{45}\text{Hf}_1$  alloy microstructure close to the surface, shown in Fig. 7, exhibits similar signs of damage as that observed in the super-polished  $\text{Ni}_{55}\text{Ti}_{45}$  alloy (Fig. 4). Low and high magnification BF-TEM micrographs (Fig. 7 (a,b)) show deformation bands with average width of  $21 \pm 8$  nm with an average spacing of  $64 \pm 12$  nm within the damaged region (Table 1). They are most dense within the material 1  $\mu\text{m}$  beneath the surface of the sample. The SAED pattern taken near the surface (Fig. 7 (I)) shows a spot pattern of a single B2 grain oriented along  $[011]_{\text{B2}}$  zone together with a diffuse ring pattern from amorphized material.  $\text{Ni}_4\text{Ti}_3$  precipitates were not observed up to 350 nm beneath the surface of the sample. The HRTEM image (Fig. 7 (c)) and corresponding FFT (inset) taken close to the surface shows that the material within the deformation bands is mostly amorphous, but also contains B2 nanocrystals. The interface of the deformation band is zig-zagged, following  $(110)_{\text{B2}}$  and  $(\bar{1}0\bar{1})_{\text{B2}}$  planes. The dislocation density of the B2 matrix close to the surface is  $3.6 \pm 0.3 \times 10^{16}/\text{m}^2$ , or about half of that observed in the super-polished  $\text{Ni}_{55}\text{Ti}_{45}$  alloy (Table 1).

this depth beneath the surface. The existence of  $\text{Ni}_4\text{Ti}_3$  phase throughout the aged and undeformed B2 microstructure is expected from previous studies of the  $\text{Ni}_{54}\text{Ti}_{45}\text{Hf}_1$  alloy microstructure [25]. The weak diffraction signal from this phase, together with a change from unmottled to mottled contrast in the BF-TEM micrograph of Fig. 7(b) indicate that these precipitates were mostly dissolved up to  $\sim 350$  nm beneath the surface due to deformation induced by sample preparation (again, most likely the centerless grinding operation).

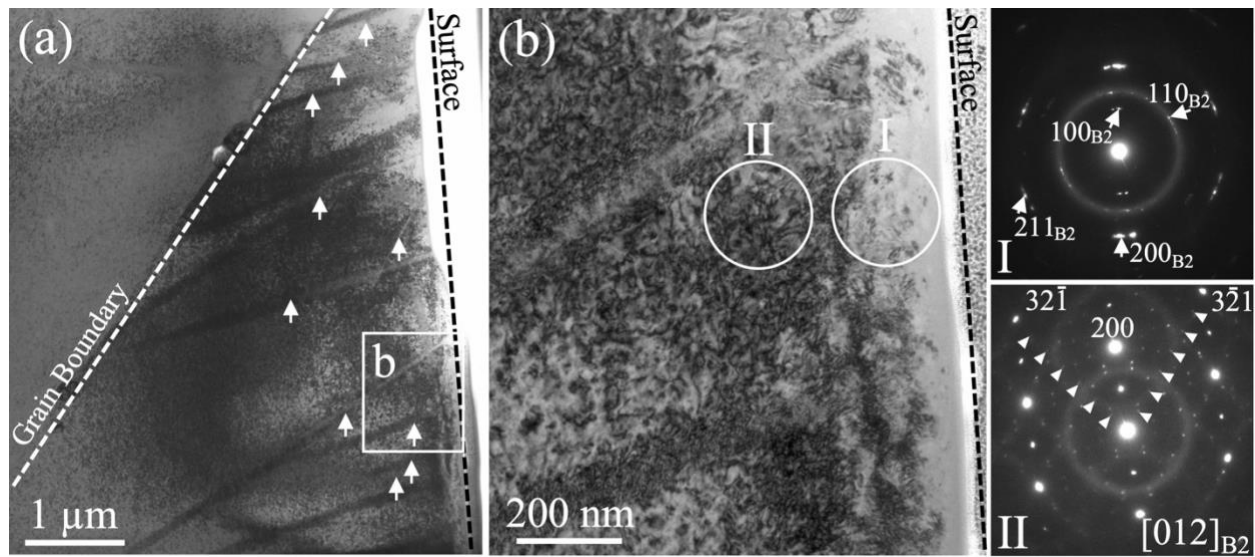
**Fig. 8.** (a) BF-TEM micrograph of the material beneath the surface of a  $\text{Ni}_{54}\text{Ti}_{45}\text{Hf}_1$  wear track that achieved the runout condition shows broad deformation bands (e.g., those marked with white arrows) propagating beneath the wear surface. (b) Magnified BF-TEM image indicated by the white box in (a). The material within the circled region marked I consists of a 200 nm amorphous surface layer containing B2 nanocrystals, as confirmed by (I) the corresponding SAED pattern, which exhibits a weak diffuse ring and sharp spots. Precipitates were not observed up to 250 nm into the sample. The material 250 – 450 nm beneath the wear track surface within the circle labeled II in (b), together with (II) the corresponding SAED pattern indicate a single B2 grain oriented along the  $[012]_{\text{B2}}$  zone axis, containing two variants of  $\text{Ni}_4\text{Ti}_3$  precipitates, as indicated by the superlattice reflections marked with white arrowheads.

Material beneath the surface of the worn, passed  $\text{Ni}_{54}\text{Ti}_{45}\text{Hf}_1$  wear track is shown in the BF-TEM micrograph of Fig. 8(a). The average width of the deformation bands increased by 4X compared to the as-polished condition, to  $85 \pm 20$  nm, while the average band spacing increased by more than 6X to  $422 \pm 232$  nm (Table 1). Recall that in the  $\text{Ni}_{55}\text{Ti}_{45}$  alloy, deformation bands were only observed to widen by  $\sim 20$  nm while the space between them concomitantly decreased by  $\sim 65$  nm; i.e., the changes in the deformation bands were well described as the existing bands coarsening due to the wear. In contrast, the changes in deformation band structure of the  $\text{Ni}_{54}\text{Ti}_{45}\text{Hf}_1$  alloy exhibit significant coalescence, in addition to coarsening. The worn deformation band structures were most dense up to  $3.5 \mu\text{m}$  beneath the surface, and some of them were observed to terminate at a grain boundary (white dashed line in Fig. 8(a)), though note that the contrast in the other grain is different – a few of them did transmit across the grain boundary as well.

amorphous material that contains a sparse distribution of B2 nanocrystals, again evidenced by diffuse ring and spot patterns. However, from Fig. 8(b), it appears that the material within 50 nm of the wear surface was almost completely amorphized – contrast from nanocrystals is more prevalent 50 – 200 nm beneath the surface. Ni<sub>4</sub>Ti<sub>3</sub> precipitates were not observed up to 250 nm into the sample. Following the same descriptions given in the previous analyses, the SAED pattern taken 250 – 450 nm from the surface (Fig. 8(II)), together with the dense mottling in the BF-TEM image (Fig. 8(b)) indicate that the material in between the deformation bands at depths greater than 250 nm below the surface is predominantly polycrystalline B2 matrix containing the expected distribution of Ni<sub>4</sub>Ti<sub>3</sub> precipitates. Similar to the Ni<sub>55</sub>Ti<sub>45</sub> alloy, the dislocation density of the B2 matrix close to the surface doubled due to wear, compared with the super-polished condition, only here to a lower overall density of  $6.7 \pm 0.2 \times 10^{16}/\text{m}^2$  considering the lower density in the super-polished material (Table 1).

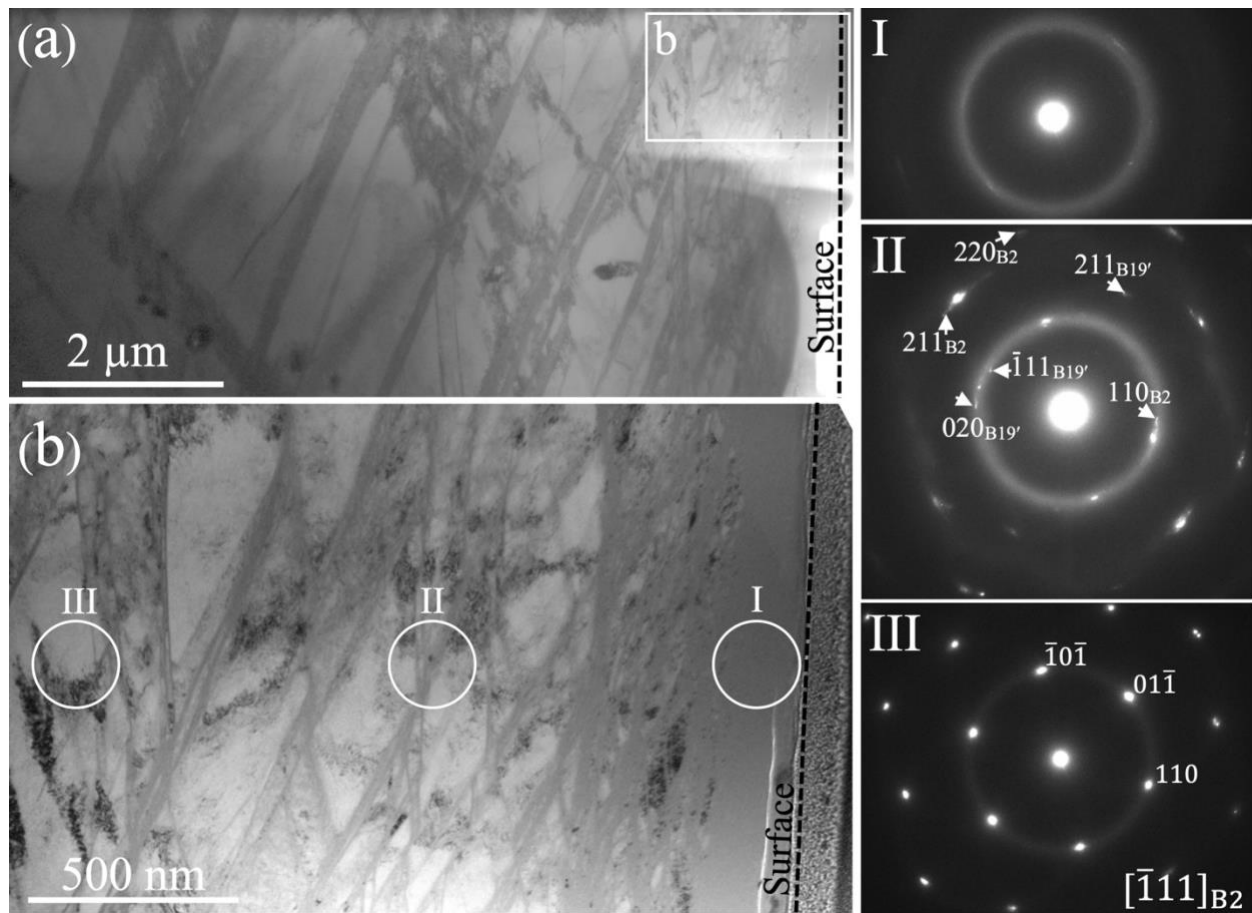
**Fig. 9.** (a) BF-TEM image of the material beneath a spalled region of a failed  $\text{Ni}_{54}\text{Ti}_{45}\text{Hf}_1$  spalled wear track shows the prevalence of deformation bands to more than  $7\ \mu\text{m}$  depths beneath the sample surface. (b) A higher magnification BF-TEM micrograph from the boxed region in (a), as well as (I-III) SAED patterns taken from the corresponding circled regions in (b). (I) a diffuse ring SAED pattern taken near the surface indicates predominantly amorphous phase. (II) a combined diffuse ring and spot SAED pattern taken  $800\ \text{nm} - 1\ \mu\text{m}$  beneath the surface indicates the presence of both an amorphous phase and B2/B19' nanocrystals. (III) SAED pattern taken  $1.6\ \mu\text{m}$  beneath the spalled surface indicates a single B2 grain oriented along the  $[\bar{1}11]_{\text{B2}}$  zone axis containing dispersed amorphous bands. Evidence for  $\text{Ni}_4\text{Ti}_3$  precipitates was not found anywhere within the FIB sample.

Electron microscopy observations of spalled Ni<sub>54</sub>Ti<sub>45</sub>Hf<sub>1</sub> (Fig. 9) indicates a microstructure similar to spalled Ni<sub>55</sub>Ti<sub>45</sub> (Fig. 6). Dense distributions of deformation bands extended more than 7  $\mu\text{m}$  beneath the spall surface (limitation of FIB sample size in the BF-TEM shown in Fig. 9(a)) in a morphology measured to be  $79 \pm 53$  nm wide with average spacing of  $93 \pm 46$  nm (Table 1). Relative to the worn, passed condition, the deformation bands are of the same average width, but greater variation in the widths was observed. However, they are much denser within the spalled material, as the spacing between them decreased by 4X. The magnified BF-TEM image (Fig. 9(b)) confirms that the deformation band density was higher close to the surface and further into the sample (1.5 – 7  $\mu\text{m}$ ) the bands were more dispersed.

The SAED pattern taken just beneath the surface (Fig. 9(I)) was predominantly a single diffuse ring, indicating the existence of a nearly completely amorphized layer of material within 200 nm of the spall surface. The SAED pattern taken 800 nm – 1  $\mu$ m from the surface (Fig. 9(II)) contained diffuse rings and spot patterns corresponding to the coexistence of amorphous material and B2/ B19' nanocrystals. The SAED pattern taken 1.6 – 1.8  $\mu$ m from the surface showed a much weaker diffuse ring with an intense spot pattern from a B2 crystal oriented along the  $[\bar{1}11]_{B2}$  zone (Fig. 9(III)). Note that Ni<sub>4</sub>Ti<sub>3</sub> precipitates were not observed anywhere in the foil, indicating a denuded precipitate zone that extended at least 7  $\mu$ m beneath the spall surface. The dislocation density within the B2 nanocrystals that could be analyzed with HRTEM nearest to the surface was  $9.9 \pm 0.2 \times 10^{16}/\text{m}^2$  (Table 1). This maximum measured dislocation density is less than that observed of the spalled Ni<sub>55</sub>Ti<sub>45</sub> alloy, though sample preparation differences could also be a factor.

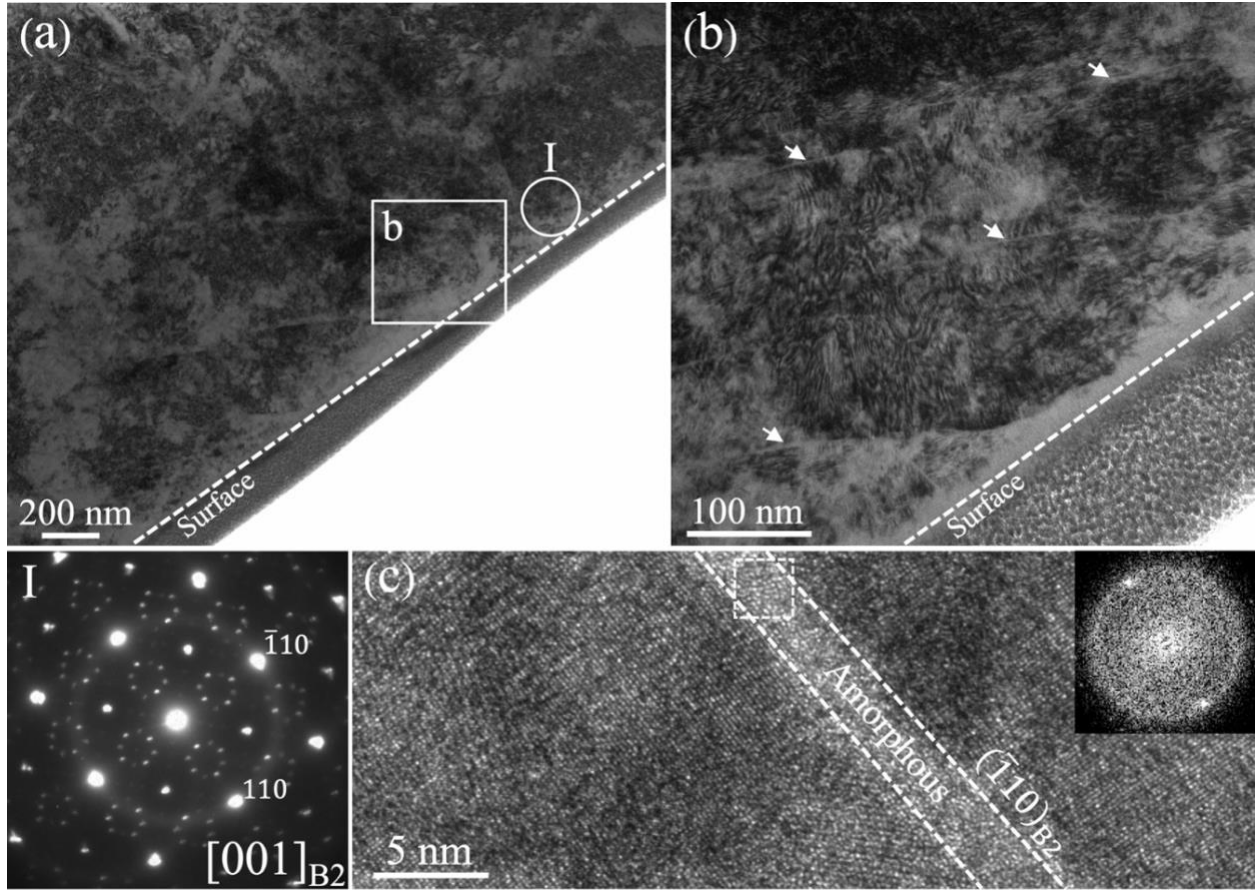
**Fig. 10.** (a) Low and corresponding (b) high magnification BF-TEM micrographs of the material beneath the super-polished (unworn) surface of a  $\text{Ni}_{56}\text{Ti}_{36}\text{Hf}_8$  sample. The deformed microstructure contains narrow deformation bands (e.g., those marked with white arrows in (b)). (I) SAED pattern taken near the surface (as circled in (a)) indicates a single B2 grain oriented along the  $[001]_{\text{B2}}$  zone axis (bright spots), containing amorphous bands (weak diffuse ring pattern), and H-phase/cubic  $\text{NiTiHf}$  phase precipitates (superlattice reflections). (c) HRTEM image and corresponding FFT (inset) indicates an amorphous deformation band within interfaces along  $(\bar{1}10)_{\text{B2}}$  planes.

Based on concurrent studies [ ] the microstructure of undamaged, aged Ni<sub>56</sub>Ti<sub>36</sub>Hf<sub>8</sub> material is expected to be a 3-phase mixture of ~ 10 to 20 nm sized H-phase precipitates and precipitates of a newly identified NiTiHf cubic phase densely packed together within a B2 matrix phase (e.g., Table 1 and Figs. 8-9 of [ ]). The specimen FIB'd from the super-polished, unworn surface of a Ni<sub>56</sub>Ti<sub>36</sub>Hf<sub>8</sub> RCF sample is shown in Fig. 10. The lower resolution BF-TEM micrographs (Fig. 10(a-b)) show that much less damage occurred within this sample during fabrication relative to the Ni<sub>54</sub>Ti<sub>45</sub>Hf<sub>1</sub> (Fig. 7(a-b)) and Ni<sub>55</sub>Ti<sub>45</sub> (Fig. 4(a-b)) alloys. The expected mottled contrast in the BF-TEM images from the 3-phase nanostructured mixture is evident

throughout the sample. Deformation bands are only observed within 300 nm of the surface. Comparatively, they are incredibly fine, with average width of  $9 \pm 3$  nm (indicated by white arrows), and also sparser, with average spacing of  $178 \pm 86$  nm (Table 1).

The SAED pattern in Fig. 10(I) taken from region I in Fig. 10(a) shows a spot pattern of a single B2 grain oriented along the  $[001]_{B2}$  zone together with superlattice reflections originating from H-phase  $[40,41]$  and the cubic NiTiHf precipitate phase, confirming the expected microstructure exists throughout the sample [add a ref to the current paper describing this phase]. Consistent with other reports of undeformed, aged Ni<sub>56</sub>Ti<sub>36</sub>Hf<sub>8</sub>, the average size of the cubic NiTiHf precipitates was measured to be  $17 \pm 3$  nm and H-phase precipitates  $25 \pm 7$  nm (length),  $15 \pm 2$  nm (width). The average width of the narrow B2 channels is  $9 \pm 2$  nm and the measured dislocation density within these channels is  $4.1 \pm 0.3 \times 10^{16}/m^2$ . The weak intensity of the diffuse ring pattern in Fig. 10 (I) is consistent with the signal expected from the existence of amorphous material within the fine, sparse deformation bands. The HRTEM image (Fig. 10(c)) and corresponding FFT (inset) taken just beneath the surface confirm the amorphous structure of a 2 – 4 nm wide deformation band surrounded by crystalline nano precipitates and B2 matrix. However, other deformation bands that extended further beneath the surface were observed to be crystalline, of B2 structure.

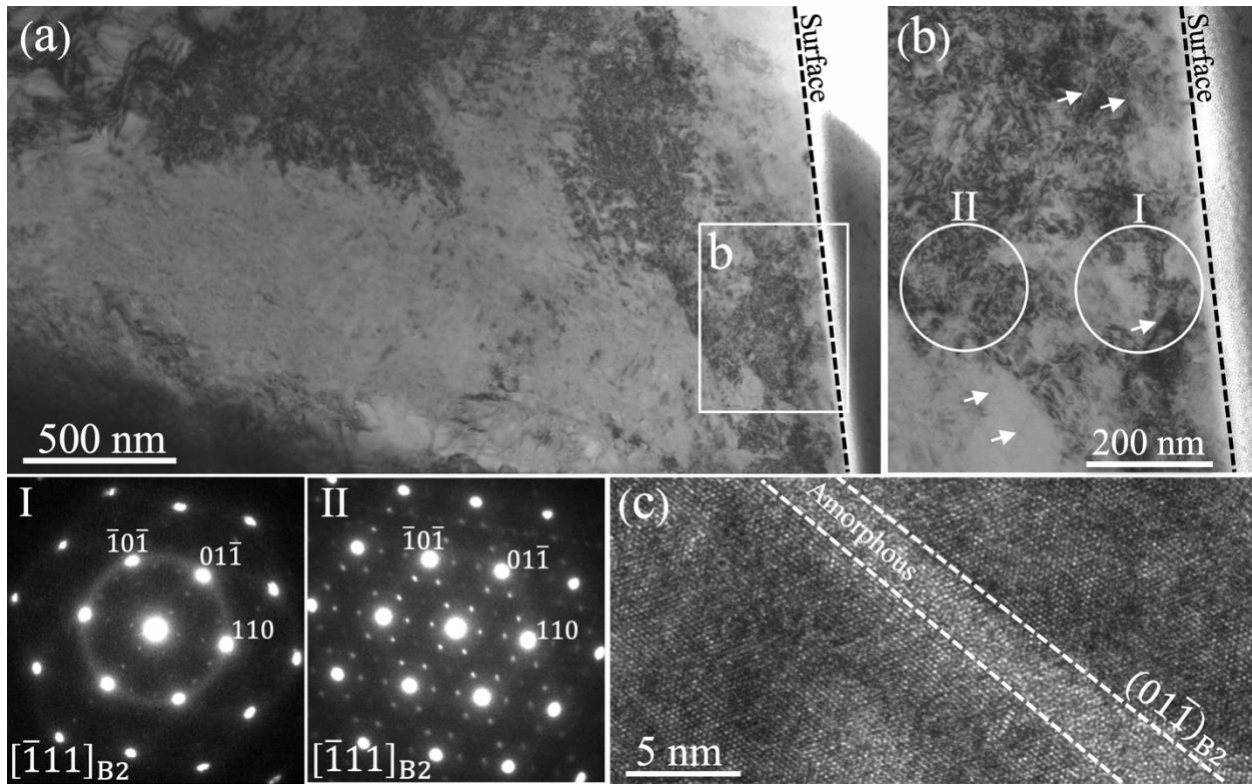
**Fig. 11.** (a) BF-TEM image of the material beneath a runout wear track of a Ni<sub>56</sub>Ti<sub>36</sub>Hf<sub>8</sub> sample. The corresponding (b) magnified BF-TEM micrograph shows narrow deformation bands (e.g., those marked with white arrows) within the region less than 500 nm from the surface. (I) SAED pattern taken near the surface, as circled in (b), contains an intense spot pattern corresponding to a single grain along  $[\bar{1}11]_{B2}$  zone, a diffuse ring originating from thin amorphous deformation bands and weak superlattice reflections from H-phase and cubic NiTiHf precipitates. (II) SAED pattern taken 300 – 500 nm from the surface, as circled in (b), along  $[\bar{1}11]_{B2}$  zone of the B2 matrix, contains a very weak diffuse ring from a few amorphous bands and intense superlattice reflections from H-phase and cubic NiTiHf precipitates. (c) HRTEM micrograph taken close to the surface shows a narrow amorphous deformation band with interfaces that follow  $(01\bar{1})_{B2}$  planes.

The microstructure of worn Ni<sub>56</sub>Ti<sub>36</sub>Hf<sub>8</sub> material under a passed wear track of an RCF sample is shown in Fig. 11. The BF-TEM micrographs of Fig. 11(a,b) show narrow deformation bands, such as those indicated with white arrows in Fig. 11(b). The average width of the deformation bands was  $10 \pm 3$  nm, their average spacing was  $102 \pm 36$  nm within the material

500 nm beneath the surface. The SAED pattern taken at the surface (Fig. 11(I)) shows a spot pattern of a single B2 grain oriented along the  $[\bar{1}11]_{B2}$  zone, a diffuse ring pattern from amorphous material, and weak superlattice reflections from H-phase and cubic NiTiHf precipitates very near the surface. The low intensity of the precipitates indicates that some precipitate dissolution occurred within the first several hundred nanometers of material beneath the wear surface. The HRTEM micrograph in Fig. 11(c), taken close to the surface, shows that amorphization occurred within a narrow (2 – 4 nm wide) deformation band that has interfaces that lie along  $(01\bar{1})_{B2}$  planes.

300 – 500 nm beneath the surface, the SAED pattern (Fig. 11(II)) contains a very weak diffuse ring originating from the presence of a few amorphous bands and an intense spot pattern of a B2 crystal oriented along the  $[\bar{1}11]_{B2}$  zone together with H-phase and cubic NiTiHf superlattice reflections. Similar to the other alloys, the dislocation density within the narrow ( $11 \pm 5$  nm) B2 channels approximately doubled relative to the super-polished condition, to  $7.7 \pm 0.2 \times 10^{16}/m^2$ . H-phase precipitates coarsened to  $43 \pm 17$  nm (length) and  $28 \pm 8$  nm (width) due to the wear; however, B2 channel sizes and cubic NiTiHf precipitate sizes did not change. This result implies that the H-phase precipitates tend to coalesce as a result of deformation.

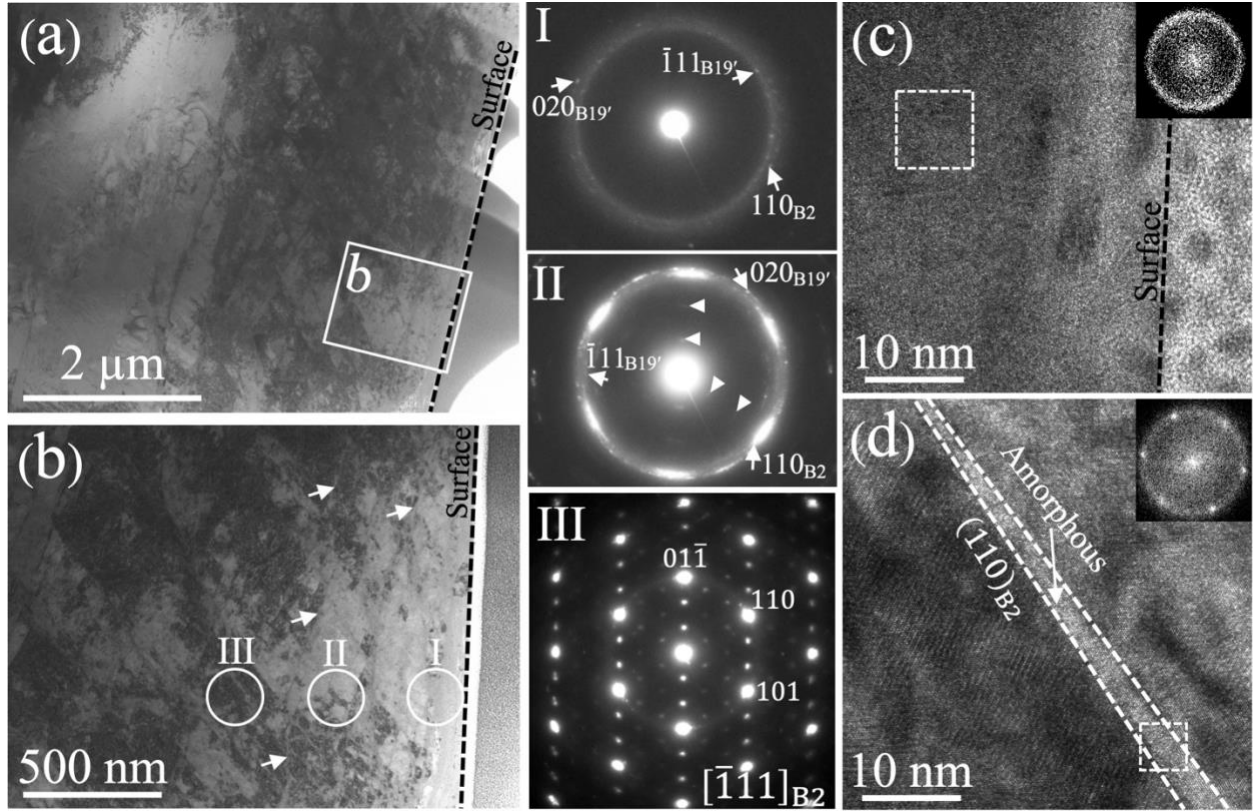
**Fig. 12.** (a) Low and (b) high magnification BF-TEM micrographs of the material beneath a spalled region of a failed wear track of a  $\text{Ni}_{56}\text{Ti}_{36}\text{Hf}_8$  sample shows that the heavily damaged region extends  $1.5\ \mu\text{m}$  beneath the surface. Narrow deformation bands are marked with white arrows in (b), and regions corresponding to the electron diffraction patterns that are presented are circled. (I) SAED pattern taken near the surface indicates the presence of an amorphous phase (diffuse ring) and both B2 and B19' nanocrystals (spots). (II) SAED pattern taken 200 – 400 nm beneath surface indicates a greater density of B2 and B19' nanocrystalline grains (more intense spots) together with the amorphous phase (diffuse ring pattern). Additional faint reflections such as those indicated by white arrowheads correspond to precipitation. (III) SAED pattern taken 700 – 900 nm from surface indicates a single B2 grain oriented along the  $[\bar{1}11]_{\text{B2}}$  zone axis, small amounts of amorphous phase (a weak diffuse ring) and H-phase/cubic  $\text{NiTiHf}$  precipitates (superlattice reflections). This corresponds closely with the typical 3-phase crystalline structure for the alloy in the undeformed super-polished condition (Fig. 10). (c) HRTEM micrograph taken near the surface and corresponding FFT (inset), which confirms a fully amorphous structure very near the wear surface. (d) HRTEM micrograph taken in the primarily crystalline region (III) and corresponding FFT (inset) shows an amorphous deformation band with interfaces that follow  $(110)_{\text{B2}}$  planes.

The spalled microstructure of the Ni<sub>56</sub>Ti<sub>36</sub>Hf<sub>8</sub> alloy is shown in Fig. 12. The BF-TEM micrographs of Fig. 12(a,b) indicate that most of the damage occurred within 1.5  $\mu$ m beneath the surface, in contrast to the other alloys where significant damage was observed throughout the entirety of the spalled samples (Ni<sub>55</sub>Ti<sub>45</sub> (Fig. 6(a)) and Ni<sub>54</sub>Ti<sub>45</sub>Hf<sub>1</sub> (Fig. 9(a))). Still, the spalled Ni<sub>56</sub>Ti<sub>36</sub>Hf<sub>8</sub> (Fig. 12(a,b)) is significantly more damaged than the untested (Figs. 10(a,b)) and

worn-but-not-failed (Figs. 11(a,b)) material. Narrow deformation bands within the damaged region have an average width of  $10 \pm 5$  nm and are spaced  $64 \pm 18$  nm apart. The diffuse ring and spots of the SAED pattern taken at the surface (Fig. 12(I)) indicate that just beneath the surface, the material structure is B2 and B19' nanocrystals grains within an amorphous phase. The amorphous surface layer was confirmed by the maze-like pattern in the HRTEM micrograph (Fig. 12(c)) and corresponding FFT pattern (inset). This mostly amorphous layer extended 100 nm beneath the surface.

200 – 400 nm beneath the surface, the diffuse ring and more intense B2/B19' spots of the SAED pattern (Fig. 12(II)) indicate a higher volume fraction of nanocrystals exist together with the amorphous phase. Faint superlattice reflections (e.g., those marked with white arrowheads) corresponding to precipitate phases are also observed, indicating that precipitate dissolution occurred, but not completely. 700 – 900 nm beneath the spall surface fewer amorphous bands and more/larger H-phase and cubic NiTiHf precipitates were observed, as evidenced by the SAED pattern (Fig. 12(III)) and the HRTEM micrograph and corresponding FFT (Fig. 12(d)). Similar to the NiTiHf alloy, the dislocation density within the B2 material near to the surface, just beneath the amorphous layer, has increased to  $9.2 \pm 0.2 \times 10^{16}/\text{m}^2$ .

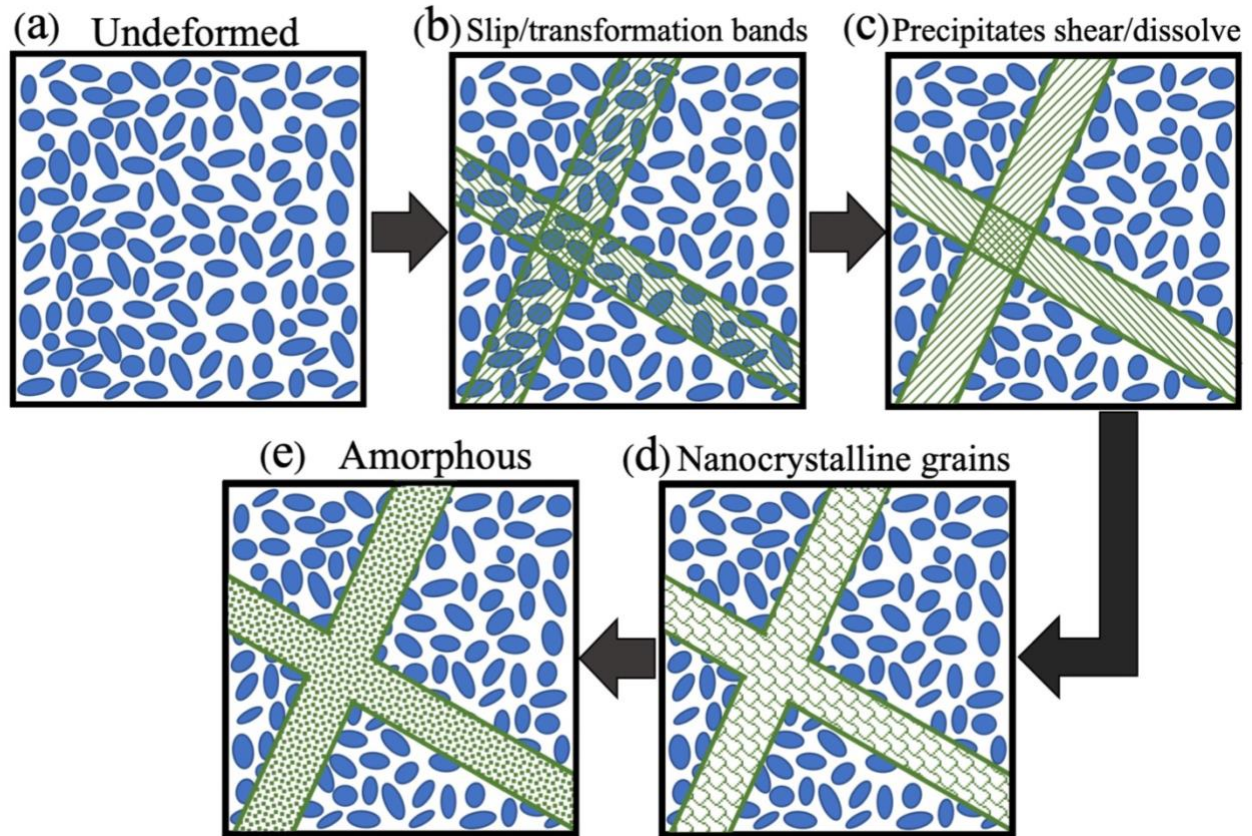
**Fig. 13.** Schematic illustrating the proposed mechanistic sequence that ultimately leads to the formation of amorphous deformation bands within these NiTi-based alloys. (a) Initially (undeformed) the alloys are B2 polycrystals that contain a homogenous distribution of strengthening nanoprecipitates. (b) Initially, localized slip and/or martensitic transformation leads to dislocation accumulation on deformation bands/transformation fronts, then (c) precipitates shear and dissolve within the deformation bands, while (d) dislocation structures rearrange into cells resulting in the formation of nanocrystals, and (e) eventual amorphization. Our results (Figs 5,6,8,9,11,12) indicate that in the most heavily damaged regions, completely amorphized regions/bands are observed, while in less damaged regions, mixtures of these states are observed.

Altogether, the proposed deformation mechanism sequence to accommodate RCF-induced damage in precipitate-strengthened, nickel-rich NiTi and NiTiHf alloys is schematically illustrated in Fig. 13. First, slip occurs within the B2 matrix. Then, localization of that slip

nucleates deformation bands, and further concentration of the slip within the deformation bands coarsens them. Eventually, they consume the strengthening precipitates via shear and dissolution. Then, when the dislocation densities are high enough, cellular patterns of dislocations form nanocrystals, and localization of chemical and mechanical thermodynamic driving forces cause some of those nanocrystals to transform to martensite. Finally, full amorphization occurs, first within the bands, and then as the bands coalesce, eventually complete layers of amorphous material are created, leading to spall failures in the RCF tests when they can no longer accommodate anymore deformation.
