A cracking oxygen story: a new view of stress corrosion cracking in titanium alloys

Keywords: stress corrosion, dislocations, oxygen, hydrogen, atom probe, electron-energy loss spectroscopy

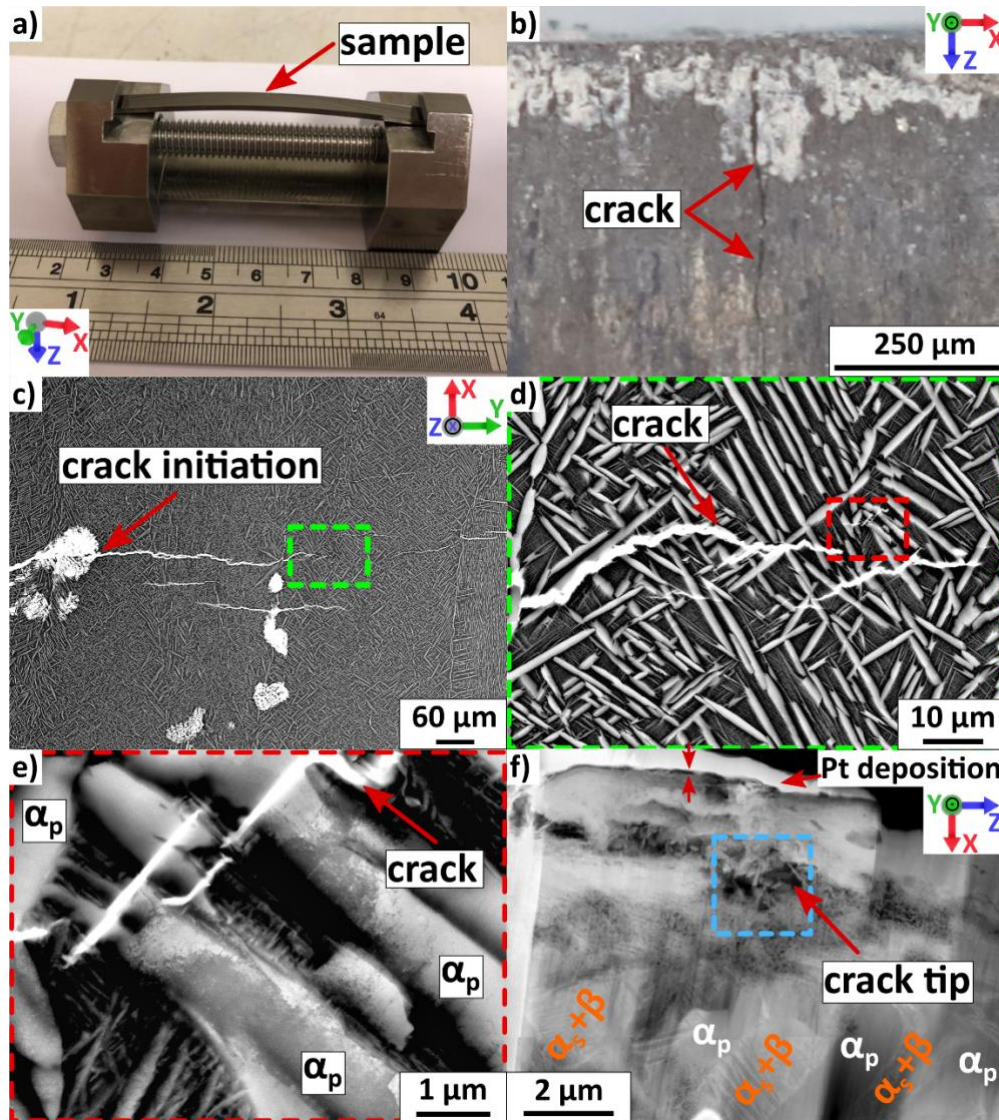
Figure 1: Hot salt stress corrosion cracking in alloy Ti-6Al-2Sn-4Zr-6Mo. (a) Sample loaded in a two-point bending rig before heat treatment. (b) Optical image showing one of the cracks in the sample after testing. Inverse contrast ECCI micrographs showing: (c) a representative crack initiation site and crack growth within the specimen, (d)-(e) zoomed in detail of the crack tip from the crack initiated from where a salt crystal was located. (f) Zoomed-in detail of the crack tip area, from a FIB-lift out TEM foil imaged using HAADF-Scanning transmission electron microscopy. The blue dashed box in (f) denotes the region where the EELS analysis was performed in **Error! Reference source not found.5**.

Figure 1a shows the 2-point bending set-up, at which specimens of Ti6246 were loaded at 650 MPa (~60% of the yield strength) with a drop of NaCl deuterated salt solution, in a stream of D₂¹⁸O vapour with ¹⁶O₂ carrier gas at a pressure of 0.2 bar and 450°C for 100 h. One of the resulting cracks, initiated where a salt crystal was located revealed by the presence of a crater, is shown in detail in **Error! Reference source not found.**b–e, illustrating the multi-scale nature of microstructural cracking. Note that the electron channelling contrast images in Figure 1c–e were captured in reversed contrast mode, which explains the bright contrast of the crack. A rutile TiO₂ film thinner than 100nm is observed at the surface of the specimen, indicated by red arrows in **Error! Reference source not found.**f. This film is far thicker than arises without the application of salt[21]. The microstructure, Figure 1c–e, consists of primary plates ~20 µm long of the hcp α_p-Ti phase in a basketweave morphology, in a matrix of bcc β-Ti containing nm-scale secondary α_s-Ti plates. The crack traverses this microstructure with only minimal deflection by the microstructural features, which is a typical so-called brittle behaviour usually reported for ductile metallic alloys under stress-corrosion cracking conditions[22].

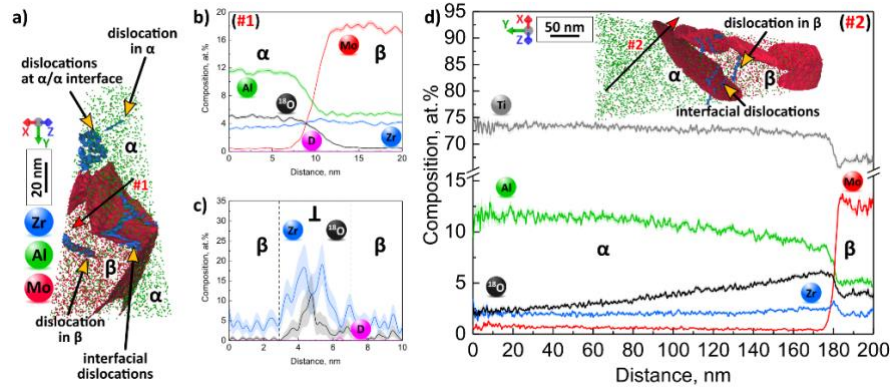
Figure 2: Atom probe microanalyses. (a) APT reconstruction from a high dislocation density region ahead of a crack showing α/β and α/α interfaces and dislocations within the α and β phases and at the α/β interface. The dislocations are shown with an iso-composition surface at 5.9 at.% Zr and the α/β interface is shown with an iso-composition surface at 12 at.% Mo. (b) 1D composition profile across the α/β interface as indicated by arrow #1. (c) 1D composition profile across a dislocation in the beta phase. (d) 1D composition profile across the α/β interface in a different APT reconstruction as indicated by arrow #2, inset, from a high dislocation density region ahead of a crack. Error bars are shown as lines filled with colour and correspond to the 2σ counting error.

We prepared a series of APT specimens every 2–3 µm ahead of the crack tip, with the needle-shaped specimen tip approx. 300–500nm below the exposed surface. The APT analysis, from ~5 µm ahead of the crack tip, shown in Figure 2**Error! Reference source not found.**a reveals almost no pick-up of D (<0.06 at.%). The composition of ¹⁸O resulting from the water vapour in the gas stream is remarkably high at ~5 at.% of ¹⁸O, and as expected, oxygen segregates to the α phase, Figure 2b. The base alloy contained around 1800 ppmw ¹⁶O (0.5 at.%), which is used as a solid solution strengthener of the majority α phase. Beyond around 2500 ppmw (0.8 at.%) O, titanium alloys are found to be brittle with negligible ductility, because O affects the dislocation behaviour. In the literature at least two possible mechanisms are discussed, (i) by enhancing Ti₃Al precipitation result in a requirement for dislocations to travel in pairs, which supresses cross slip and results in localisation into slip bands, and (ii) as a consequence of strongly repulsive solute-dislocation interaction, meaning that gliding dislocations must clear the slip plane of interstitials, resulting in a pinning effect and in localisation[23]. Within β, Zr segregates along linear features, identified as dislocations in other alloy systems[24,25]. A compositional analysis from the core of this segregated region, Figure 2c, revealed almost 12 at.% ¹⁸O, but no D. There was also a slight increase in the H and ¹⁶O signals, which can be attributed to the changes in the field evaporation behaviour at the linear defect. Zr excess was also observed in the

interface, Figure 2b **Error! Reference source not found.** & Figure 2d, believed to be associated with Zr segregation to interface (misfit) dislocations, which is also present in the undeformed sample[26]. No D or ^{18}O excess was observed at the α/β interface.

The presence of ^{18}O at dislocations in β is indicative of the possibility of pipe diffusion of oxygen[27]. The composition profile in Figure 2Error! Reference source not found.d was obtained from an APT analysis obtained almost at the crack tip. This evidences a strong ^{18}O ingress into α , which extends over a very substantial distance – over 150 nm, from the α/β interface. The high concentration of ^{18}O in β is a strong indication that the continuous network of β helps with the penetration of oxygen within the alloy, since O has a much higher diffusivity in β compared to α [28]. The presence of a high density of dislocation in this region can help increase the amount of O accommodated within β , especially in light of Figure 2Error! Reference source not found.c, and facilitate O transport via pipe diffusion[27,29] through solute dragged by moving dislocations[30,31]. These mechanisms may facilitate the ingress of O into α .

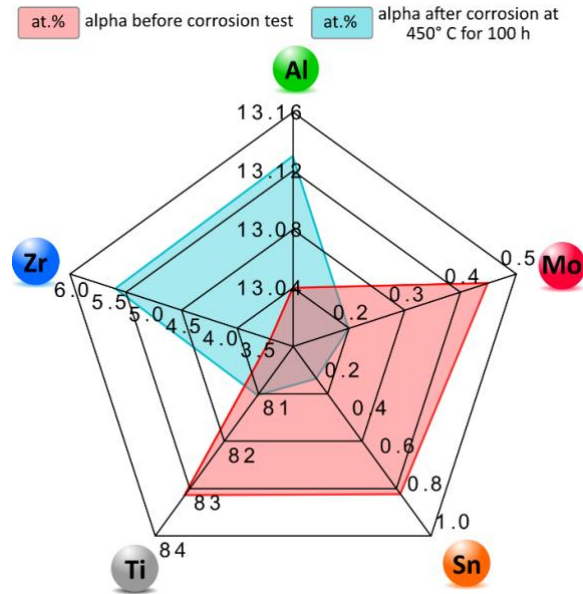
Figure 3: Comparison of atom probe results for the α_p composition before corrosion cracking (red) and after corrosion cracking, near the crack tip (blue). Relatively large decreases in Mo and Sn are observed, and an increase in Zr content.

We also performed APT prior to stress-corrosion testing. The composition of the α phase is notably different after corrosion cracking at the crack tip, where the Ti content decreases from 83 to 81 at.%, Sn from 0.8 to 0.1 at.% and Mo from 0.45 to 0.2 at.% whilst the Zr content increases from 3.2 to 5.6 at.% (Figure 3). In previous work, we have observed the formation of alloy chlorides in the interaction layer with the salt particle consistent with this result, and long-range transport of solutes in highly plastically deformed regions has also been observed in Ni superalloys[32,33]. Increases in Zr content in TiZr binary alloys have previously been associated with an increase in hardness and drop in toughness[34,35].

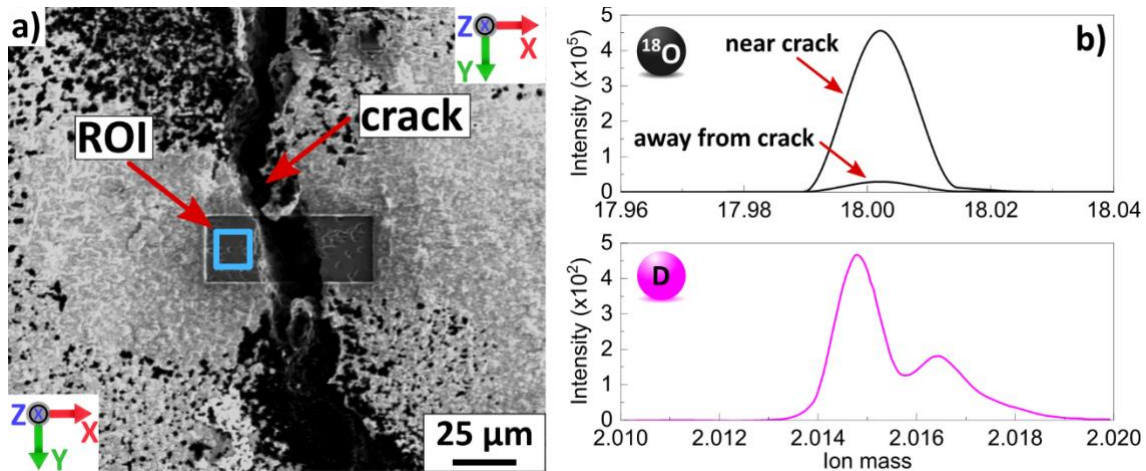
Figure 4: ToF-SIMS analysis adjacent to crack. (a) Scanning electron microscopy image showing the region from which ToF-SIMS spectrum were captured. (b) Oxygen and deuterium mass spectra obtained near the crack.

Given the understanding that stress corrosion embrittlement in Ti alloys is caused by hydrogen, a very low concentration of D was unexpected. To complement the APT analyses, time-of-flight secondary-ion mass spectrometry (ToF-SIMS) spectra were also obtained from regions adjacent to the crack in samples maintained at cryo-temperature (see methods), Figure 4. The sample surface is covered by the corrosion deposits which hides the underlying microstructure. These analyses also showed substantial enhancement of ^{18}O in a $\sim 20\ \mu\text{m}$ region adjacent to the crack wall, far higher than the ^{18}O concentration measured in the rest of the sample. We have observed both ^{18}O and ^{16}O peaks, however, only the ^{18}O peak is shown for clarity to eliminate ^{16}O counts coming from the atmospheric oxygen. In contrast, whilst some D was measured, this was at a level over 1000 times lower than for ^{18}O and barely higher than for the H_2^+ ion usually found in the ultrahigh vacuum system.

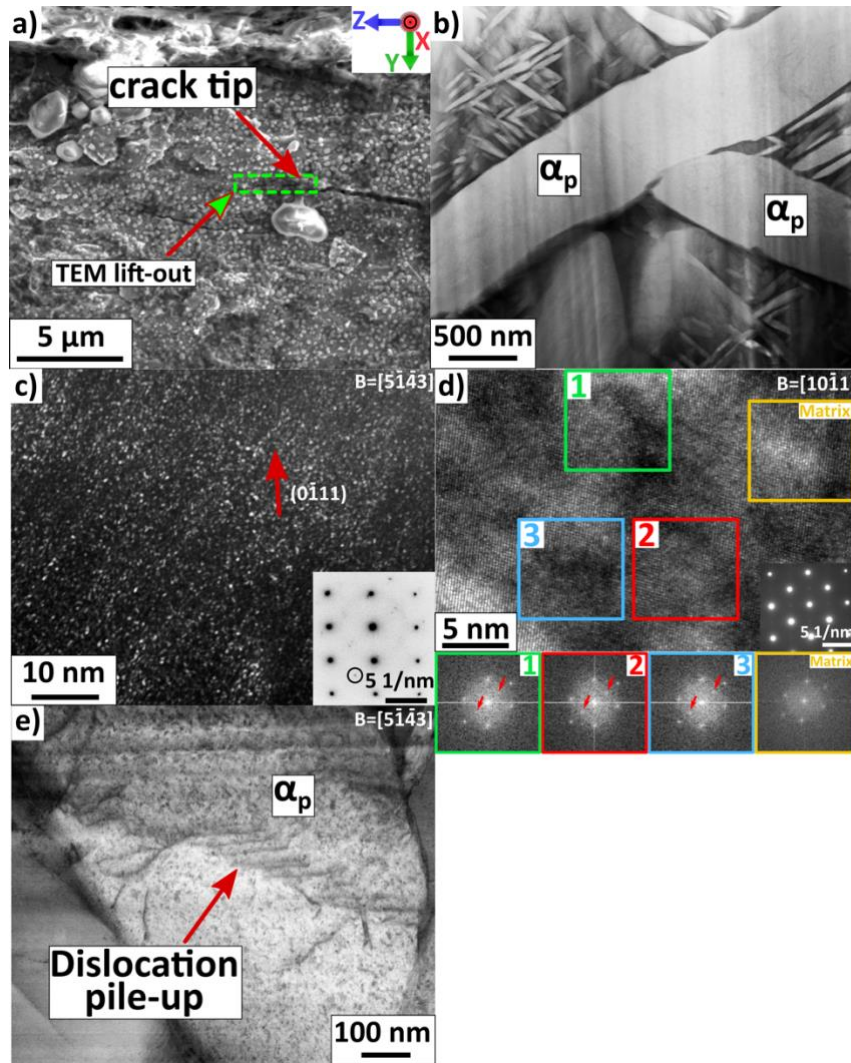
Figure 4: TEM analysis at the crack tip. (a) SEM image showing the location from where the TEM lift-out was made ahead of the crack tip. (b) STEM BF image showing the region analysed in the foil. (c) TEM dark field image showing nanosized Ti_3Al precipitates in the primary α phase. (d) HRTEM image showing the precipitates and 1-4 the corresponding FFT with superlattice spots in 1-3. (e) BF-STEM image showing $\langle a \rangle$ basal pile-up under $B = [5 \ 1 \ 4]_3$.

To better understand the cracking process and its interplay with local composition, a TEM specimen was prepared from the crack tip, Figure 6a (see methods for details). The analysis was done on the α_p grains of this TEM foil, Figure 6b. Ti_3Al precipitates, on the order of few nm in size, could readily be observed near the crack in dark field imaging with the superlattice reflection (shown with a circle in the inset of the figure), Figure 6c. High-resolution imaging was performed, Figure 6d, and FFT pseudo-diffraction patterns were obtained from those precipitate. An FFT from the matrix without precipitates is also shown for comparison. O reduces the solubility of Al in α -Ti, leading to local clustering. Dark field imaging on the sample far away from the crack also showed Ti_3Al precipitation, albeit with an apparently lower number density.

BF-STEM imaging revealed the presence of a slip band piled-up near the crack at an α_p grain, Figure 6(f), which was found to be composed of basal $\langle a \rangle$ dislocations by g.b invisibility analysis under two beam conditions. The α_2 Ti_3Al phase is an ordered *hcp* superstructure of the α phase and therefore dislocations are required to traverse it in pairs, which reduces the propensity for cross slip and hence, forest hardening. Slip bands are therefore a flow localisation mechanism that can produce high stress along slip bands, leading to crack propagation. Previously, oxygen associated with oxidation of a titanium surface has been shown to cause Ti_3Al precipitation[37], consistent with the ternary Ti-Al-O phase diagram. The influence of the level of oxygen on slip planarity in Ti-Al alloys was also reported by Gray et al.[38]. Others also observed that dislocations, e.g. those associated with a crack tip plastic zone, can enhance oxygen ingress into titanium surfaces[39].

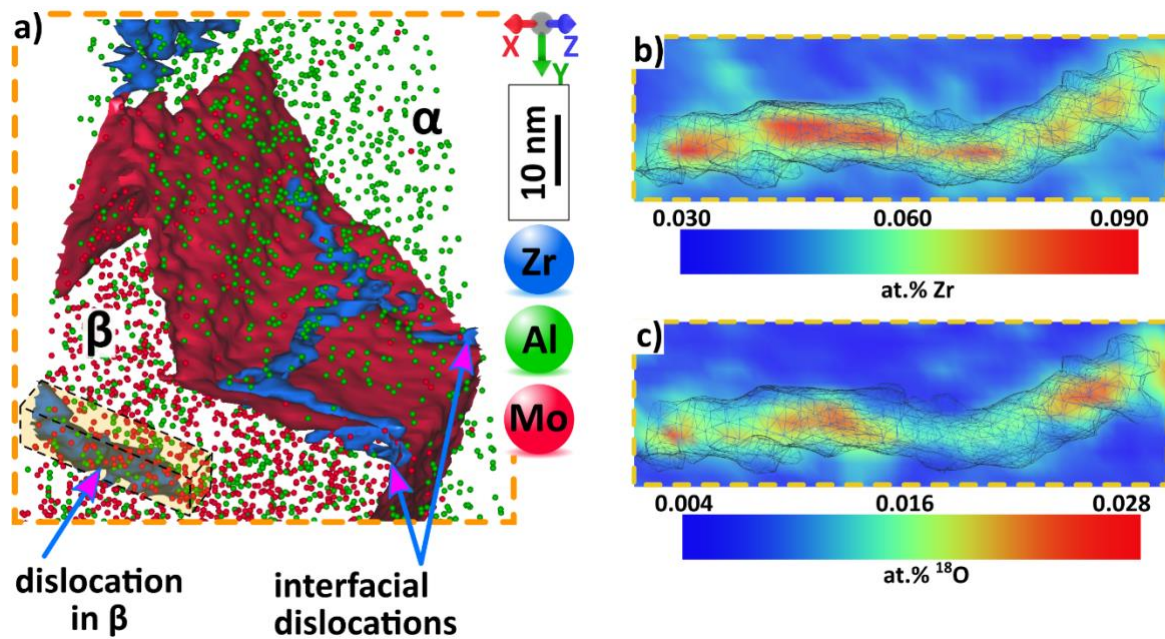
Figure 7: Detail from the APT reconstruction in Figure 2a, showing the interfacial dislocations and dislocation in the beta phase. b) and c) 2D contour map of Zr and ^{18}O for the dislocation in beta as denoted by the yellow sampling box at the bottom-left of (a).

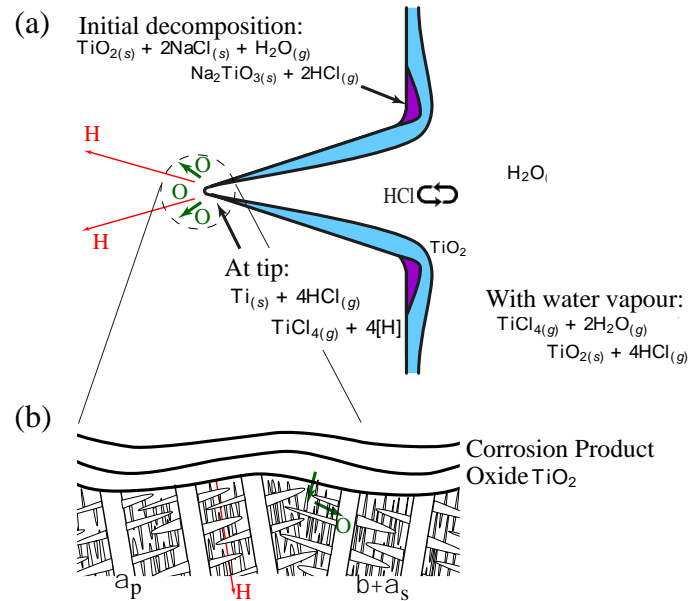
Figure 8: Schematic of the corrosion implantation process. (a) showing the initial decomposition of the NaCl and then cycling of Cl to crack water vapour in the gas stream and implant solute [O] and [H] (adapted from [8]), and (b) at the crack tip showing diffusion away through the β matrix of the implanted [H], with low solubility in the α ; and via pipe diffusion of solute [O] in β to then enter and embrittle the α phase.

results suggest that there in contrast, hydrogen originating from the dissociation of $D_2^{18}O$ either forms hydrides on the surface (which we have observed), penetrates and subsequently diffuses away into the beta (which is effectively an infinite sink for a large component and a small corrosion site), or simply recombines at the surface. A possible schematic is provided in Figure 8.
