Quality Control (QC) of FBK Preproduction 3D Si Sensors for ATLAS HL-LHC Upgrades

ABSTRACT: The challenging demands of the ATLAS High Luminosity (HL-LHC) Upgrade aim for a complete swap of new generation sensors that should cope with the ultimate radiation hardness. FBK has been one of the prime foundries to develop and fabricate such radiation-hard 3D silicon (Si) sensors. These sensors are chosen to be deployed into the innermost layer of the ATLAS Inner Tracker (ITk). Recently, a pre-production batch of 3D Si sensors of $50 \times 50 \mu\text{m}^2$ pixel geometry, compatible with the full-size ITKPix (RD53B) readout chip, was fabricated. Two wafers holding temporary metal were diced at IZM, Germany, and a systematic QC test campaign was carried out at the University of Trento electronics laboratory. The paper briefly describes the 3D Si sensor design for ATLAS ITk and the required QC characterization setups. It comprises electrical tests (i.e., I-V, C-V, and I-T) of non-irradiated RD53B sensors. In addition, the study of several parametric analyses, i.e., oxide charge density, oxide thickness, inter-pixel resistance, inter-pixel capacitance, etc., are reported with the aid of P

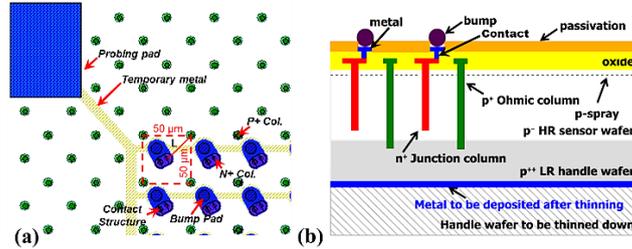
Figure 1: (a) micrograph of $50\times 50\ \mu\text{m}^2$ layout geometry. 'L' is the interelectrode distance, $\sim 35\ \mu\text{m}$, and (b) schematic cross-section (not to scale).

implemented at FBK to address this issue, reducing the ReadOut Chip (ROC) input capacitance. The state-of-art Deep Reactive Ion-Etching (DRIE) process used to create 3D electrodes has an aspect ratio of about 30:1, compatible with active substrate thickness (150 μm). An FBK pre-production batch of $50\times 50\ \mu\text{m}^2$ geometry was recently released with the temporary metal (Figure 1a). Figure 1b shows the 3D Si sensor cross-schematic fabricated on the 6-inch wafer. The single-sided process has been adopted to assure mechanical integrity, a lower risk of high wafer bow, and bump-bonding complexity.

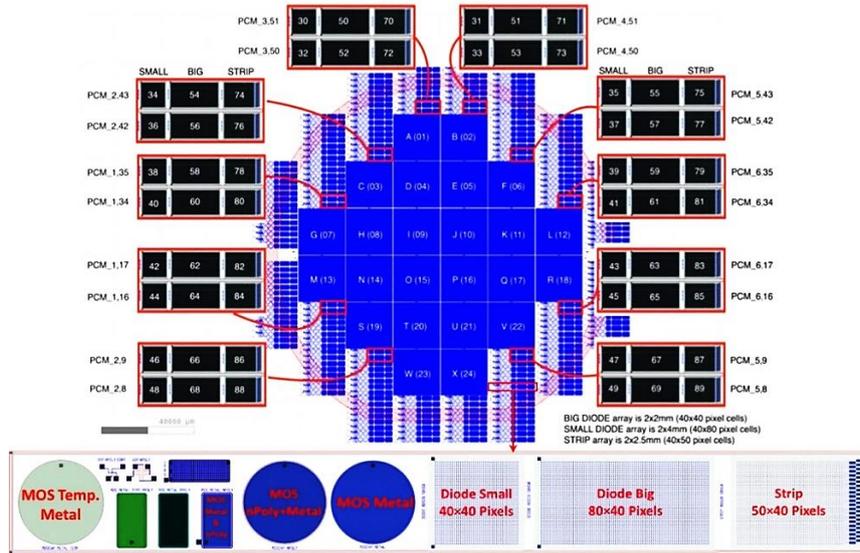
Figure 2: Wafer layout details.

As a part of the fabrication steps, DRIE is applied to form P⁺-columns through 150 μm high-resistive silicon after the necessary oxidation and implantation of p-spray to the sensor front side, penetrating the low-resistive 500 μm handle wafer (thus allowing the sensor back bias). N⁺-columns are formed at a safety distance of 25 μm from the handle wafer to avoid an early breakdown. Both columns are doped with the respective dopants by the thermal diffusion process, followed by filling (at least partially) with poly-Si. A small extrusion poly-Si cap structure is kept in the column openings for a lower leakage current [6]. Several layers of tetra-ethyl-ortho-silicate (TEOS) oxide are poured into protecting the etched columns. Near N⁺-columns, metal and n-poly Si are separated by $\sim 150\ \text{nm}$ thick thermal oxide and TEOS. Bump pads are placed a little further away to avoid a possible capacitive discharge-driven early breakdown and connected with n-poly Si via the contact structure. Finally, an oxide-nitride passivation layer is deposited over the metal, followed by the openings of bump pads. A temporary metal grid is realized on pixelated sensors and finally removed once the electrical tests are complete. FBK's recent 3D production technology uses stepper lithography, with a minimum feature size of 350 nm and alignment accuracy of 80 nm [7], allowing enough room to fabricate 24 ITkPix-compliant sensors on a 6-inch wafer (see Figure 2). Process Control Monitor (PCM) structures were added around the wafer's periphery, holding different test structures: 3D diode of different dimensions, 3D strips, planar-MOS, etc.

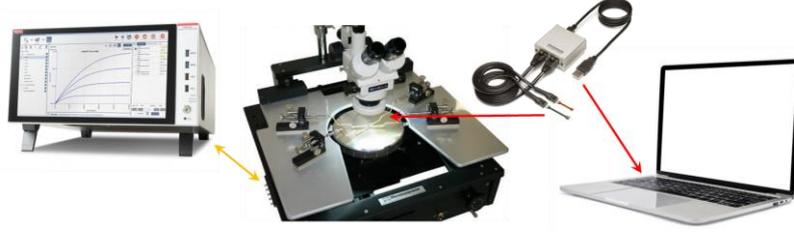
Figure 3: UniTN sensor QC probing setup.

QC setup at UniTN holds a manual probe station without thermal chuck in a dark enclosure. No dry air or N₂ flash-inlet is available. A commercial Sensirion temperature & humidity sensor was placed close to the measuring die, and data were logged through an external computer (see Figure 3). The experimental ambient condition remained almost stable (temperature $\sim 21^\circ\text{C} \pm 2^\circ\text{C}$, and RH $< 25\%$). A Keithley 4200 SCS parametric analyzer with four 4210 medium HV-SMUs was used in tests, allowing bias up to $\sim 400\text{V}$ ($\pm 210\text{V}$), with the applied voltage accuracy of $\pm 2 \mu\text{V}$ and the current sensing resolution of 100 fA. This instrument also has a 4210-CVU unit, allowing C-V measurements of the frequency sweep range between 1kHz-1MHz. This CVU unit can measure 100 fF noise-limited capacitance. A long integration window was applied for measuring small capacitances below 1 nF. For noise-sensitive C-V measurements, a custom measurement window was used: (A/D integration time, 10 PLC) \times (Fill Factor, 10).

An Agilent/Keysight SMU mainframe E5270B with Keysight Precision LCR-Meter E4980A was used to perform electrical tests. HV-SMU of the E5270B mainframe has a precision sensing resolution of 10 fA, and the precision LCR-meter can measure aF capacitance. Wafers were probed in dark conditions with a semiautomatic probe station using a dedicated probe card in the controlled ambience: temperature $\sim 20^\circ\text{C} \pm 1^\circ\text{C}$ and RH $< 5\%$.

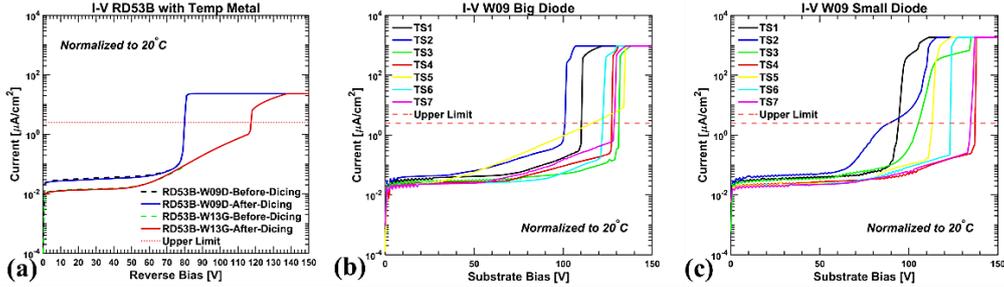
Figure 4: I-V curves normalized to 20°C: (a) RD53B sensors of wafer W09 and W13 before and after dicing, (b) W09 big diodes (80×40 pixels) after dicing, and (c) W09 small diodes (40×40 pixels) after dicing.

UniTN data were acquired after dicing up to a maximum reverse bias of 150 V or until a hard breakdown was noticed. For example, Figure 4a shows the I-V data for two RD53B sensors of both wafers (W09 and W13), where the leakage current is in good agreement before and after dicing. These results point to a good dicing recipe applied at IZM and minimal contribution of peripheral leakage. The measured leakage before and after dicing is almost two orders of magnitude smaller than the specification. I-V tests were also made for diced diode test structures of different dimensions from wafer W09 (Figure 4b & 4c), showing a hard breakdown greater than 100 V.

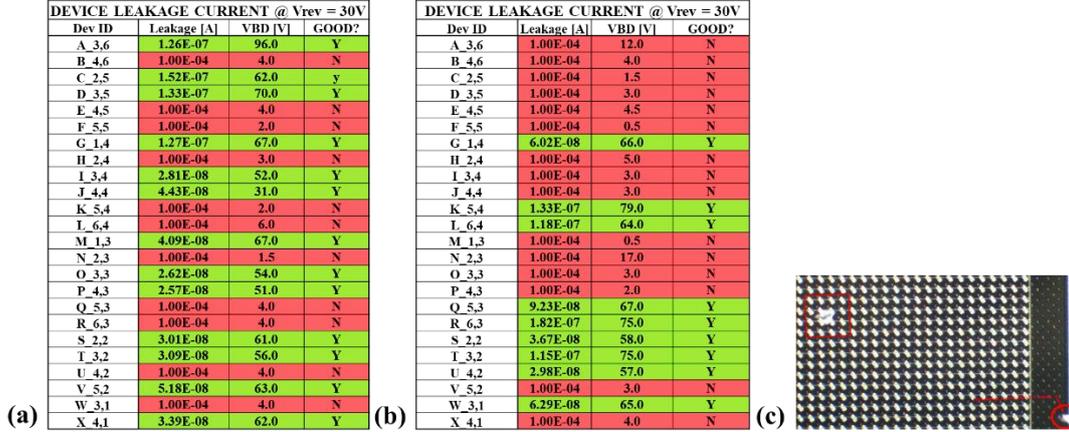
Figure 6: Measured I-V summary of RD53B sensors of different wafers after dicing: (a) W09 and (b) W13. (c) An RD53B reticle 'F' micrograph of wafer W13 after dicing.

Figure 6a and 6b report the I-V data summary of RD53B sensors, measured at UniTN after dicing. An RD53B sensor is marked good when it has $V_{bd} > 30$ V and leakage $< 2.5 \mu A/cm^2$. The determination of V_{bd} based on k-function allows finding the sensor's actual avalanche-driven breakdown (~ 50 -70 V). Sensors' operation beyond V_{bd} can input a higher noise to ROC and may also lead to sensor surface-quality degradation by employing electrical stress-driven oxide-charge enhancement over time. For wafer W09, the yield appears precisely the same at 54% after dicing, whereas for wafer W13, the yield drops to 38%. It can be anticipated from the saw dicing uncertainties: (1) broken and rough edges that may lead to form micro-cracks and creates peripheral leakage channel into the active sensor volume, and (2) surface damage

during handling, a possible source of point-defects. For example, damages were noticed in the W13 RD53B 'F' sensor (Figure 6c), indeed exhibiting an early breakdown.

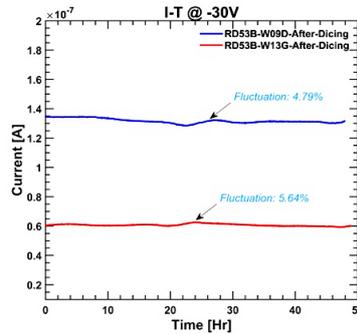
Figure 7: Measured RD53B I-T data of different wafers: W09 and W13.

Possible time evolution of leakage current is an important operational aspect of 3D Si sensors at ATLAS ITk. The same sensors in Figure 4a were studied for leakage stability by applying a reverse bias voltage of 30 V for 48 hours at UniTN. The ambient temperature and relative humidity were logged: $20.5\text{ }^{\circ}\text{C} \pm 1^{\circ}\text{C}$ and $\sim 19.6 \pm 3.1\%$. The leakage fluctuation was estimated by using Eqn. (3):

Figure 7 reports the stability test report. The estimated fluctuation of both sensors was $\sim 5\%$, well below the specification (25%), and can be anticipated from the variation in the ambient conditions.

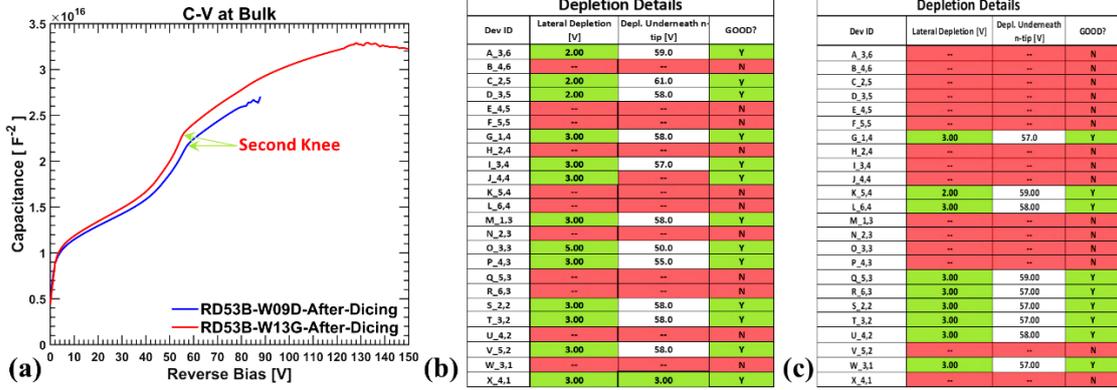
Figure 8: (a) Bulk C-V plot of RD53B sensors after dicing, and C-V summary after dicing: (b) W09 and (c) W13G.

Bulk capacitance measurements were performed to define the sensor depletion voltage. During the C-V tests of both RD53B sensors and test diodes, an AC signal was chosen with an amplitude of 100 mV. The frequency was set to 10 kHz. For example, Figure 8a shows RD53B sensors $1/C^2$ -V data from different wafers after dicing. The reverse bias was systematically applied with a 1 V increment up to a large reverse bias (till breakdown or dissipation factor < 1). The lateral inter-electrode full depletion is reached at a few volts of substrate bias (~ 2 -3 V). The capacitance continues decreasing up to large voltage due to the depletion of the p-spray layer at the surface. A second knee is noticed at ~ 60 V. A possible explanation is that a weak electric field can be expected underneath the non-passing through N^+ -column, requiring a sufficiently large bias to deplete the gap region. The depletion summary of all RD53B sensors of both wafers can be found in Figures 8b and 8c. Here, V_{depl} is determined by the interception of two fitted linear

segments. The uncertainty of values accounts for the instrument sensing accuracy, errors of linear fits, and the ramp step chosen for substrate biasing. The maximum uncertainty of the reported value is 20%.

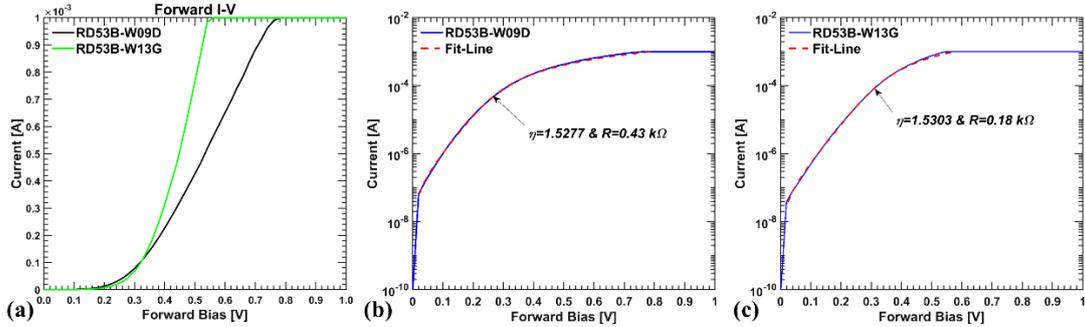
Figure 9: (a) Forward I-V plot of RD53B sensors from both wafers. The numerical fit model of the parasitic resistance was applied on: (b) RD53B-W09D & (c) RD53B-W13G.

Figure 9a shows the measured forward I-V data of RD53B sensors. A numerical fitting model was developed in a MATLAB framework for Eqn. 4 & 5 and applied to the measured forward I-V data using a robust fit-option (i.e., Bisquare). The fit lines are also shown in Figures 9b & 9c. The parasitic series resistance has been several 100Ω only (negligible), while the ideality factor was found to be ~ 1.5 .

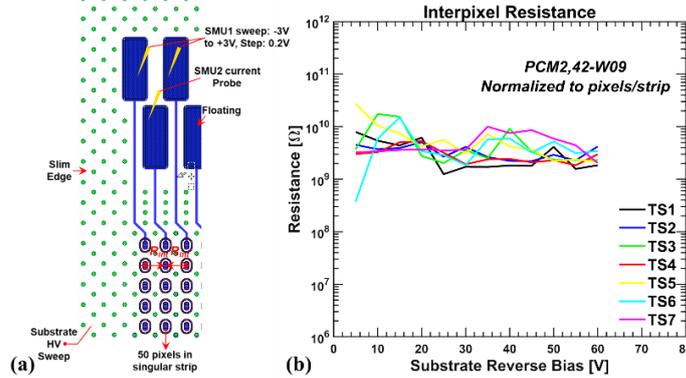
Figure 10: (a) Experimental setup, and (b) Inter-pixel resistance of PCM2,42-W09 strip.

Interpixel resistance (R_{int}) measurement allows the information of the p-spray isolation implanted between electrodes. A strip test structure was chosen for the test. The central strip was used for sensing current (I_{int}). Two neighboring strips were shorted together (Figure 10a), and a systematic voltage sweep

The ambient temperature was ~ 21.5 °C, and relative humidity was below 20%. The remaining strips of the strip structure were kept floating during the tests. Inter-pixel resistance was normalized from the number of pixels per strip (Figure 10b). As expected, the interpixel resistance is the order of several G Ω (well above the specification) and is independent of the substrate reverse bias.

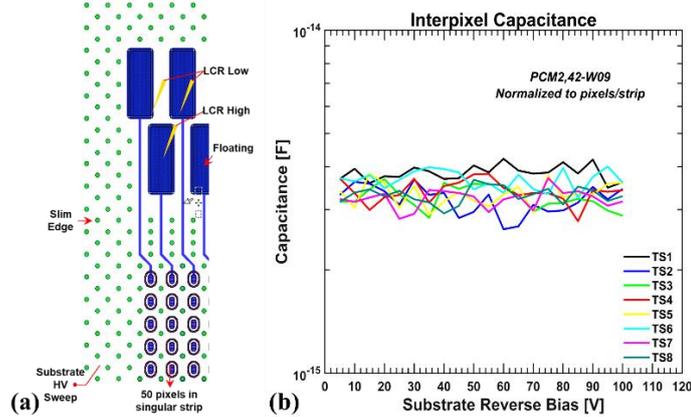
Figure 11: (a) Experimental setup, and (b) Inter-pixel capacitance of PCM2,42-W09 strip.

Inter-pixel capacitance (C_{int}) measurement quantifies the input capacitance of ROC, which impacts noise. The same strip structure of section 4.5 was chosen for the test. Figure 11a shows the experimental setup schematics. 4210 CVU along HV-SMUs was used to probe the inter-strip capacitance. An input AC signal of 100 mV amplitude and 10 kHz frequency was applied from the central strip to neighboring strips in a parallel mode for a substrate bias (varied from 5 V to 100 V with a 5 V step). The rest neighboring strips were kept floating, which would cause a 10% additional contribution to measured capacitance. The maximum uncertainty would vary by 20% of the reported values, considering the instrumentation errors.

The measured interstrip capacitance has been only a few 100 fF per strip, which makes the measurement very challenging. The test needs precise open corrections to eliminate parasitic capacitance from the cables and the whole setup. Particular attention is required for placing several probe needles onto a tiny area on strip pads that generates large stray capacitances whose fluctuations caused by minimal movements of the probe holders are much higher than the value to be measured. Inter-strip capacitance has been normalized to the number of pixels per strip. Inter-pixel capacitance is ~ 4 fF (Figure 11b) and is independent of applied substrate bias (as expected).

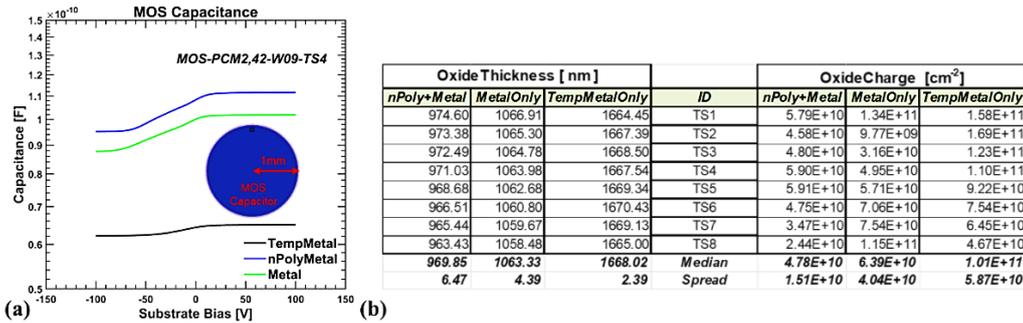
Figure 12: (a) C-V plot of PCM2,42-W09 different MOS structures for the different substrate biases. (b) Summary of estimated oxide thickness and oxide charge.

Dedicated planar MOS structures (with nPoly&Metal, Metal, and TempMetalOnly gate electrodes) were studied to quantify the sensor's surface conditions from both wafers. Substrate bias varied from -150 V to 150 V with 1 V step. Figure 12a shows three distinctive regions: accumulation, depletion, and inversion. The depletion state has been spread over a large bias range, ascribed from the continuous p-spray depletion between electrodes. A careful finding of flat-band voltage from the measured C-V data, material work-function values, and the FBK process parameters (i.e., substrate doping, etc.) allows for estimating oxide charge and thickness, summarized in Figure 12b. Values are in excellent agreement with the FBK process. Oxide charge density was at most $\sim 10^{11} \text{ cm}^{-2}$, indicating a good surface quality.
