# The analysis of internal stresses on a welded joint in Grade 91 steel under creep test loading: synchrotron X-ray diffraction measurements and modeling

The analysis and understanding of creep damage of Grade 91 steel welded joints is an important topic in the energy industry. Creep tests on welded joints were carried out at 600°C, 100MPa and then interrupted at 0%, 10%, 30%, 50%, 80% of the expected life and after failure. Creep damage is characterised by cavity bands located exclusively in the core of the sample in the InterCritical Heat Affected Zone (ICHAZ). These samples were tested using *in situ* synchrotron XRD along the welded joint under creep conditions for the different creep life time. The experimental results show a significant strain evolution and creep damage characteristic on the welded joint, with a local maximum at the Heat Affected Zone (HAZ). Following this, a finite element creep strain analysis was performed for comparison with the experimental results.

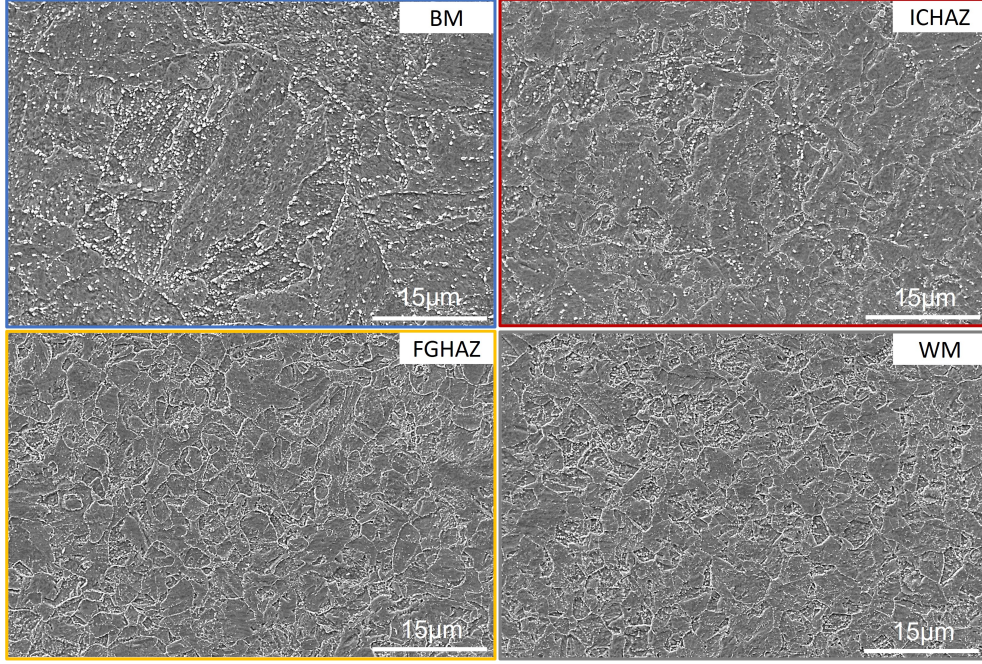
Figure 1: SEM pictures of the welded joint microstructures for: BM, HAZ with the ICHAZ and FGHAZ, and the WM.

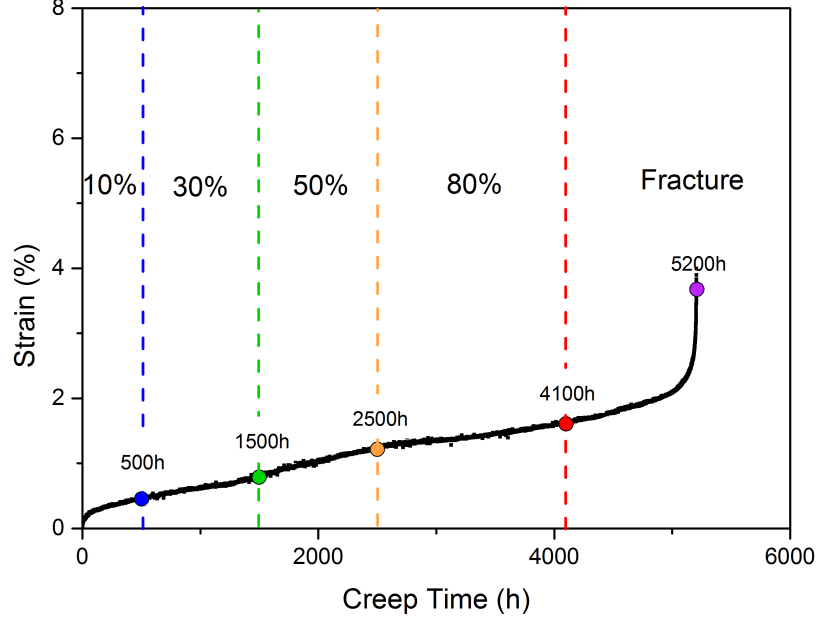
Figure 2: Intermediate and failed creep tests of the welded joint sample, at 600°C and 100MPa.

furnace did not exceed  $\pm 2^\circ\text{C}$ . The crossheads displacement was measured by two extensometers, on both heads of the sample. Temperature and stress levels have been chosen to lead to the same kind of damages as the ones observed in power plants pipes. Constant load creep tests were performed at  $600^\circ\text{C}$ , 100 MPa, under controlled atmosphere. Several samples were tested under the same creep conditions (temperature and stress) and the tests were interrupted at respectively 0%, 10%, 30%, 50%, 80% of the expected lifetime and after fracture. With these creep conditions ( $600^\circ\text{C}$  and 100 MPa) the fracture occurs after 5200 hours, as shown in Figure 2.

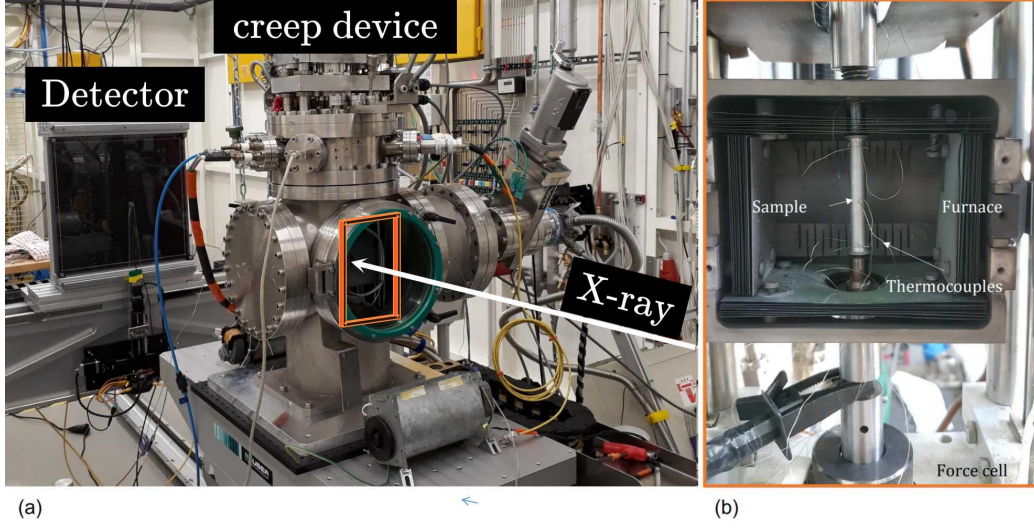
Figure 3: a) *in situ* testing device on beamline P21 at the DESY PETRA III synchrotron (Germany), with schematic X-ray beam path, b) focus on testing device furnace, showing the sample with welded thermocouples.

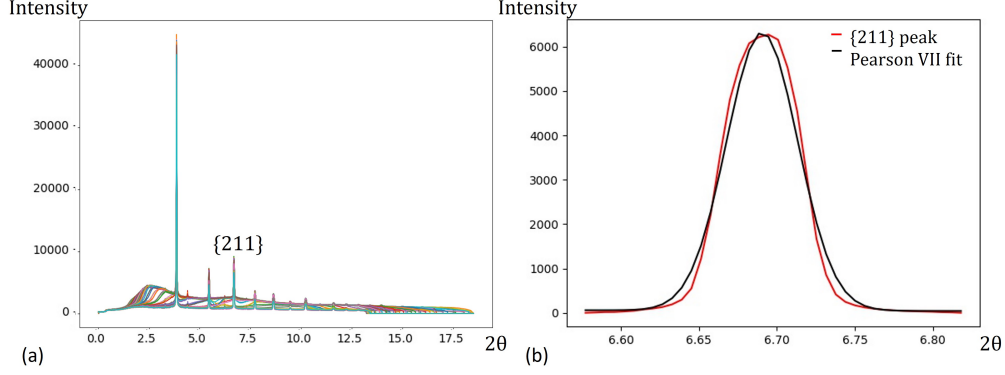
Figure 4: a) Diffractogram of intensity in function of Bragg diffraction angle  $2\theta$ , for one position on the welded joint and for the 90 sectors of the diffraction rings. b) Focus on the peak 211 with Pearson VII fit.

intensity in function of diffraction angle  $2\theta$ , in order to precisely measure the angular variations of the deformed diffraction peaks. The diffractogram peaks were fitted with a Pearson VII function as shown in Figure 4. To remove uncertainties due to the variations of the beam position over time, averaging of opposite azimuths was used.

with  $\varepsilon_{ij} = \frac{1+\nu}{E}\sigma_{ij} - \frac{\nu}{E}\delta_{ij}\sigma_{kk}$  and  $\delta_{ij} = 1$  if  $i = j$  or 0 if  $i \neq j$ . Peak fitting was focussed on the  $\{211\}$  peak (see Figure 4b) because the radiocrystallographic elastic constants for  $\{211\}$  peak are representative of macroscopic constants [14].

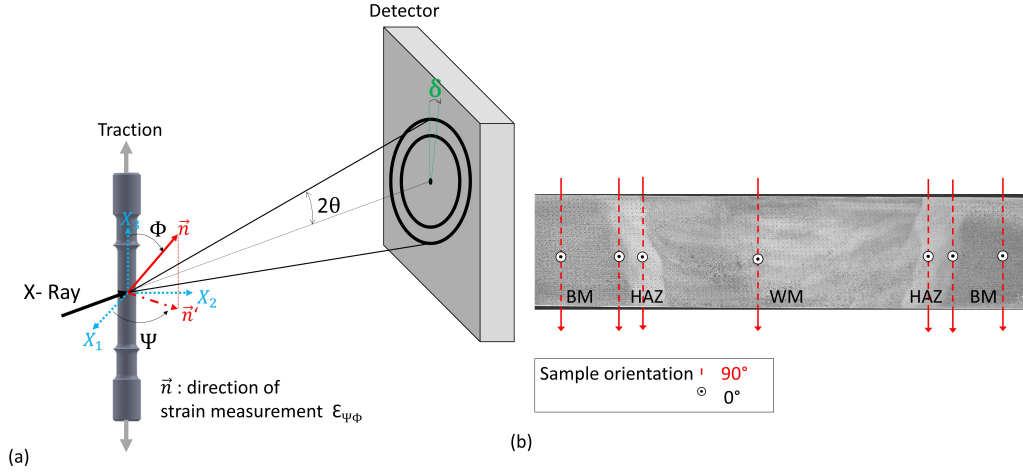
Figure 5: a) Illustration of the strain measurement direction and angles for a XRD test, b) the optical micrograph of the welded joint, crossed by the X-ray beam for the  $0^\circ$  and  $90^\circ$  specimen orientation.

The  $\sin^2 \Psi$  method is used to determinate the internal residual stresses with the XRD experiments, because it is sensitive to small variations [13, 14]. The angles ( $\Psi$ ,  $\Phi$ ,  $\theta$ ,  $\delta$ ) used for this method are defined in the scheme Figure 5 a), by equations [14, 15, 16]:

$X_1X_3$  (resp.  $X_2X_3$ ) middle plane, as shown in Figure 5b. To further simplify the problem, it is assumed that the constitutive law remains the same for the BM and the WM, while the strain rate of the HAZ is more than double under the same conditions [17].

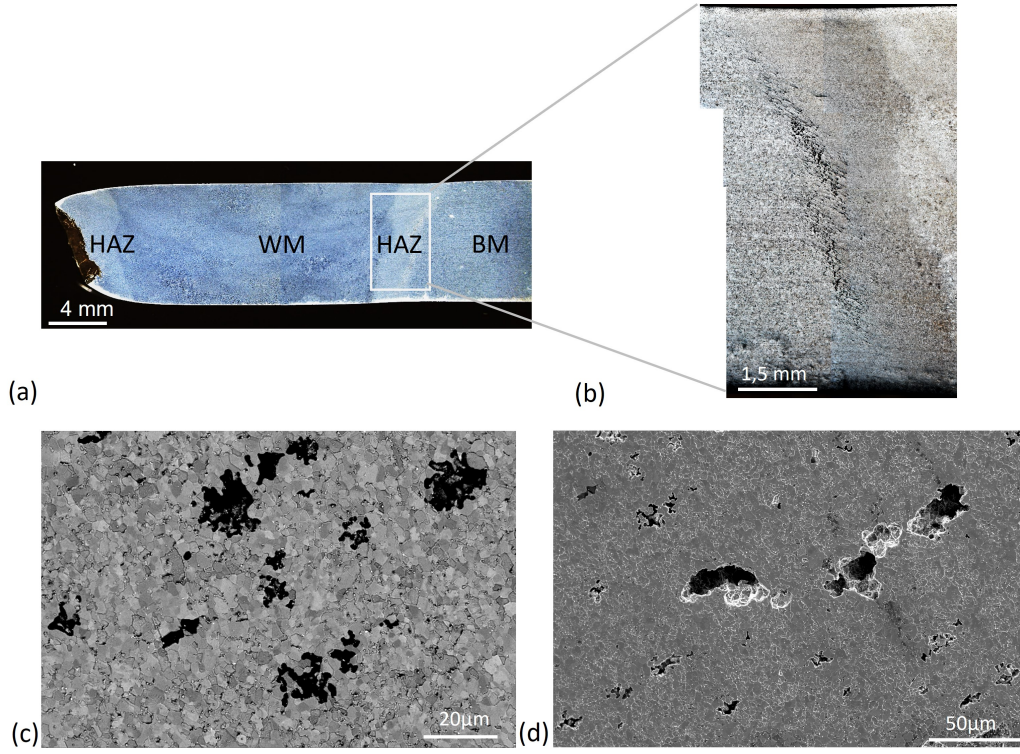
Figure 6: a) Optical macrograph of a cross-section along the fractured specimen length, after 5200 hours of creep at 600°C and 100MPa, b) zoom in the HAZ, c)- d) SEM pictures in the ICHAZ cavity band, in BSE and SE mode, respectively.

A creep test was performed at 600°C and 100MPa until failure at 5200 hours. The sample fracture occurred in the HAZ and more especially at ICHAZ, close to the BM and parallel to the fusion line (see Figure 6). This Type IV fracture is produced by creep cavitation. The fracture zone exhibits a significant necking which is also apparent in the second HAZ of the welded joint, with less area reduction. This necking suggests a high local viscoplastic deformation, which started during stage II of creep and increased during stage III. The major part of the specimen elongation results from this local strain.

The optical micrographs in Figure 6 show the two necking zones of the fractured sample. A high density of cavities is observed along the fracture and in the second ICHAZ. These cavity bands are located exclusively in the core of the sample and not on the surface. The SEM pictures in Figure 6 indicate that these cavities were intergranular and appeared mainly in the vicinity

of prior austenite grain boundaries. There are three categories of cavities as pointed out by the SEM pictures: small isolated cavities between the grains, clusters of connected medium sized cavities and finally a coalescence of cavities that forms the nuclei of cracks. The crack tips at grain boundaries are blunted. However, despite the high local strain, the grains near the cavities do not seem distorted. Thus, the cavities nucleation would not be only very local visco-plastic phenomena. These observations justify the analyses of internal stress distributions to explain the occurrence of these cavities. The SEM characterisation shows that cavities are clustered in a band located at 2 mm from the fusion line *i.e.*, in the ICHAZ, close to the BM. This band is only present in the core of the sample, relatively far from the surface. Cavitation damage starts during stage II of creep (20-30% of the lifetime), with the presence of a low density of small cavities. Then, a band of cavities appears from 2500 hours (50% of lifetime) and increases in density with creep time. The cavities size drastically increases from 4100 hours, *i.e.* during stage III creep. These results are in agreement with Li [4].

The strain evolution is driven by a microstructural softening, which is not constant over the time of creep. The nucleation of initial cavities is due to strong local plasticity related to the softening of the material. Nevertheless, according to the SEM analysis (Figure 6), the cavities are located in the zone with the highest deformation, *i.e.* the ICHAZ, but exclusively in the core of the sample. This phenomenon is also found through FEM simulations

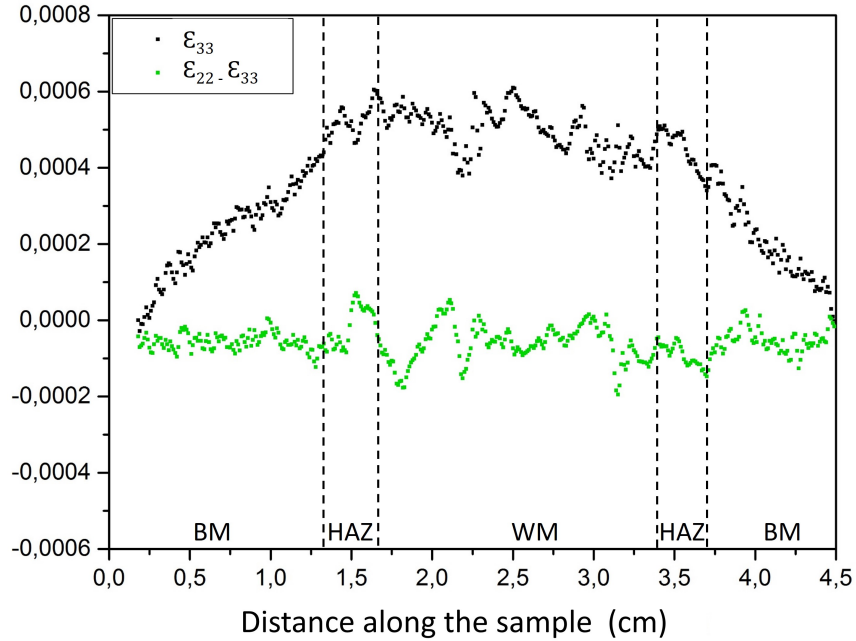
Figure 7:  $\varepsilon_{33}$  and  $\varepsilon_{22} - \varepsilon_{33}$  evolution along the sample interrupted after 4100h creep test, experimentally determined by the  $\sin^2 \Psi$  method.

The values of  $\varepsilon_{33}$  and  $\varepsilon_{22} - \varepsilon_{33}$  along the welded joint are shown in Figure 7. The  $\varepsilon_{33}$  intercept exhibits an unusual variation, caused by the superposition of a temperature gradient along the sample and a variable elastic strain. As  $\varepsilon_{22} - \varepsilon_{33}$  is not sensitive to the temperature gradient, it provides more robust results. As it can be seen,  $\varepsilon_{22} - \varepsilon_{33}$  is constant within the BM, but exhibits strong variations within the WM and the HAZ. In the former case, this reveals that heterogeneities due to the multipass welding are neither fully relieved by the post weld stress annealing nor by the creep. In the latter case, we suppose that the variations result from internal stresses due to differences in the plastic behavior of the BM, the HAZ and the WM. In the following, a particular focus will be paid on the evolution of  $\varepsilon_{22} - \varepsilon_{33}$  and  $\varepsilon_{11} - \varepsilon_{33}$  along the specimens during *in situ* tests.

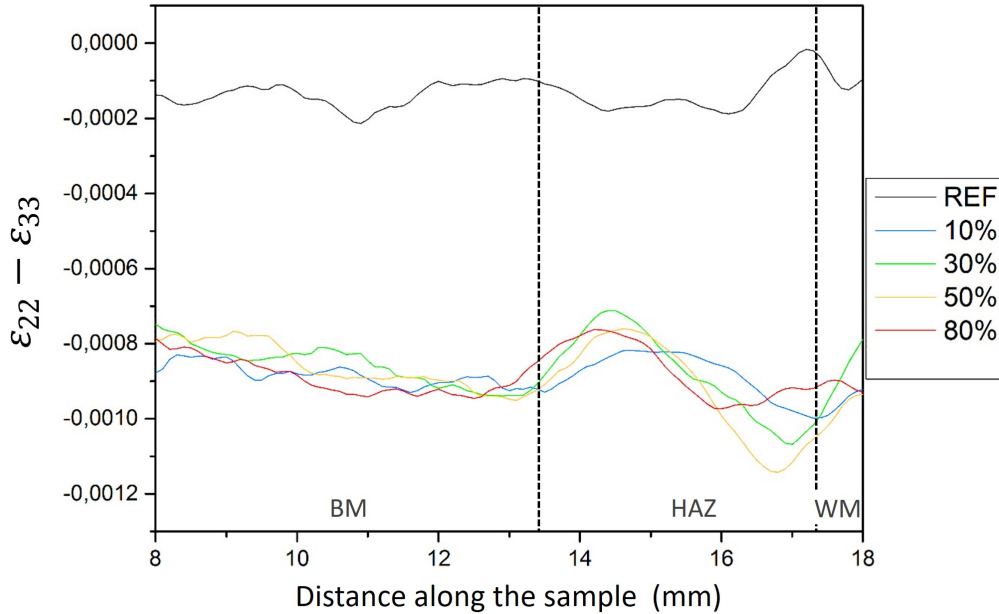
Figure 8: Strain evolution  $\varepsilon_{22} - \varepsilon_{33}$  along the welded joint after creep interrupted test.

The evolution with time of the elastic strain  $\varepsilon_{22} - \varepsilon_{33}$ , along the sample (from the BM to the HAZ) is illustrated in Figure 8. The strain is averaged on 10 consecutive measurements (*i.e.* 1 mm) to reduce experimental noise. For the reference case, without loading, (blackline in Figure 8), the strain

values are shifted near 0. Due to some dispersion on the curve  $\varepsilon_{\Psi\Phi}$  as a function of  $\sin^2 \Psi$  for the reference sample, variations in the value of the strains along the specimen are visible but are not significant. For all crept specimens, the strain evolves in a similar way along the welded joint, *i.e.* with a local maximum at the HAZ, bounded by local minima at the boundary with the BM and the WM. Due to the repeatability of the strain evolution on 5 different samples after 5 independent experiments, this strain evolution is significant and characteristic of creep damage on the welded joint.

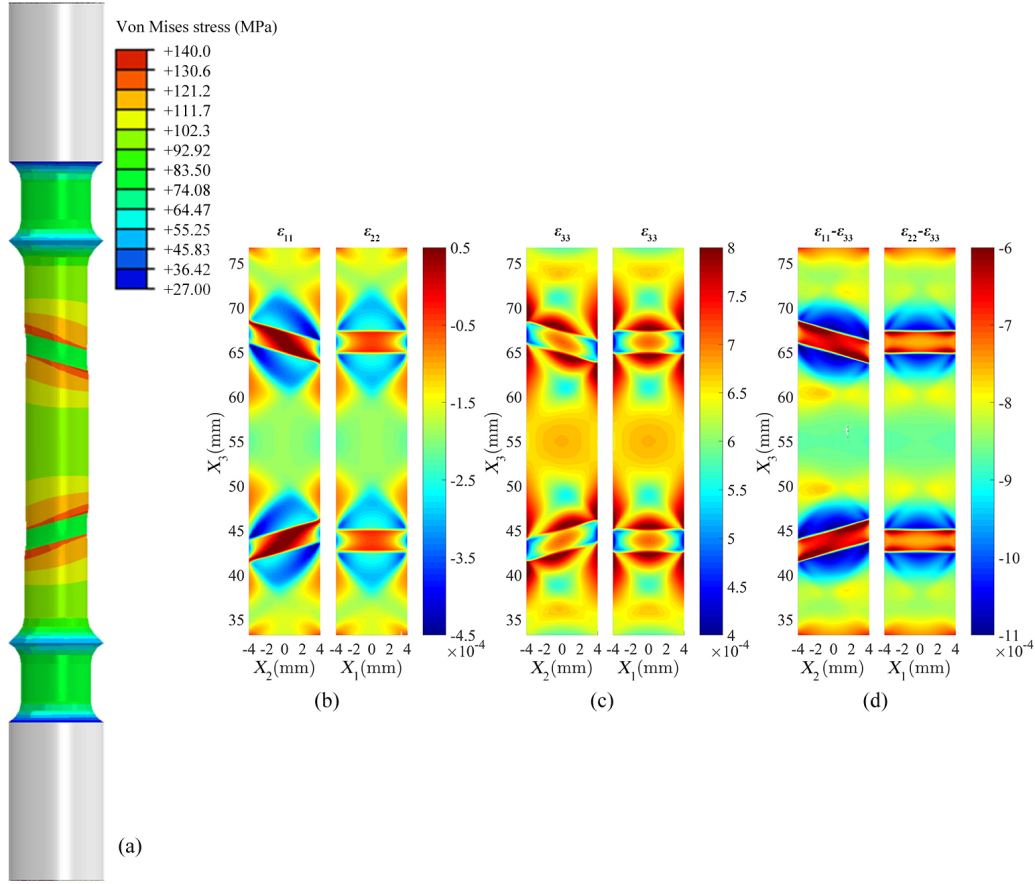
Figure 9: a) Von Mises stress, b)-d) calculated elastic strains in  $X_1(X_2)$ - $X_3$  plane of the virtual sample.

as shown in Figure 9, the HAZ deforms more than the others, resulting in internal stresses, and the distribution of creep strain on the HAZ varies from the surface toward the center.

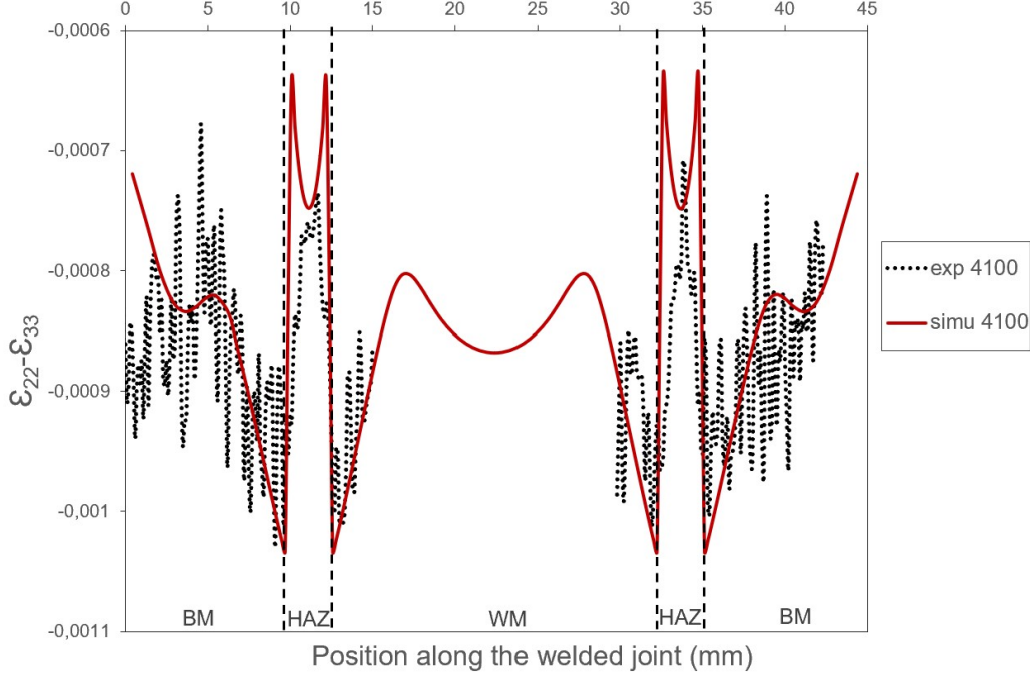
Figure 10: Experimental (dotted) and calculated (plain line)  $\varepsilon_{22} - \varepsilon_{33}$  strain curves after 4100 hours.

The variation of the slopes  $\epsilon_{22} - \epsilon_{33}$  along the specimen axis at  $t = 4100$  hours between experimental and simulated values, for the parameters chosen in the previous paragraph, are shown in Figure 10. The experimental curve is derived from the raw data, which explains the high level of noise. The experimental curve of the WM is not plotted, due to the large number of small grains and the presence of gas holes in this area, which increase noise and random variations. In Figure 10, simulated and experimental curves fit with a good representability of the peak in HAZ.

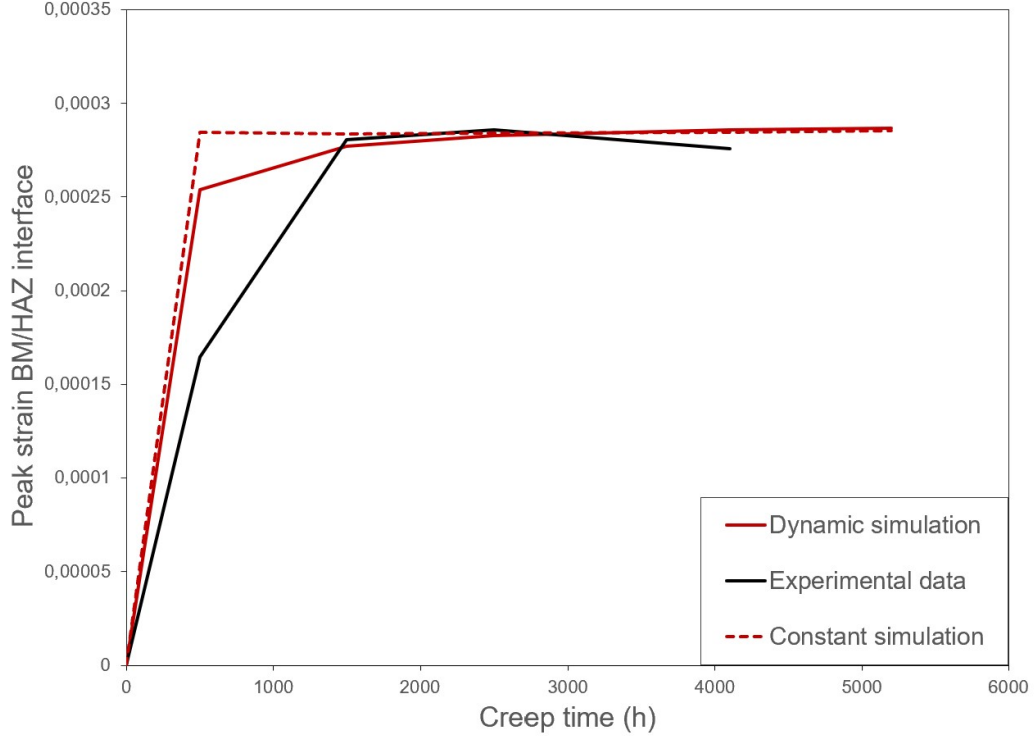
Figure 11: Step of  $\varepsilon_{22} - \varepsilon_{33}$  at the BM/HAZ interface as a function of creep time for experimental and simulation data. Simulation curves are performed for dynamic (plain line) and constant (dashed line) strain rate.

The evolution of the step, at the BM/HAZ interface as a function of creep time, illustrates the damage kinetics of this zone. This evolution is illustrated in Figure 11, with the comparison of the simulated (red and dashed red lines) and experimental (black line) values. Experimentally, the step at the BM/HAZ interface is visible from the end of creep stage I, and increases up to 2500 hours, *i.e.* in the middle of stage II, and then saturates. In the simulation, the initial HAZ strain rate is chosen to be constant as  $A_{\text{HAZ}} = A_{\text{BM}} \times 200$ , resulting in stabilisation within a few hours as shown in Figure 11 by the red dotted line. To obtain a better fit, the parameter  $A_{\text{HAZ}}$  was allowed to vary with time in order to simulate a gradual softening:

The time constant  $t_0$  was taken as 1000 hours and  $A_{\text{HAZ}} = A_{\text{BM}} \times 200$ . With this gradual softening, the simulated deformation kinetic fits more closely the experimental one.

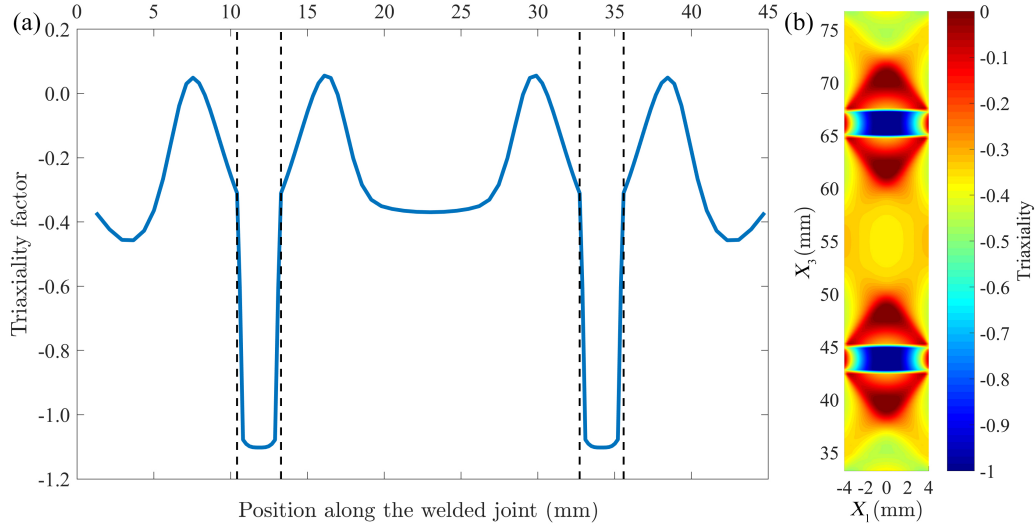
Figure 12: Simulated TF as a function of position along the welded joint.

The distribution of the TF along the welded joint after 4100h creep is shown in Figure 12. The sign of the TF depends on the sign of the hydrostatic stress. In our case the TF is positive in tension and negative in compression. TF is lowest in the HAZ, with a jump on the interfaces with other zones. A large TF favors brittle fracture by cleavage [18] which was experimentally observed in Figure 6, where cavities and undeformed grains are present. HAZs exhibit maximum creep strain and minimum of the TF, favoring creep damage with cavities in the core of the welded joint.
