# Observation of Buried Phosphorus Dopants near Clean Si(100)-(2×1) with Scanning Tunneling Microscopy

Geoffrey W. Brown,\* Holger Grube, and Marilyn E. Hawley

*Materials Science & Technology Division, Los Alamos National Laboratory, Los Alamos, NM 87545*

(Dated: May 24, 2004)

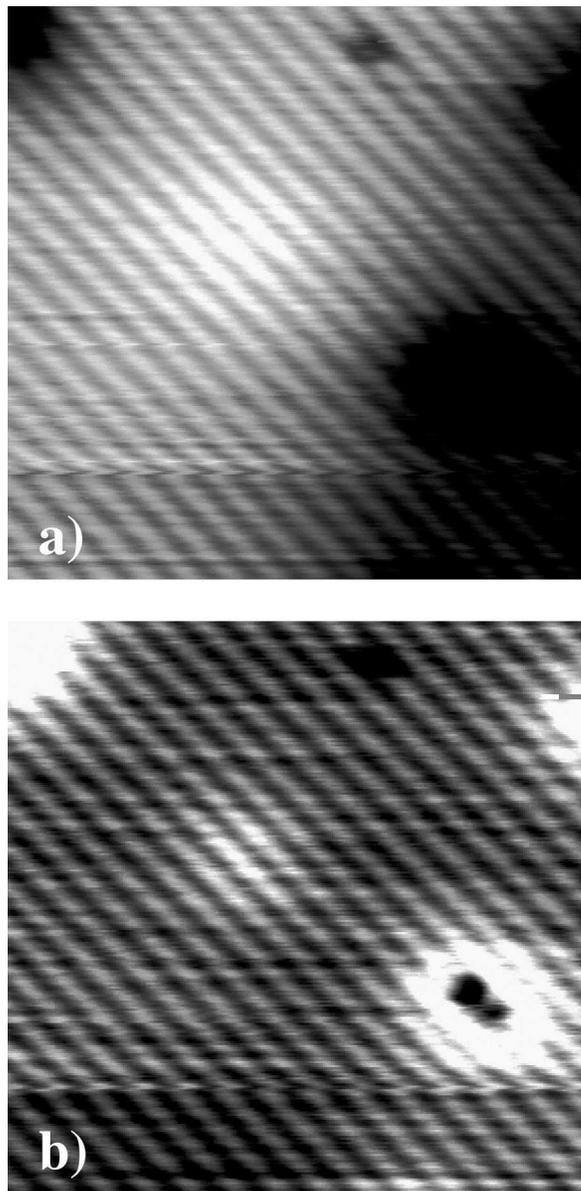
FIG. 1: a) Filled- and b) empty-state images of the same area on a Si(100)-(2×1) surface. The images show a feature in the center which appears as a long range enhancement in both biases but which does not have an associated surface structure. The filled states image was acquired at -0.7 V sample bias and the empty states at +1.0 V. The tunnel current for both was 130 pA and the image area is  $100 \text{ \AA} \times 100 \text{ \AA}$ .

Figure 1 shows images of the features that we attribute to subsurface dopants. Figures 1a and 1b are simultaneously acquired filled- and empty-state images, respectively, of a feature that appears as a long range enhancement in both biases, but without a corresponding surface defect. For comparison, a positively charged multi-dimer vacancy defect appears in the lower right section of the image. As expected for these PtIr tips, the filled state depression associated with the positively charged surface vacancy is visible. The extent of the dopant signature is similar to that of the charged defects but the amplitude is somewhat weaker in the empty states.

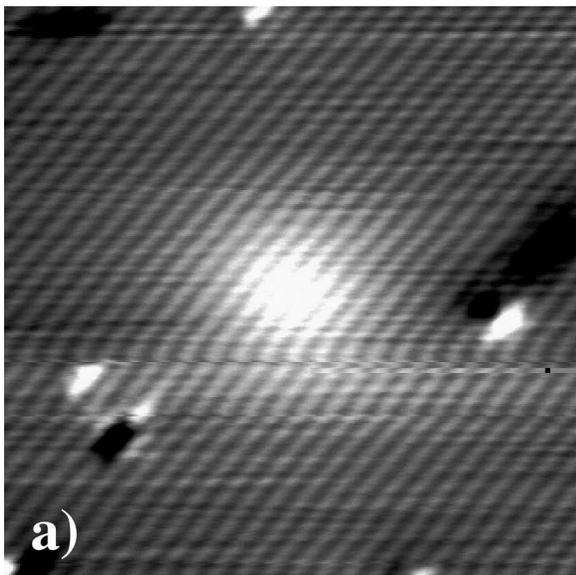
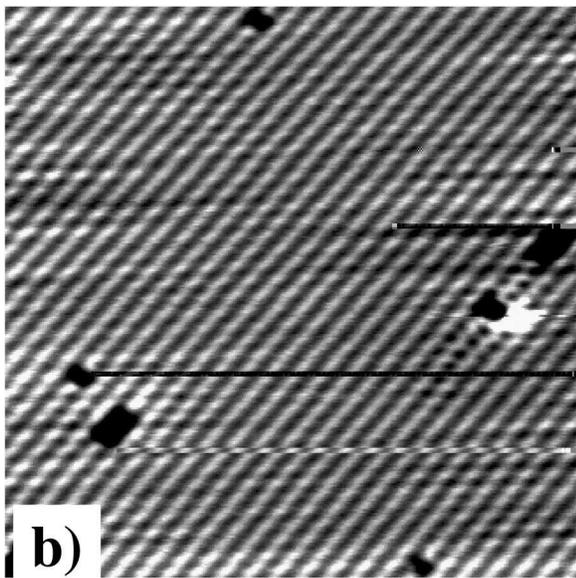
FIG. 2: Filled-states image of a subsurface dopant acquired at a)  $-0.6$  V and b)  $-1.5$  V sample bias. The dopant signature has a strong bias dependence and is not visible at  $-1.5$  V. There is also no topographic surface structure (i.e. vacancy or adsorbate) associated with the feature. Image areas are both  $220 \text{ \AA} \times 220 \text{ \AA}$  and the tunnel currents were  $110 \text{ pA}$ .

Figures 2a and 2b show another one of these features at low (-0.6 V) and high (-1.5 V) sample bias, respectively. The images were taken sequentially in the same area, as seen from the other defects. In Figure 2b we clearly see the absence of a surface defect, indicating that the signature in Figure 2a arises from a subsurface feature. At low bias, the band edges contribute strongly to the tunnel current and the effect of band bending is visible. At high sample bias the band edge states contribute only very weakly to the tunnel current.

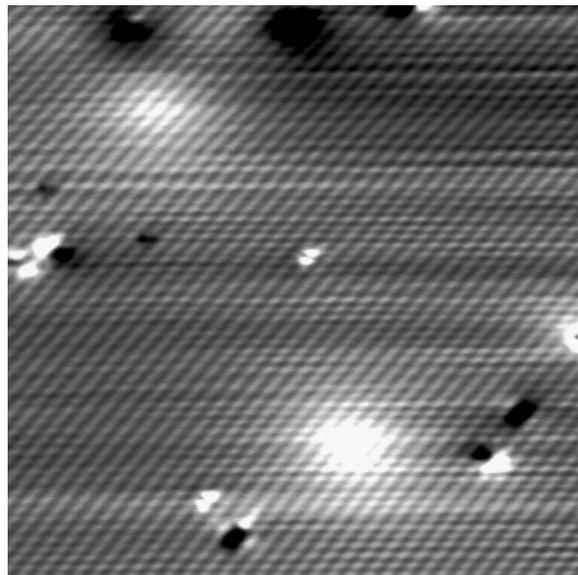
FIG. 3: Filled-state images of a pair of dopants on  $\text{Si}(100)-(2 \times 1)$ . The upper feature is weaker than the lower feature implying that it is either farther below the surface or has a smaller charge. The tunnel current in both cases was  $110 \text{ pA}$ , the sample bias was  $-0.7 \text{ V}$  and the image size is  $320 \text{ \AA} \times 320 \text{ \AA}$ .

Finally, in Figure 3 we see two of the dopant features in a single filled state image. The upper feature has weaker amplitude than the lower one, implying that the upper dopant is either farther below the surface or has a smaller charge.
