# **Initial energy deposition and initiation mechanism of nanosecond**

## **laser damage caused by KDP surface micro-defects**

## Abstract:

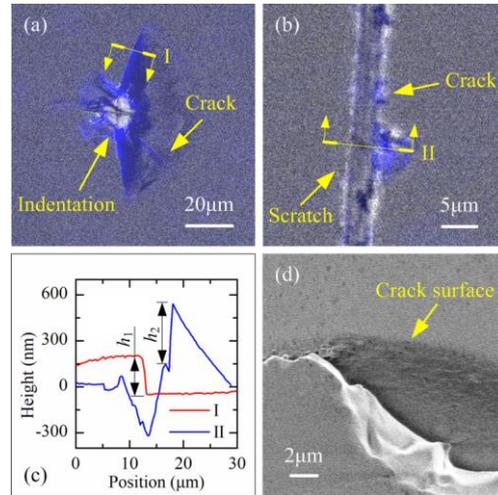
Fig. 1 Micromorphology of the surface defects on the KDP crystals. (a) Fluorescence image of the indentation defects with the surrounding cracks on the KDP crystals. (b) Fluorescence image of the scratch defect with surrounding cracks on the KDP crystals. (c) 2D cross-sectional profile of the cracks around the indentation and the scratch defects on the KDP crystals surface. (d)

Scanning electron micrograph of crack surface on the KDP crystals.

The indentation and the scratch defects are first prepared on the surface of the KDP crystals (Fig.1). There are many lateral cracks around the indentation and the scratch [[12]]. The lateral cracks are caused by a sideways extrusion of the material. The cracks extend laterally along the element surface. Figures 1(a) and 1(b) show the fluorescence images of the surface indentation and the scratch, respectively. The fluorescence intensity of the positions near to the lateral crack is much higher than those of the indentation and the scratch itself. The fluorescence intensity is strongly related to the laser absorption characteristics of the material [[13]]. The stronger the fluorescence intensity, the more intense the laser energy absorption. The material close to the lateral crack has a strong absorption effect on the laser. The two-dimensional cross-sectional profile of the crack around the indentation and the scratch is shown in Fig. 1(c). The heave height at the crack can reach  $\sim 240$  nm and  $\sim 380$  nm. The opening width of the crack is much smaller than the overall crack width, generally only  $\sim 1$   $\mu\text{m}$ . Figure 1(d) shows the scanning electron micrograph of the

crack surface on the KDP crystals. The crack has an arc-shaped surface inside, and the crack surface close to the element surface is rough. This indicates that the crack starts on the crystal surface and it then extends into the crystal interior. In the fluorescence image, the fluorescence intensity is at its strongest at these locations. The material near to the crack is modified and the sub-band gap energy level structure appears, which is straight-forward to generate for a local electron excitation under laser irradiation [[13],[14]].

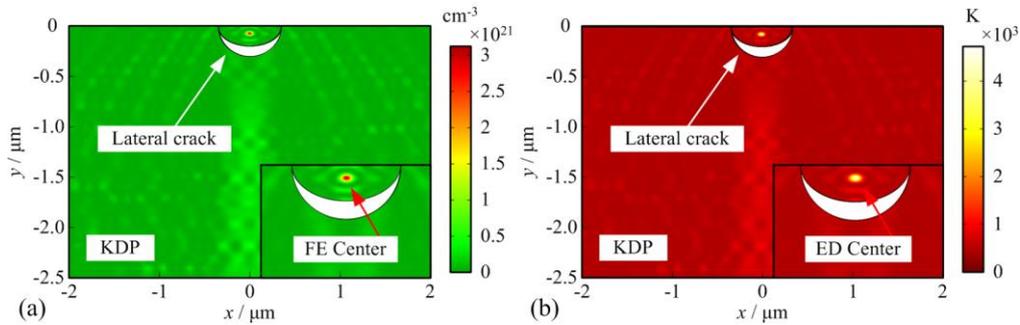
Fig. 2 Graphs of the calculations of the IED model caused by the lateral crack on the KDP surface under laser irradiation at 40ps. (a) Local electronic density distribution near to the lateral crack on the KDP crystals surface at 40ps. (b) Local temperature distribution in the vicinity of the lateral crack on the KDP crystals surface at 40ps.

Figure 2 shows the calculations of the IED model caused by a lateral crack on the KDP surface under laser irradiation at 40 ps. In the model, the lateral crack width is assumed to be 600 nm, the laser wavelength is 355 nm, and the power density is 5 GW/cm<sup>2</sup>. The local electron density distribution close to the lateral crack at 40 ps is shown in Fig. 2(a). The electron density in the KDP crystals is generally at a low level. Moreover, there is a small amount of electron accumulation towards and at the bottom of the lateral crack. The electron density there is no greater than  $1 \times 10^{21}$  cm<sup>-3</sup>, which has little effect on the laser energy deposition. However, due to the combined effects of light field modulation and the sub-band gap energy level structure, the free electron density increases dramatically, and eventually exceeds  $3 \times 10^{21}$  cm<sup>-3</sup> at the lateral crack center. The increase of the free electron density is extremely helpful for the laser energy deposition. Figure 2(b) shows the local temperature distribution near to the lateral crack on the KDP crystals surface at 40 ps. A high temperature region with a local temperature  $\sim 4931$  K appears at the center of the lateral crack. The ellipsoid high-temperature region is the IED center; here, it is extremely easy to induce the laser damage initiation under the subsequent laser irradiation.

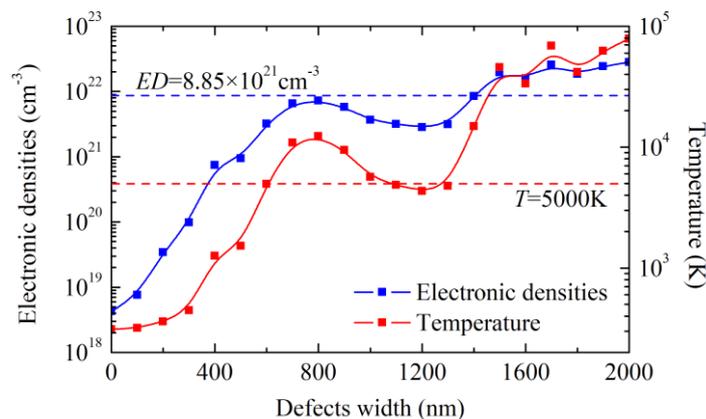
Fig. 3 Graph showing the curves of the electronic density and temperature against the widths of lateral cracks on the KDP crystals surface, calculated by the IED model.

By plotting graphs using the IED model of the lateral cracks with various widths, the curves of the electronic density and the temperature against the widths of the lateral cracks on the KDP crystals surface are shown in Fig. 3. The two curves show the same trends. With an increase in the lateral crack width, the values of both curves generally increase. However, the curves are seen to decrease at the width of 800 nm for a period. When the width is greater than 1200 nm, the curves again have an upward trend. From the results of the dynamics model coupled with the multi-physical field of the laser damage, it is inferred that (when the local temperature caused by the IED is greater than 5000 K) the laser damage on the KDP crystals occurs under subsequent laser irradiation. According to the critical temperature

criterion, the lateral cracks with widths that range from 600 nm to 1100 nm and greater than 1300 nm will cause laser damage at 40 ps. However, based on the critical electron density criterion ( $8.85 \times 10^{21} \text{ cm}^{-3}$ ), only the lateral crack with a width greater than 1400 nm can induce the avalanche ionization at 40 ps. This indicates that the laser damage caused by the surface defects on the KDP crystals surface at low energy density is not caused by the electrical breakdown. For example, for defects with a width of 600 nm, the local temperature (at 40 ps) extends into the critical values and the laser damage is initiated. However, the electronic density did not reach the critical breakdown density at this time. Thus, the temperature rise is the critical factor to trigger the laser damage. This differs from some previous studies that analyze the breakdown regime [[6]]. However, research on the strongly nonlinear laser energy absorption process supports our viewpoint [[15]]. With the increase of the subsequent laser irradiation time, the material phase transition and the hydrodynamics go into effect after the local temperature reaches a critical value. This temperature rise, which is caused by the IED, is the key factor for the initiation of the laser damage. The local maximum temperature inside the KDP crystals can be used as the laser damage criterion. The lateral cracks, with the widths ranging from 600 nm to 1100 nm and greater than 1300 nm, are vulnerable under laser irradiation; this should receive much more attention in relation to processing and application.

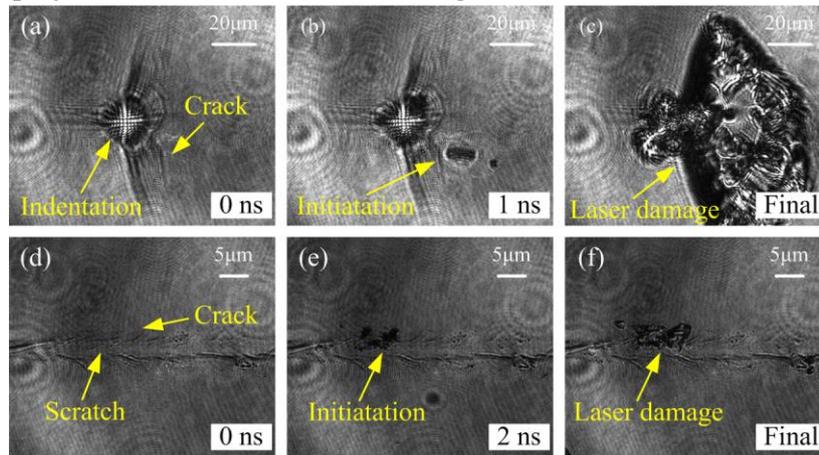
Fig. 4 Transient images of the laser damage, caused by the lateral cracks on the KDP crystals, that are taken by the time-resolved system. (a-c) Microscopic images of the lateral cracks around the indentations on the KDP crystals surface after the laser irradiation at 0 ns, 1 ns and the resulting final damage site. (d-f) Microscopic images of lateral cracks around the scratch on the KDP crystal surface after laser irradiation at 0 ns, 2 ns and the resulting final damage site.

To verify the defect-assisted IED model, and the initiation mechanism of the laser damage, we design a time-resolved system [[17],[18]] to capture the transient images of the laser damage that is caused by the lateral cracks on the KDP crystals. Figure 4 shows the resultant images. Here, there are black shadows in the positions near to the lateral cracks, when the laser is irradiated for 1-2 ns. These black shadows are morphologically similar to the simulated high-temperature region in Fig. 2(b). This is due to the strong absorption of laser light by ionized materials. On comparing the final microscopic images of the indentation and the scratch, it is determined that the position of the IED strictly corresponds to the final damage sites. The results demonstrate the validity of the defect-assisted IED model for the KDP crystals. Besides, it reveals that the IED caused by surface defect, under nanosecond laser

irradiation, plays a vital role in the laser damage initiation.
