Visual investigation of possible degradation in GEM foil under test

Abstract

Visual investigation of a Single Mask (SM) Gas Electron Multiplier (GEM) foil, showing small resistance ($\sim 40 \text{ k}\Omega$), is performed manually using an optical microscope. The GEM foil is scanned and the different imperfections in the foil are identified. Different techniques are used to clean the GEM foil to remove the short paths created between the GEM electrodes. The details of the method used for cleaning the GEM foil and the result of leakage current measurement after the cleaning of the foil are discussed in this article.

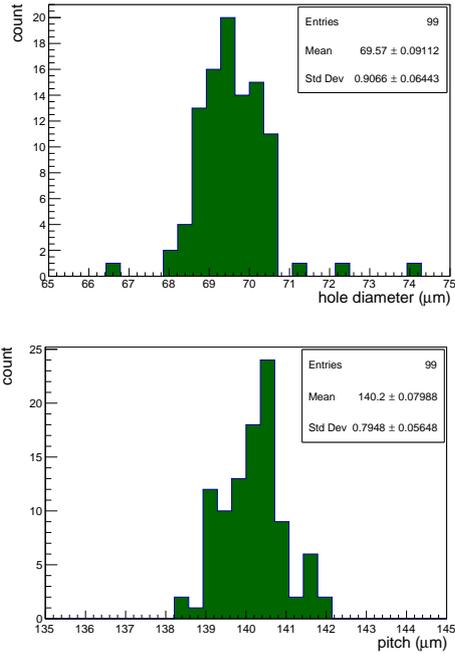
Figure 2: Distribution of GEM hole diameter (top) and pitch (bottom).

under scanning. The visual inspection revealed several imperfections in the foil and they are shown in Fig. 1. The pitch and diameter of the GEM holes are also measured using the microscope and their distributions are shown in Fig. 2. The average hole diameter is found to be $69.57 \pm 0.09 \mu\text{m}$ and the average pitch is found to be $140.20 \pm 0.80 \mu\text{m}$.
