RELIABILITY STUDIES OF ELECTRONIC COMPONENTS FOR THE OPERATION AT CRYOGENIC TEMPERATURE

*N.Poonthottathil, F.Krennrich, A.Weinstein, J.Eisch

Department of Physics and Astronomy Iowa State University Ames, Iowa, 50010 Email: pnav@iastate.edu

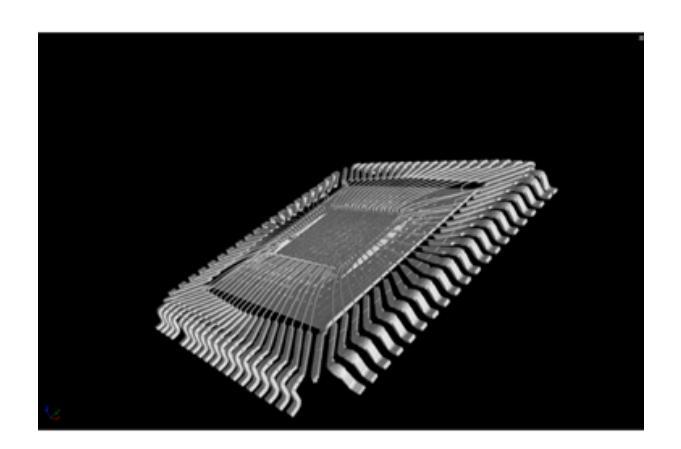
FIGURE 1. X-ray micrograph image of a ProtoDune ASIC, the wirebond and the internal structure are clearly visible, the spatial resolution of the instrument is $10 \ \mu m$.

In this paper, we demonstrate the use of Scanning Acoustic Microscopy to probe and identify defects in the chip packaging or circuitry resulting from thermal cycling. A dedicated correlation analysis technique is presented. Scanning Acoustic Microscopy (SAM) is a powerful non-destructive evaluation technique for the inspection of microelectronics integrated circuit packages [6]. The main advantage of SAM is that it is highly sensitive to defects including voids, cracks, and delamination inside the packaged chip. The technique also helps to identify weak spots inside the package. The integrated circuits are made from composite materials and are susceptible to thermally induced stress. A such induced discontinuity inside the chip might affect the reliability of an integrated circuit and could cause long-term performance problems. In addition to the SAM technique, we have also used X-ray microscopy to inspect chip internal wire-bonds. Broken wire-bonds and solder defects can be detected using X-ray microscopy. Not all defects are sensitive to both X-ray and SAM, it depends on the nature of the defects [7].

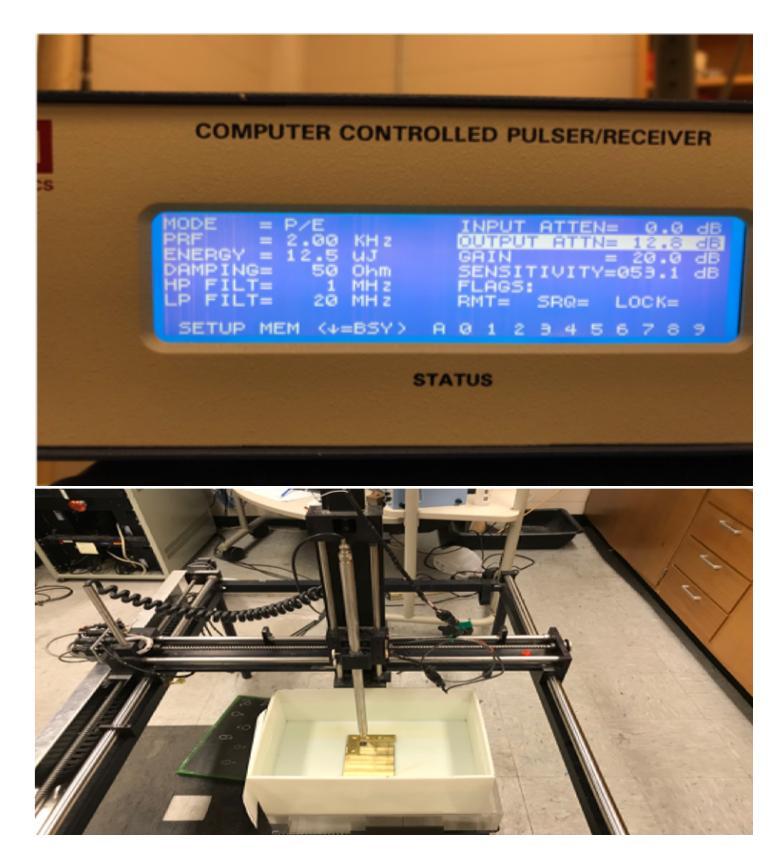
FIGURE 2. The image shows a pulser/receiver (top), which is connected to the transducers that generates acoustic wave. A fixture is used to place the sample that avoids the positional variations from scan to scan (bottom).

For collecting the data presented in this paper, the scanning microscopy apparatus is set to its simplest configuration, called the pulse-echo mode. With this particular configuration, a single transducer generates the pulse and receives the reflected signal at a given position of the sample. The transducer sends pulses into the material using water as a coupling medium and collects the reflected signal. The signal will be a function of the acoustic impedance of the different material layers. The resolution of the measurement depends on the frequency of the incident wave; higher frequency waves provide for better resolution, but also result in more attenuation, effectively decreasing the penetration depth inside the material. In order to probe the material sufficiently deep with good resolution, one has to select an optimum frequency. The entire experimental setup is shown in Figure 2.

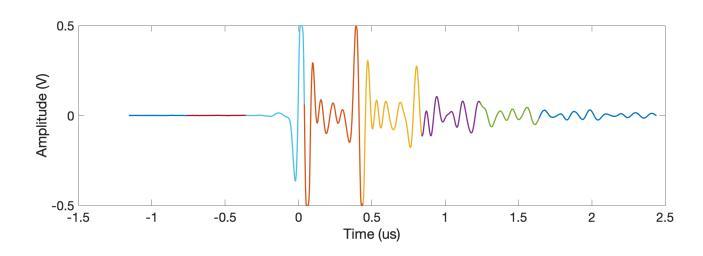
FIGURE 3. An example of reflected wave signal. Each color represents different depth in the sample.

SAM uses ultrasound to interrogate a material by focusing periodic sound waves onto a small region of a sample. The technique uses a transducer to generate, transmit and detect waves reflected by the various interfaces inside the sample. Timing and amplitude of the reflected wave provide information about changes in acoustic impedance, i.e., different materials along the path of the sound wave. The amplitude of the reflected signal is a measure of the strength of the echoes and the position on the time axis represents the time required to travel through the sample (it is a measure of the depth). Figure 3 represents an example of a reflected wave signal.

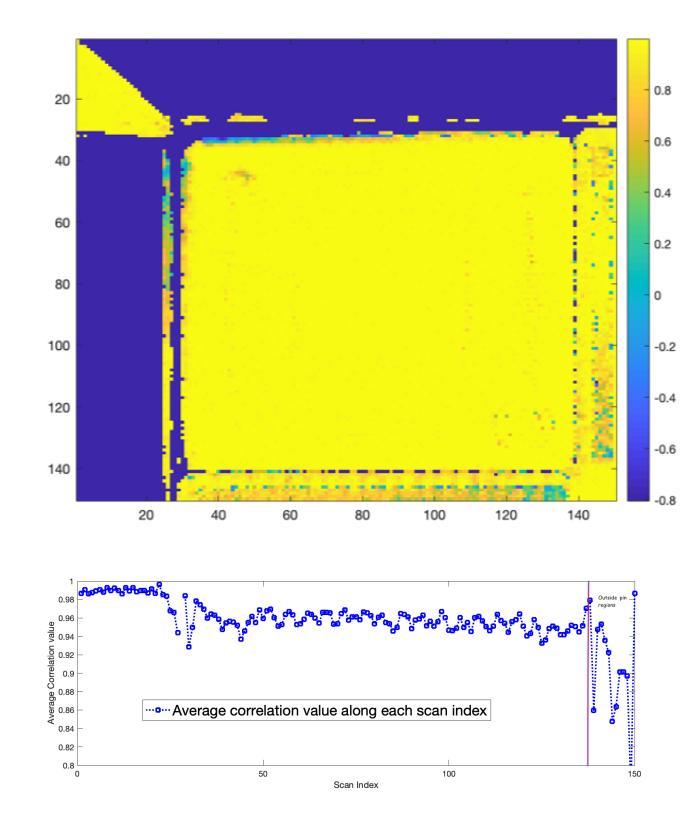
FIGURE 4. The top is the correlation of the same chip by taking after two consecutive measurement, and the bottom is the average value of correlation along the scan indices. The Low correlation values corresponds to the scattering from the edges are due to the scattering of the acoustic wave.

measurement. The uncertainty in the correlation measurement is about 5%, see Figure 4 (the outside pin region on the sample is not included due to the known effect of the scattering of the acoustic wave). The similarity of the sample is evaluated by looking at the 2-D image formed using the correlation values. Images were created by forming the correlation values for the entire time window, and a select narrowed time-window to focus on a given depth inside the material. To get a sense of the sensitivity of this analysis, a set of ASICs was used to compare their inner structure to one reference chip.

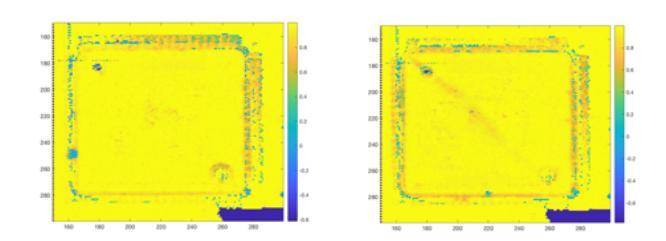
FIGURE 5. Images of the correlation analysis applied to 3 different ASICs are shown. To the left, we show the correlation map of two similar ASICs. It can be seen that there are no substantial differences inside the packaging (plastic packaging) of the chips. The smaller correlation values at the edges correspond to the pins and as it would be difficult to align those to the level of the imaging resolution. To the right, we show two ASICs that show substantial differences along a diagonal line, related to a difference inside the packaging of the circuitry.

Figure 5, shows the image formed using the correlation values for two different ASICs. To check for artifacts associated with a particular pixel size, we also performed the same study by averaging the correlation values over a pixel size three times the nominal pixilation (125 microns). As a result, a substantial number of ASICs show a diagonal feature in the correlation value images. The time integration window chosen provides an estimate of the depth of this feature, and we conclude that this feature appears to coincide with the depth of the thermal paste-layer of

those ASICs.

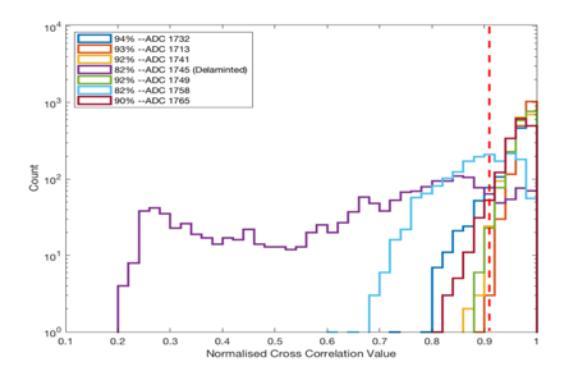
FIGURE 6. The distribution of the correlation values for the damaged ASICs is compared with the other ASICs, a clear shift towards the lower correlation value is noticed.

A more general view of a collection of 9 ASICs and their internal structural similarities can be gleaned from Figure 6. Here, a distribution of the correlation values is shown for 8 chips compared to a reference chip. As can be seen, most chips show correlation value distributions clustered around 1, corresponding to a high level of similarity of the inner structure when compared with the reference chip. One sample (chip identification number 1745) exhibits a very broad correlation value distribution. This chip had been purposely exposed to mechanical pressure to induce delamination inside. Furthermore, ASIC 1732 shows a broadened correlation value distribution compared to the other chips, indicating that the inner structure also differs substantially from the reference chip.

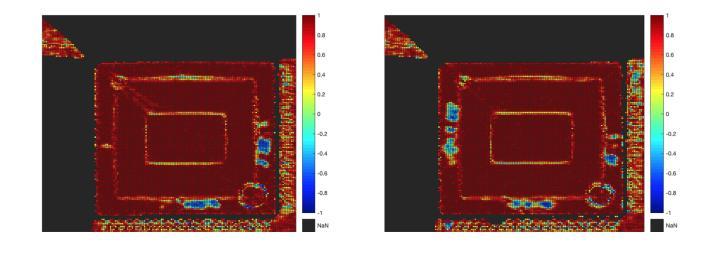
FIGURE 7. The C-scan image of two the ASICs formed using the correlation values of the samples before and after treated with liquid nitrogen, a clear change is observed in the sample. We have noticed these changes in a few of the samples. This image corresponds to a particular depth inside the sample. The waveform from the blue region shows a clear phase inversion.

One of the key motivations for this study is to determine if any structural changes inside the ASICs composite material occur as a result of temperature cycling between room temperature and submersion in liquid nitrogen. In these tests, several ASIC chips were immersed in liquid nitrogen followed by an acoustic microscopy scan done immediately after taken out. The summed amplitudes of the acoustic scans (C-scan) for one chip comparing the correlation images of two ASICs before (left) and after (right) the temperature cycling is shown in Figure 7. There is an apparent difference in the internal structure as indicated in Figure 7, to the left. A small strip feature appeared at a depth of 0.4 mm inside the ASIC package (calculated from the time of the reflected wave, the velocity of the sound in this composite material is taken as 2800 m/s) [9]. This mode of feature inside the ASICs can be explained by the stitch crack caused by delamination [10],

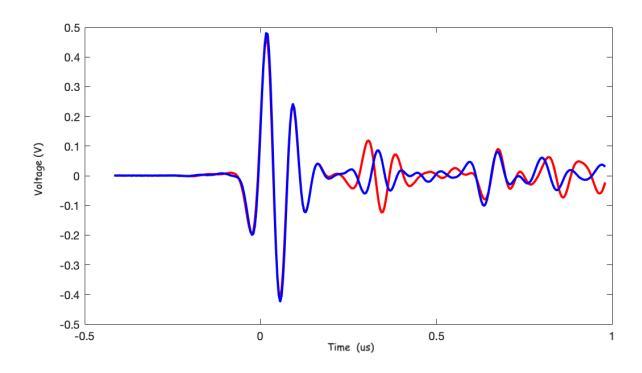
FIGURE 8. The waveforms are compared after and before treating with the liquid nitrogen at the low correlation regions, the clear phase inversion in the waveform, which is typically considered as an defect in the SAM (corresponding to the blue region in Figure 7).

here in order to confirm we need to chemically open up the package and also to study the variations in the functional test. To gain a more detailed view of the regions of interest, we show in Figure 9 the corresponding B-Scan images of the chip before (top) and after the liquid nitrogen treatment (bottom). The comparison shows a clear change in the center region. It appears that a multilayer indentation was already present before the temperature cycling (top), and is much enlarged after the cycling (bottom). To extract more information about the low correlation region, the pure waveforms from this region is compared before and after the liquid nitrogen treatment, we have observed a phase inversion in the waveform at a particular depth inside the chip, this is shown in Figure 8.

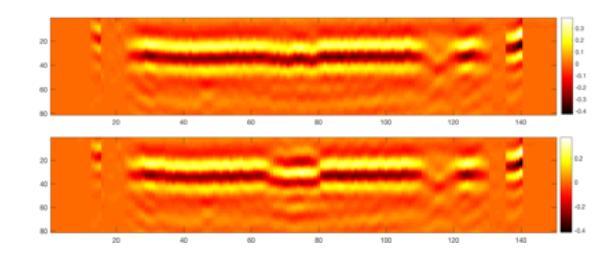
FIGURE 9. The B-scan image from one of the ASICs before (top) and after(bottom) treated with the liquid nitrogen for 20 minutes. A shift in the B-scan waveform could be an indication of sensitive regions inside the chip package.
