# In situ mechanical testing of an Al matrix composite to investigate compressive plasticity and failure on multiple length scales

SiC particle-reinforced Al matrix composites exhibit high strength, high wear resistance, and excellent high-temperature performance, but can also have low plasticity and fracture toughness, which limits their use in structural applications. This study investigates the plasticity and failure of such a composite on multiple length scales, from strain localization through a complex microstructure to the debonding of individual microparticles from the matrix. Three microscale pillars containing microstructures with different complexities and sizes/volume fraction of SiC particles were used to study the effect of these features on deformation. For the matrix, nanoscale intermetallic precipitates within the Al grains contribute most to the strengthening effect, and the Al grain boundaries are shown to be effective obstacles for preventing strain localization by dominant shear bands and, therefore, catastrophic failure. When shear localization occurs, SiC particles can then debond from the matrix if the shear band and interface are aligned. To investigate wh

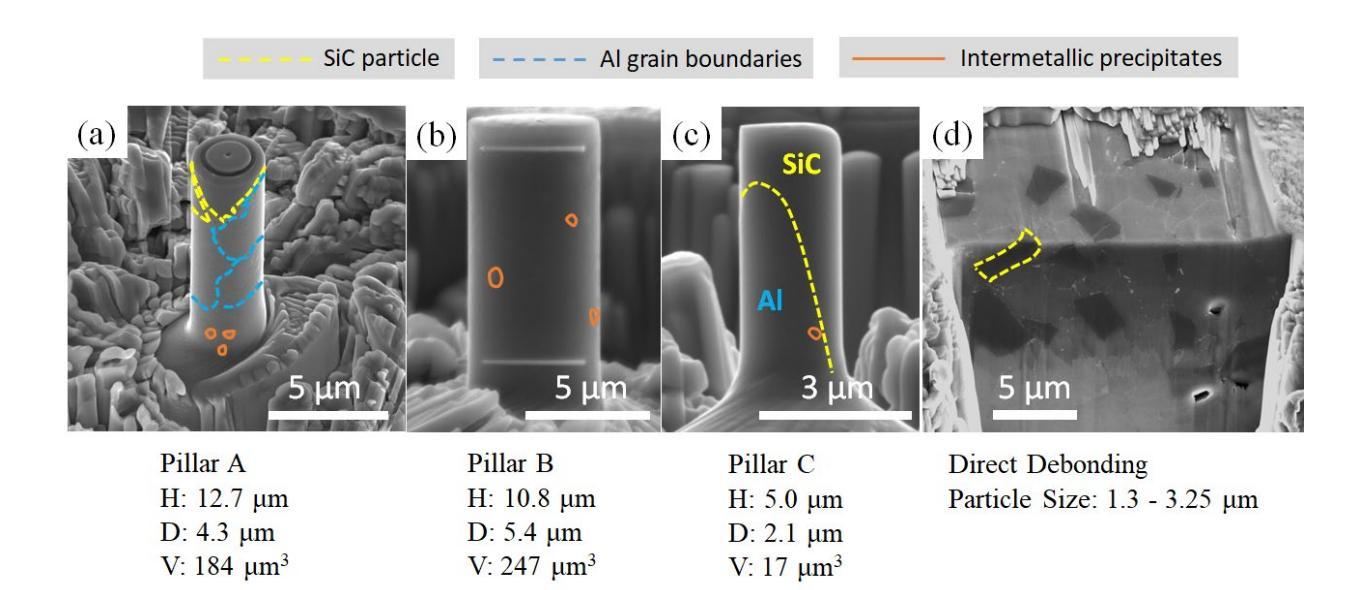
Fig. 1 (a)-(c) SEM micrographs of three pillars with different microstructures and (d) two perpendicular surfaces milled to reveal a SiC particle. H, D, and V correspond to height, diameter, and volume, respectively. Various features including SiC particles, Al grain boundaries, and intermetallic precipitates are outlined

In situ microcompression tests were performed inside an SEM on micron-size pillars using a FemtoTools FT-NMT03 nanomechanical testing system. The load was applied by a small platen, which was FIB milled from a 50×50 µm flat Si MEMS-based force sensor-head (model FT-S200'000 with a  $\pm 200,000 \,\mu$ N force range and 0.5  $\mu$ N force resolution). The pillar displacement was controlled using a subnanometer-resolution piezo-based actuation system. Pillars with a height-to-diameter ratio of 2-3 were fabricated to prevent plastic buckling [25] in the FEI Quanta 3D FEG dual beam SEM/FIB with a Ga<sup>+</sup> beam. Concentric annular milling was used to minimize the initial tapering effect, followed by lathe milling [26] to smooth the pillar surface and remove taper. Best practices for microcompression experiments suggest that pillars should have a nearzero taper angle to ensure a uniform stress-state during loading [25]. A thin protective Pt cap deposited on the pillar surface and decreasing ion beam current during the annular milling were employed to minimize Ga<sup>+</sup> implantation, so that Ga<sup>+</sup> effects do not play a dominant role in the plastic behavior and failure mode [27,28]. Figures 1(a)-(c) show the three pillars investigated in the present study. Pillar A contains several Al grains, one SiC particle at the top and another inside the center of the pillar, and has a variety of multiscale intermetallic precipitates inside the matrix grains. This sample can be thought of as a representative volume element of the composite, as it contains all of the important structural features found in the bulk material. Both Pillar B and C contain a SiC particle at the top and one Al grain at the bottom, with the volume fraction of the SiC particle being higher in Pillar C than in Pillar B. The SiC particle in Pillar B is located on the

back side of the pillar as it is viewed in Figure 1(b). Therefore, the structure of Pillar C is the closest to isolating the interface between the Al matrix and the SiC reinforcement particle (termed the "matrix-particle interface" throughout this paper), while that of Pillar B is an intermediate state between the other two pillars. These three pillars offer a chance to investigate the deformation behavior of various microstructural complexities. The microcompression tests were displacement-controlled and performed at a nominal strain rate of  $10^{-3}$  s<sup>-1</sup> at room temperature. The yield strength for each pillar was obtained using a common 0.2% offset criterion since Brandstetter et al. [29] verified that this criterion is still valid for ultrafine-grained Ni, and the grain size of the present composite is in micrometer range.

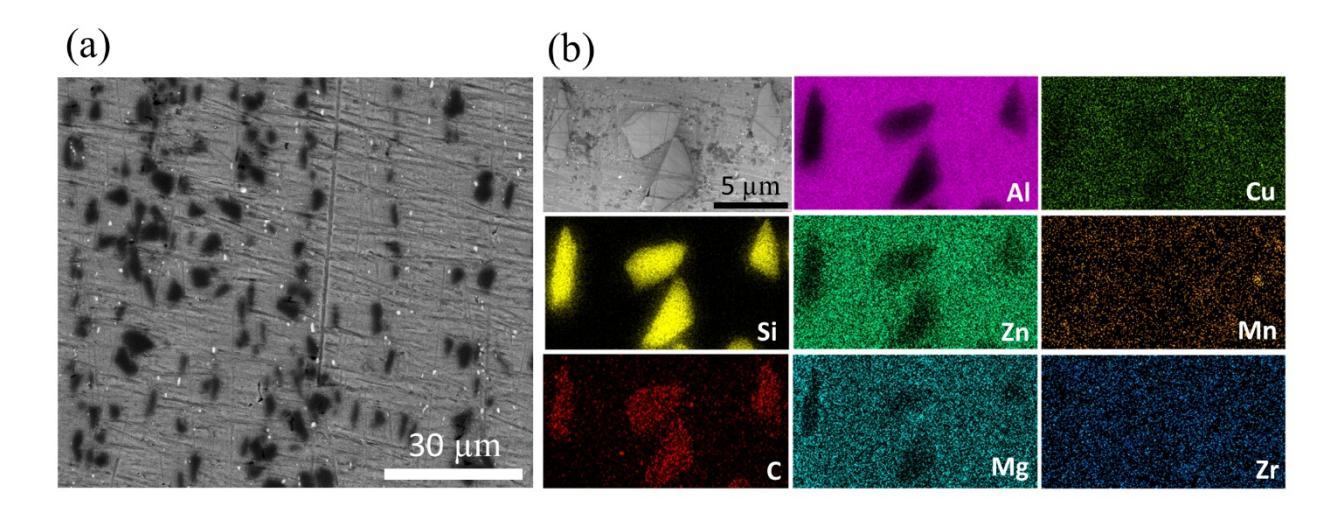
Fig. 2 (a) Backscattered electron SEM micrograph of the composite surface, which shows SiC particles (dark regions) and intermetallics (light regions) distributed in the Al matrix. (b) A magnified SEM image and the corresponding EDS maps of different elements within the composite

Figure 2(a) shows a backscattered electron SEM micrograph of the composite surface, where SiC particles appear dark due to their relatively low effective atomic number and intermetallics comprised of higher effective atomic number constituents can be seen as bright spots on the Al-matrix background. The particles have irregular, faceted shapes with sizes ranging from sub-micrometer to a few micrometers. They tend to form clusters instead of being uniformly distributed, similar to other cast SiC particle reinforced Al matrix composites [30]. Quantitative EDS analysis of the composite microstructure shows a SiC particle volume fraction of ~10%. A magnified SEM image and the corresponding EDS maps are shown in Figure 2(b), where four particles are observed and verified to be SiC. The matrix is mainly composed of Al, along with several other alloying elements such as Zn, Mg, Cu, Mn, and Zr. Zn, Mg, and Cu are commonly used as alloying elements in Al alloys because the precipitates they form are effective for precipitates [31]. In addition, small amounts of Mg and Zr have been used to improve the

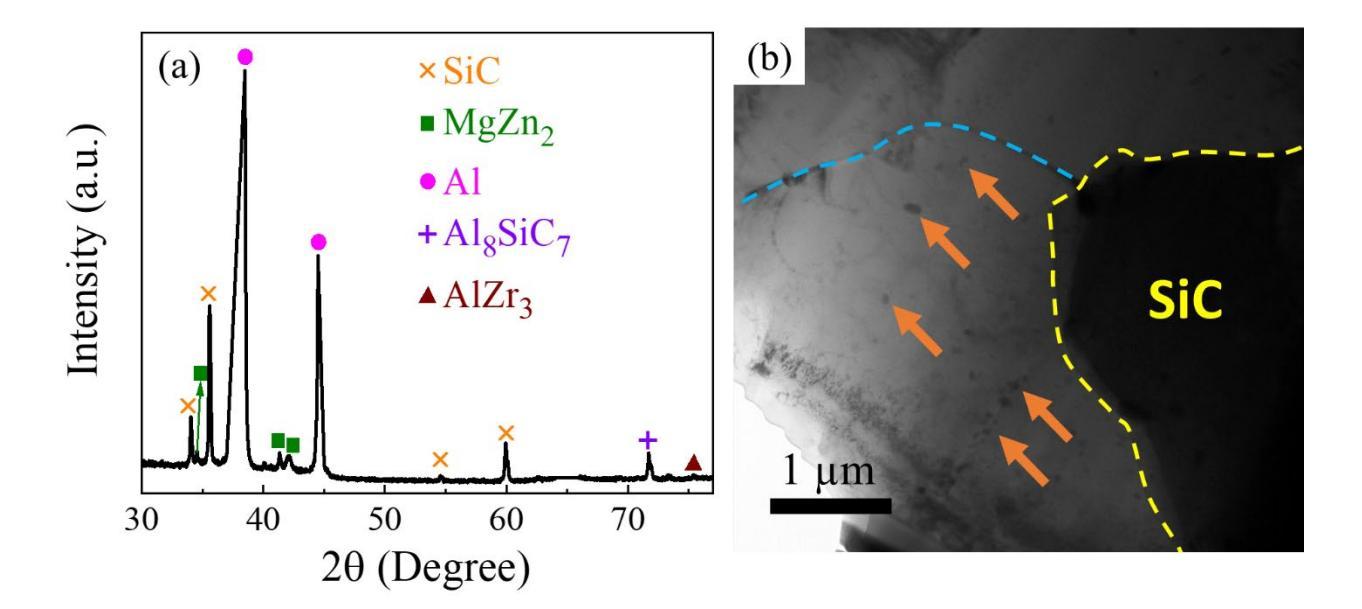
Fig. 3 (a) XRD profile showing different phases, and (b) bright field TEM micrograph of the composite. One Al grain boundary and SiC particle are outlined by blue and yellow dashed lines, respectively. Orange arrows point to intermetallic precipitates

Figure 3(a) displays a representative XRD profile of the as-extruded composite, where peaks corresponding to the face-centered-cubic (FCC) Al matrix and SiC particles are clearly identified. In addition, peaks associated with various Al- and Mg-based intermetallic phases emerge, such as MgZn<sub>2</sub>, which is one of the most commonly observed phases in the as-cast microstructures for commercial Al alloys [33]. To visualize the different phases, bright field TEM was employed and one example is shown in Figure 3(b). In this image, one SiC particle and an Al grain boundary are outlined in yellow and blue dashed lines, respectively, while sub-micrometer intermetallic precipitates (indicated by orange arrows) reside in the Al grain. Since the matrix microstructure is an important factor affecting the mechanical behavior of the composite, a more detailed and quantified characterization of the Al matrix was performed with bright field TEM.

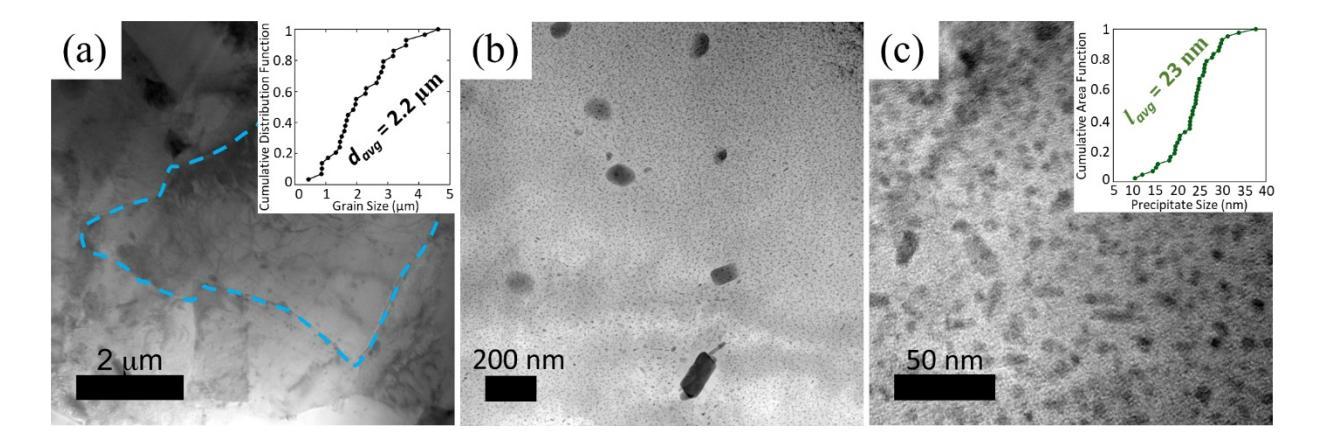
Fig. 4 Bright field TEM micrographs of the Al matrix. (a) One Al grain is outlined in blue dashed lines, and the inset is a cumulative distribution function of the grain size with an average of 2.2  $\mu$ m. (b) Precipitates of various sizes ranging from tens to hundreds of nanometers. (c) Nanoscale precipitates within the Al matrix material. The inset is a cumulative distribution function of the nanoscale precipitate size with an average of 23 nm

Figure 4 illustrates various features and their quantification within the matrix. In Figure 4(a), an FCC Al grain is outlined whose size is ~4  $\mu$ m. The inset shows a cumulative distribution function of Al matrix grain size, where the smallest and largest grain sizes are ~0.5  $\mu$ m and ~4.6  $\mu$ m, respectively, with an average of 2.2  $\mu$ m. Therefore, the sizes of the Al grains and SiC particles (Figure 2) are similar, with the SiC particles being slightly larger. Figure 4(b) shows intermetallic precipitates within the Al grains, and a wide size range is observed from tens to hundreds of nanometers. A magnified region containing only the nanoscale precipitates is shown Figure 4(c), with quantitative characterization presented in the inset. The nanoscale precipitate sizes ranged from ~ 10 nm to 38 nm, with an average size of 23 nm. The nanoscale intermetallic precipitates were therefore much smaller than the Al grains and SiC particles.

In addition to the intermetallics found by XRD, STEM-EDS also provided evidence of nanoscale MgO and Zn-rich phases that were primarily located near the matrix-particle interfaces (not shown here for brevity). The presence of MgZn<sub>2</sub> intermetallics was confirmed by STEM-EDS, as shown in Figure 5. These particles are tens of nanometers in diameter and distributed homogeneously throughout the Al matrix, in agreement with the data obtained from bright field imaging in Figure 4.

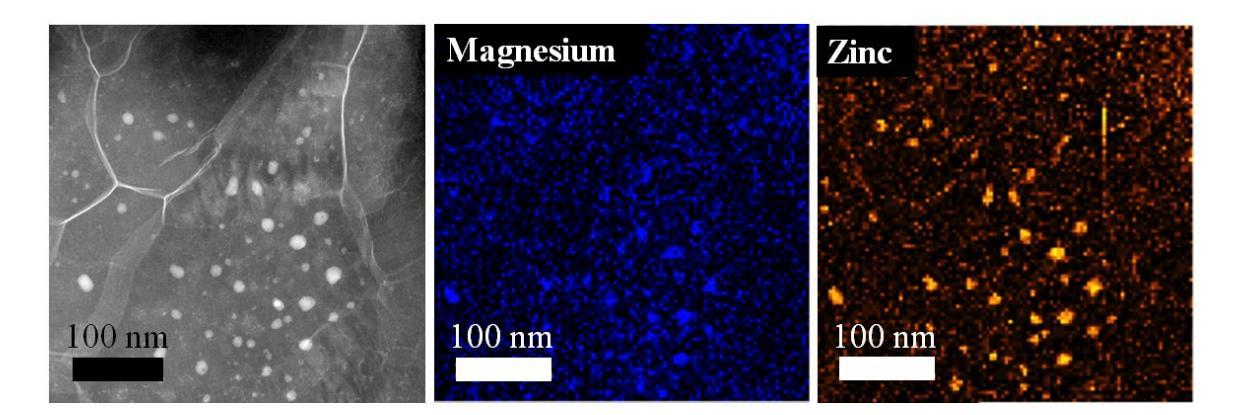
Fig. 5 STEM-EDS maps showing the presence of nanoscale MgZn<sub>2</sub> intermetallics uniformly distributed within Al grains

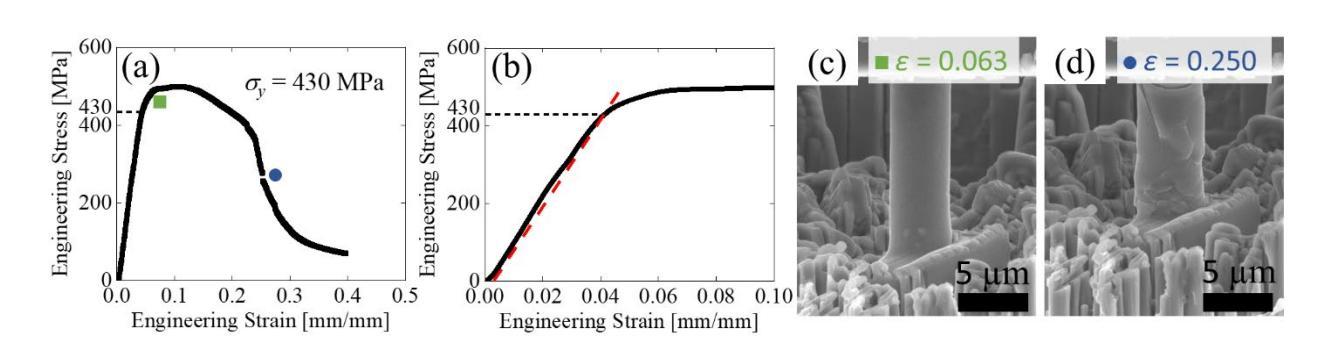
Fig. 6 (a) Engineering stress-strain curve for Pillar A from microcompression testing, with a zoomed view provided in (b). The red dashed line represents the 0.2% offset with the yield strength value indicated on the Y axis in each as  $\sigma_y$ . (c) and (d) are SEM snapshots corresponding to engineering strains of 0.063 and 0.250, respectively

Figure 6 shows the result of the microcompression test for Pillar A and the corresponding SEM snapshots at two strain values of 0.063 and 0.250. Pillar A has the most complex microstructure (Figure 1(a)), which contains one SiC particle at the top and another in the center, multiple Al grains below the top particle, and intermetallic precipitates of various sizes within the Al grains. The engineering stress-strain data are presented in Figure 6(a), where a yield strength of 430 MPa is obtained for this sample, consistent with reported values for SiC particle-reinforced Al-matrix composites [34,35]. After reaching the yield point, the stress-strain curve, if viewed by itself, suggests that the pillar might be strain softening. For Al-matrix composites, possible reasons for strain softening include strain localization and/or nucleation and growth of voids or microcracks [36]. However, no obvious shear band or voids/microcracks are observed in the SEM image corresponding to a strain of 0.063, as shown in Figure 6(c). Instead, Figure 6(d) shows that Pillar A undergoes bending and any apparent softening is due to this response, and is not an intrinsic feature of the plastic deformation of this material. We hypothesize that the bending is a result of the misalignment caused by elastic inhomogeneities, since the Young's modulus of the Al matrix (69 GPa, [37]) is dramatically lower than that of the SiC particles (410 GPa, [38]). No obvious separation of the complete particle from the matrix is observed from SEM images of the pillar after plastic deformation, although heavy deformation is found at some locations along the interface. Therefore, Pillar A with the most complex microstructure exhibits a yield strength of 430 MPa and can undergo stable plastic flow without fracture of the matrix-particle interface.

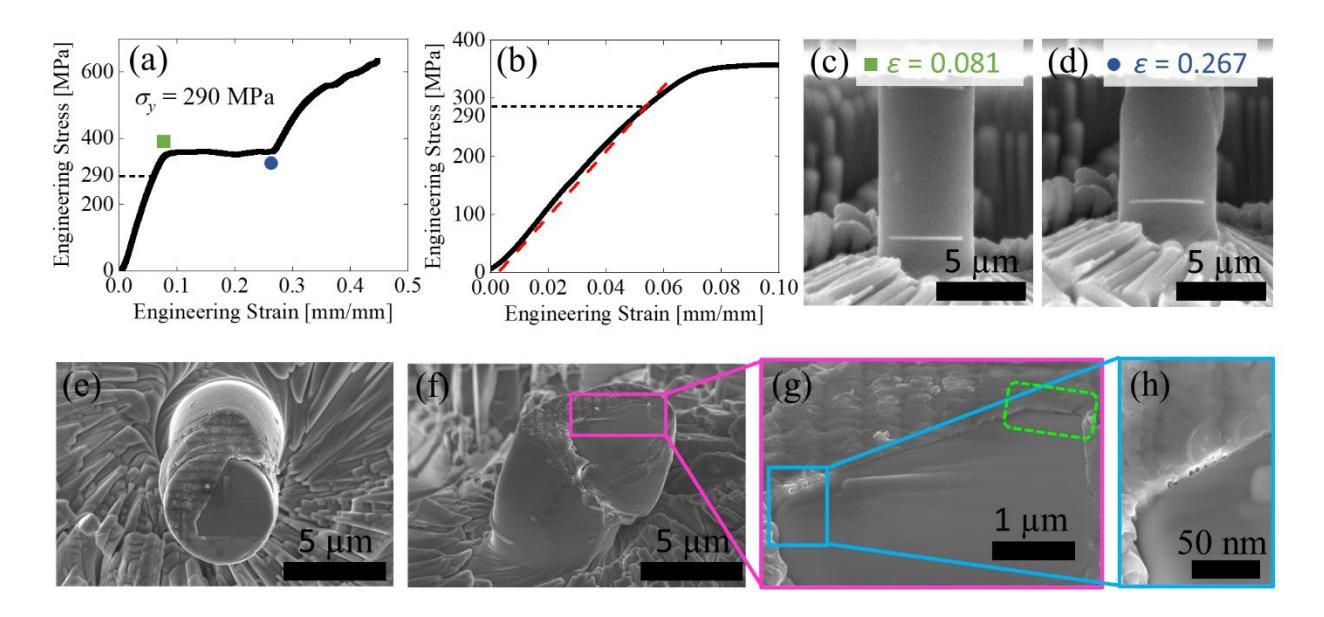
Fig. 7 (a) Engineering stress-strain curve for Pillar B from microcompression testing, with a zoomed view provided in (b). The red dashed line represents the 0.2% offset with the yield strength value indicated on the Y axis in each as  $\sigma_y$ . (c) and (d) are SEM snapshots corresponding to engineering strains of 0.081 and 0.267, respectively. (e) Top view of the deformed pillar, which clearly shows matrix-particle interface debonding. (f) Side view of the deformed pillar demonstrating catastrophic failure through strain localization within a shear band. (g) A magnified view of the interface debonding area reveals two types of debonding. The first one is brittle with no/little plastic deformation in the Al matrix, as enclosed in the green dashed box. The second one is decohesion with plastic deformation in (h)

The engineering stress-strain curve and two SEM snapshots for Pillar B are shown in Figure 7. Compared to Pillar A, Pillar B has a larger size but simpler microstructure with only one SiC particle at the top and one Al grain at the bottom region. Therefore, while Pillar A has multiple grain boundaries and the matrix was a polycrystal, no grain boundaries exist in Pillar B. In addition, the volume fraction of the SiC particle is higher in Pillar B than in Pillar A, and the matrix-particle interface terminates in the top surface of the pillar, as shown later in SEM and TEM images of the deformed pillar. Due to the different microstructure, the plastic deformation of Pillar B deviates from that of Pillar A. Figure 7(a) shows that Pillar B has a much lower yield strength of 290 MPa, after which a plateau occurs followed by apparent strain hardening. It is possible that the low yield strength is due to lack of grain boundary hardening. However, the microcompression experiment on Pillar C (reported below), which also does not contain any grain boundary yet exhibits the highest yield strength among the three pillars, rules out this possibility. At the early stage of plastic deformation, the pillar does not show any failure initiation (Figure 7(c)), such as microcracks or shear bands. When the applied strain becomes larger, the top right section of the pillar shears downwards, as clearly seen in Figure 7(d). Therefore, the apparent strain hardening after the plateau observed in Figure 7(a) is due to a quickly increasing contact area as the sheared section

moves downward and new material is exposed, meaning both the original cross-sectional area plus some near region is being contacted (Figure 7(d)). The apparent hardening during the later deformation stages in Pillar B is thus geometric and not associated with any true material response.

Figures 7(e) and 7(f) are the top and side views of deformed pillar B, respectively. Unlike Pillar A, which undergoes stable plastic deformation, Pillar B fails catastrophically through strain localization within a dominant shear band (Figure 7(f)). The shear band crosses from the top left to the middle right of the sample and is aligned closely with the matrix-particle interface, as shown more clearly in TEM images of the deformed pillar. The difference in deformation mode between Pillar A and B indicates that grain boundaries are effective obstacles for preventing shear localization. In addition to catastrophic failure, debonding at the matrix-particle is observed for the deformed pillar. To get a closer look at the interface debonding, a magnified view of the region outlined by a purple rectangular in Figure 7(f) is shown in Figure 7(g). At this top surface, two types of debonding are observed. The first type is a clean and brittle separation with no obvious deformation in the matrix, as outlined by a dashed green box. The second type is a decohesion with plastic flow in the matrix, which is enclosed by a blue rectangular in Figure 7(g), with a magnified view of this region shown in Figure 7(h). The occurrence of these two decohesion modes could be related to whether or not oxides and/or intermetallics are clustered near that particular interfacial region, but a detailed investigation of this effect is beyond the scope of this paper. Therefore, without multiple grain boundaries, Pillar B undergoes catastrophic failure through strain localization within a dominant shear band along with matrix-particle interface debonding. However, the relationship between the shear localization and interface debonding is not clear at this point.

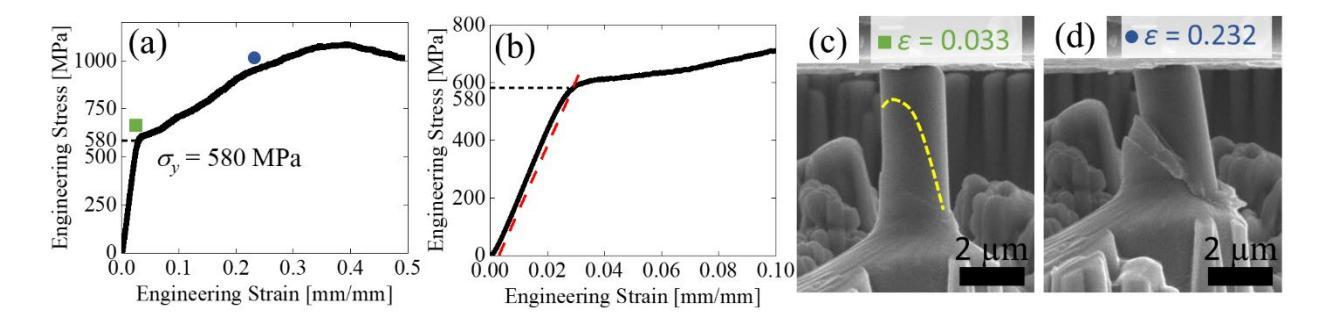
Fig. 8 (a) Engineering stress-strain curve for Pillar C from microcompression testing, with a zoomed view provided in (b). The red dashed line represents the 0.2% offset with the yield strength value indicated on the Y axis in each as  $\sigma_y$ . (c) and (d) are SEM snapshots corresponding to engineering strains of 0.033 and 0.232, respectively. Only matrix plastic deformation is observed here

Figure 8 shows the microcompression results for Pillar C, whose microstructure resembles a simple matrix-particle interface. Same as Pillar B, Pillar C contains one SiC particle and one Al grain. However, the volume fraction of SiC in Pillar C is much higher, being ~50 %, and the matrix-particle interface is across the whole sample from the top left to bottom right of the pillar (Figure 1(c)). Figure 8(a) displays the engineering stress-strain data for Pillar C, where a yield strength of 580 MPa is obtained. This is the highest yield strength among the three pillars, which indicates that grain boundary strengthening cannot be the primary strengthening mechanism for the Al matrix because Pillar C does not contain any grain boundaries. Consequently, other strengthening mechanisms should play a dominant role for the matrix and will be discussed below. After the onset of yielding, Figure 8(c) shows that a faint shear band is formed at the bottom, but this strain localization is far away and orientated differently from the matrix-particle interface. With further increasing applied strain, Pillar C experiences catastrophic failure through a dominant shear band in the Al matrix, as shown in Figure 8(d). The dominant shear band is close to the initial shear band observed in Figure 8(c) and also far away from the matrix-particle interface. The reason that the dominant shear band forms in the Al matrix and far away from the interface may be higher dislocation density in the matrix than in the near interface region, as observed by Hong et al. [39] for a 1060 Al/Al<sub>2</sub>O<sub>3</sub> composite after compression tests. This higher dislocation content can provide many easily moveable defects that can accumulate large plastic strains in a local region. Moreover, without any grain boundaries, there is an uninterrupted slip pathway that traverses the entire micropillar sample. The high yield strength of 580 MPa of Pillar C suggests that the Al matrix is intrinsically very strong.

It should be emphasized that even though both Pillar B and C exhibit catastrophic failure, the location and alignment of the dominant shear band with respect to the matrix-particle interface is not the same. The shear band in Pillar B is in the upper region of the pillar and aligned with the matrix-particle interface, while the one in Pillar C is at the bottom, far away from the interface, and at a different angle than the interface plane. Therefore, these differences between Pillar B and C may lead to different interface behavior after deformation. Unlike Pillar B, no interface debonding is observed for Pillar C. Hence, we propose that when the shear band occurs in the vicinity of the matrix-particle interface and aligns with it, as in the case of Pillar B, decohesion at the interface occurs. In contrast, if the shear band is far from the interface and does not align with any segment of the interface, the particle will not be separated from the matrix.

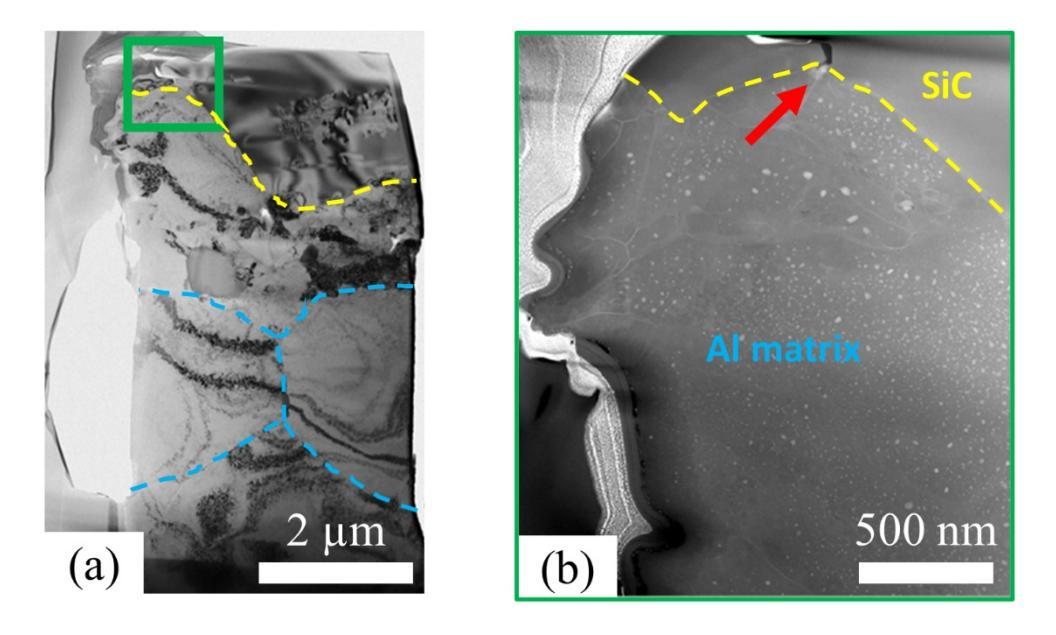
Fig. 9 (a) Bright field TEM micrograph of the deformed Pillar A. SiC particle and Al grain boundaries are outlined by yellow and blue dashed lines, respectively. A region containing a crack that has arrested at the matrix-particle interface is enclosed by a green square and magnified view is shown in (b). The exact location of crack arrest is denoted by a red arrow at the matrix-particle interface

A crack is observed that travels through the SiC particle and ends near the matrix-particle interface, as enclosed in a green rectangular in Figure 9(a) and magnified in Figure 9(b). Instead of propagating along the interface, the crack is arrested at the interface and does not lead to any obvious interface deformation. This implies that the matrix-particle interface is not an intrinsic weak point that is ready to fracture easily and to initiate macroscopic failure. By performing tensile tests on a SiC particle reinforced Al 6061 alloy after three different heat treatments with different cooling rates, Gupta et al. [41] concluded that one reason for an enhanced matrix-particle interface bonding can be a higher concentration of alloy elements at the interface than in the matrix. In the present study, we also observed some interface regions coated with alloy elements from EDS maps (not shown here for brevity), which may attribute to the strong interface observed in our composite

material. In addition, the observation of crack arrests shows that crack propagation requires additional energy to move along the matrix-particle interface. Figure 9(b) also shows many nanosized precipitates within the Al matrix which are not heavily deformed after the microcompression test in this pillar. Therefore, for a bulk-like microstructure such as that captured by Pillar A, the grain boundaries can effectively prevent shear localization up to a relatively high stress, and failure does not originate from the matrix-particle interface.

precipitates are not obviously deformed in Pillar A (Figure 9(b)), which exhibits a high yield strength, so we can conclude that the strain localization and the damaged precipitates lead to a lower yield strength for Pillar B.

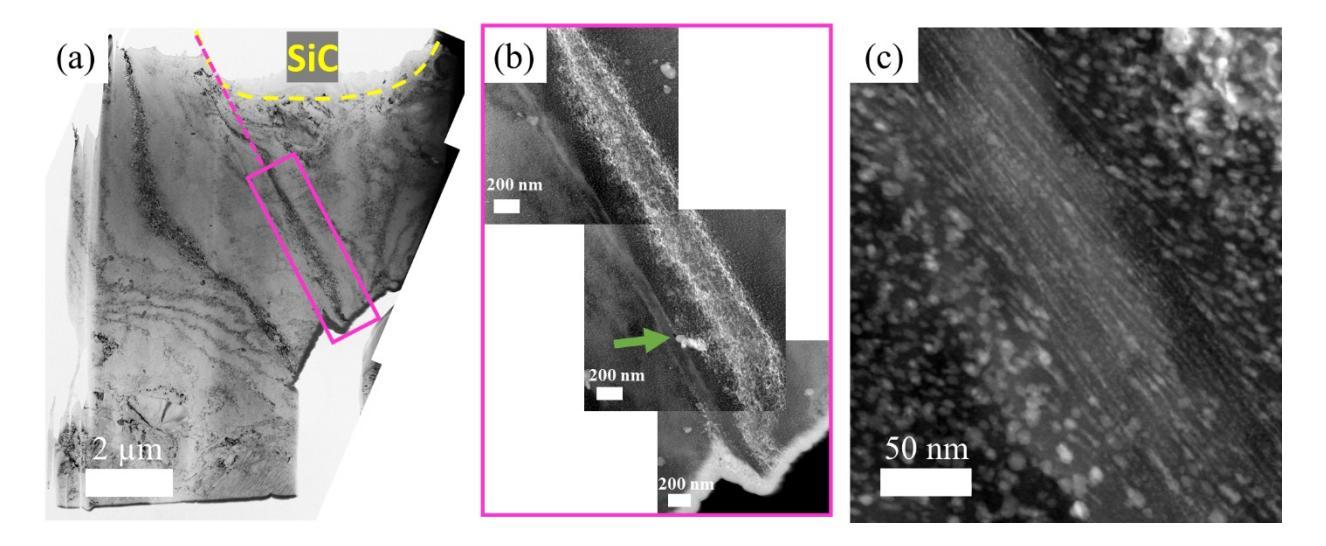
Fig. 10 (a) Bright field TEM micrograph of the deformed Pillar B. The SiC particle is outlined by a dashed yellow line, which also represents the matrix-particle interface. The area outlined by a purple box shows a dominant shear band, which is shown in more detail in (b). The dotted purple line follows the trace of the dominant shear band, which aligns well with the matrix-particle interface. (b) The dislocation density within the shear band is very high, and a void has formed at the interface between an intermetallic precipitate and matrix, as denoted by a green arrow. (c) A magnified view of the shear band demonstrates that the precipitates are severely deformed in this region

When the microstructure of the pillar becomes simpler (e.g., only one Al grain below the SiC particle as seen in Pillar B and C), catastrophic failure through shear localization occurs. Moreover, Pillar B also exhibits matrix-particle interface debonding. Figure 10(a) shows a bright field TEM micrograph of deformed Pillar B, where most of the SiC particle has been removed during FIB milling to allow for an electron transparent sample and the rest of the particle is outlined by a dashed yellow line. No grain boundaries exist in the matrix, and several regions with strain contrast are observed in the bottom region. The top part of the pillar is sheared to the right with respect to the bottom region along a major shear band, which crosses the pillar from top left to middle right and is enclosed in a purple rectangular in Figure 10(a). Since no grain boundaries exist within the sample, once shear localization is initiated, the dominant shear band can propagate through the whole material without barriers and cause catastrophic failure. Figure 10(a) also clearly shows that the dominant shear band and part of the matrix-particle interface are aligned with each other, which is suspected to be related with interface debonding. A closer examination of the shear band in Figure 10(b) with dark field TEM imaging reveals a high dislocation density. In addition, a void was formed at the interface between a precipitate and matrix (denoted by a green arrow). Figure 10(c) presents a further magnification view of the shear band, which shows that the nanoscale precipitates are severely sheared in this region. We note that the nanoscale

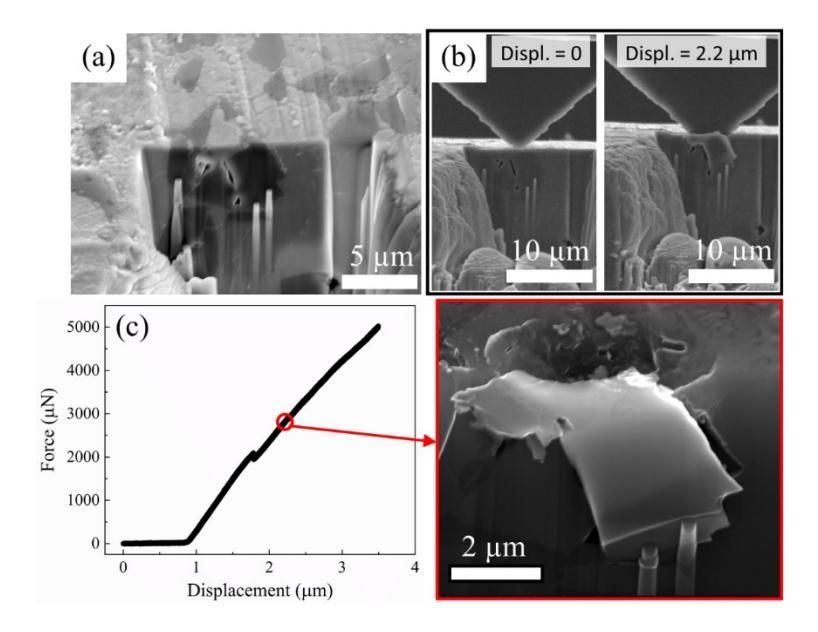
Fig. 11 (a) Two perpendicular surfaces containing one SiC particle are created using FIB milling. (b) A load is applied on the particle using a slightly rounded tip until the particle separates from the matrix. The corresponding displacements are shown for the two images. (c) Representative force-displacement data from a direct debonding test. The obvious drop in the force does not correspond to the initiation of the interface debonding, which actually takes place at a later displacement marked by the red circle. The corresponding SEM micrograph of the debonded particle shows no obvious plastic deformation of the matrix near the interface

The microstructure evolution during plastic deformation for the three pillars indicates that strain localization and matrix-particle interface decohesion are related. However, whether interface debonding precedes and causes shear localization or shear localization facilitates interface debonding still needs to be determined. To clarify the relationship, in situ direct debonding testing was next employed, where load is applied on one SiC particle to separate it from the matrix and SEM observation allows the exact moment of debonding to be isolated. Before applying the load, two clean surfaces perpendicular to each other with SiC particles on both the top and front surfaces are created using FIB milling, as shown in Figure 11(a). The dark and light regions are SiC particles and Al matrix, respectively. Next, a slightly rounded tip that is smaller than the particle is used to apply load on one particle until decohesion at the particle-matrix interface occurs. The primary output from the direct debonding experiments is the critical applied load when debonding occurs. Figure 11(b) displays two SEM snapshots, with the first being when the tip has just contacted the particle and the second being when the particle was pushed out from the matrix. The corresponding displacements of the tip are indicated. The SEM images clearly show that only one SiC particle is separated from the matrix, so the interface strength can be obtained via the applied load corresponding to interface debonding and the measured particle size. Figure 11(c) is a representative force vs. displacement curve, where a drop in the force occurs at a displacement of  $\sim 1.7 \,\mu m$ . Without in situ imaging, it would be likely that one would associate this drop with the initiation of the debonding event. However, SEM snapshots show that the debonding does not occur until a larger displacement of  $\sim 2.2 \ \mu m$  with an applied force of  $\sim 2900 \ \mu N$ . This point is marked by a red circle in the force-displacement data, and an SEM micrograph after particle debonding is displayed to the right. No obvious drop in the load is observed when the particle debonds from the matrix. This demonstrates that in situ direct debonding testing is a powerful technique to allow for a precise determination of the load associated with the interface decohesion.

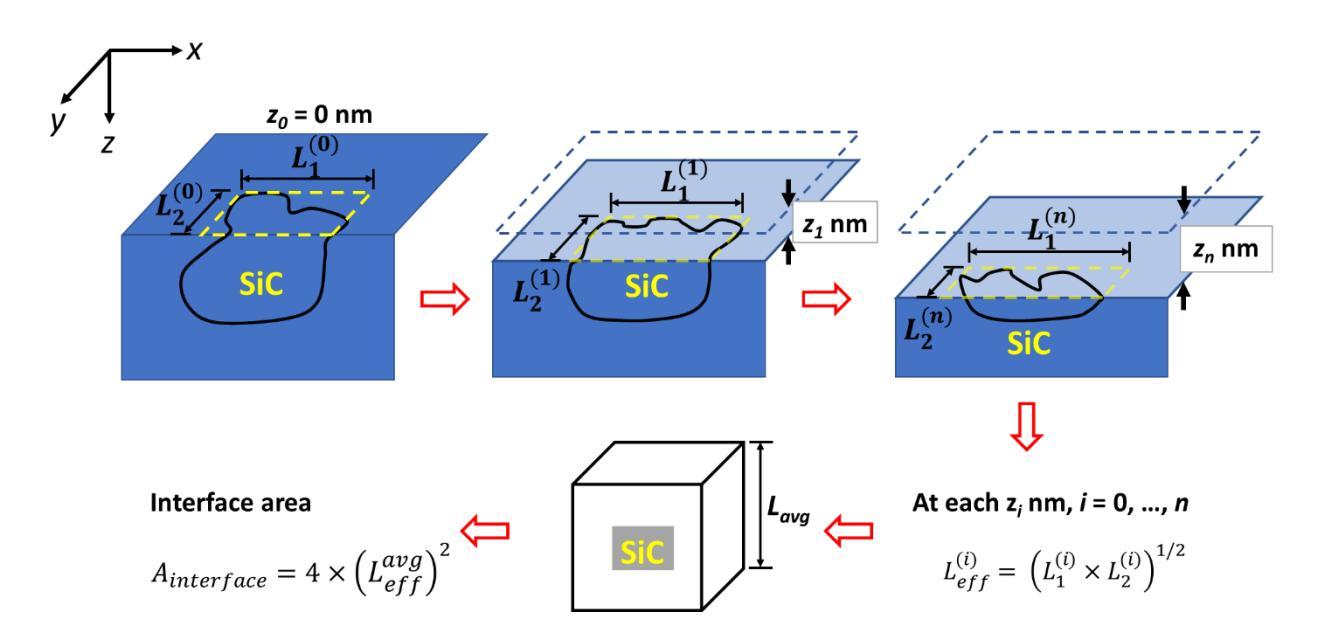
Fig. 12 Schematic illustration of measuring particle sizes via post-test milling at different depths. A rectangular is used to enclose the shape of the particle on the top surface (x-y plane) at each depth  $z_i$ , and the side lengths are  $L_1^{(i)}$  and  $L_2^{(i)}$ . Then, an effective length at each  $z_i$ ,  $L_{eff}^{(i)}$ , is obtained by taking the square root of the product of  $L_1^{(i)}$  and  $L_2^{(i)}$ . The shape of the particle is assumed to be a cube with a side length of  $L_{eff}^{avg}$ , equal to the average value of  $L_{eff}^{(i)}$  at all depths. Four sides of the particle are assumed to be contacted with the matrix. Therefore, the total interface area,  $A_{interface}$ , is four times the square of the  $L_{eff}^{avg}$

First, the shape of the particle observed on the surface during the experiment is not necessarily representative of the internal particle shape. For example, the particle cross-section can be larger or smaller underneath the surface than on the surface. To address this potential issue, particle sizes are determined by post-test milling using FIB to different depths, with SEM images of the shapes that particles left behind taken at each depth, as illustrated in Figure 12. For the SEM image with no milling depth,  $z_0 = 0$ , a rectangle is used to enclose the particle shape on the top surface, and the side lengths are  $L_1^{(0)}$  and  $L_2^{(0)}$ . Next, the top surface is milled down by a depth of  $z_1$  nm, and another rectangle with side lengths of  $L_1^{(1)}$  and  $L_2^{(1)}$  is employed to measure the particle size. After *n* milling steps, the side lengths of the rectangular used for measurement are  $L_1^{(n)}$  and  $L_2^{(n)}$ . For each depth, a corresponding effective side length is defined as  $L_{eff}^{(i)} = (L_1^i \times L_2^i)^{1/2}$ . To be conservative, the particle shape is assumed to be a cube with a side length,  $L_{eff}^{avg}$ , equal to  $(1/n) \times \sum_{i} L_{eff}^{(i)}$ , i = 1, ..., n. Finally, the total interface area between the particle and matrix is set to be  $4 \times (L_{eff}^{avg})^2$ . The assumption of four sides in contact here acknowledges that the front and top of the particle are free surfaces created by FIB milling. A second potential issue that can arise is that one matrix-particle interface can debond before the others, due to variations in local stresses, particle shape, or even interfacial strength. The effect of this would mean that the actual area of the interface that debonds is less than the total interfacial area of the particle, and the true interface strength higher than one that is calculated using that total interface area. However, to be

conservative, we assume that all four faces of the particle debond at the same time, which provides a lower bound on the interface strength.

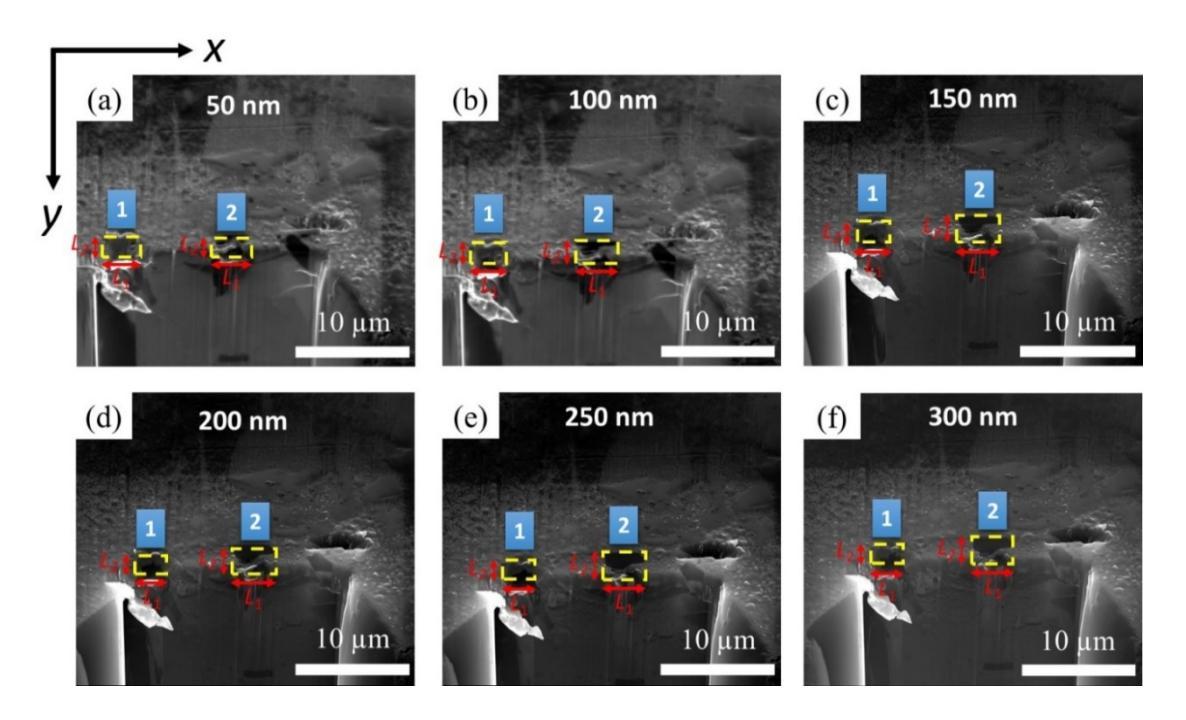
Fig. 13 Representative particle size measurements for two particles, labeled as "1" and "2", at different milling depths, as indicated in each SEM image. Dashed yellow rectangles are used to enclose the shapes that the debonded particles left behind.  $L_1$  and  $L_2$  correspond to the horizontal and vertical side lengths of the particles, respectively

Figure 13 shows representative measurements for two particles, with (a)-(f) corresponding to a milling depth of 50 -300 nm. All SEM snapshots clearly show two particles, indexed as "1" and "2" and outlined by dashed rectangles. In addition, measurements of the side lengths,  $L_1$  and  $L_2$ , are shown for each particle. It should be noted that the SEM images have a tilt angle of 52 degrees, and corrections have been made when measuring the  $L_2$  length values. Next, the  $L_{eff}$  value for each particle and milling depth is obtained by taking the square root of the product of  $L_1$  and  $L_2$ . Subsequently, an average is taken of  $L_{eff}$  values for all milling depths, and this average value is used to calculated the effective area, as described above, and calculate the interface strength of a specific particle. Six particles were tested and measured in this way, and their results are listed in Table 1, giving an average interface strength of  $254 \pm 61$  MPa. This value is much larger than the critical resolved shear stress for Pillar B of ~95 MPa, calculated using an average Schmid factor of 0.3 for face-centered cubic A1 [42]. In fact, all individual measurements are much larger than this critical resolved shear stress. Again, we remind the reader that our calculation of the interface strength is a lower bound, and that the true interface strength is at least this value and likely higher. As a whole, these results indicate that the matrix-particle interface is not a weak point to start failure and initiate strain localization. In fact, our results show that shear localization should be occurring first and can facilitate interface debonding if intense shear banding occurs.
