Adhesion mechanism of temperature effects on Sn coating on the carbon fiber reinforced polymer substrate by cold spray

Jiayu Sun^{a,b}, Shaoyun Zhou^c, Kenta Yamanaka^{b,*}, Hukang bina^b, Yuji Ichikawa^c,
Hiroki Saito^c, Kazuhiro Ogawa^c, Akihiko Chiba^b

Abstract

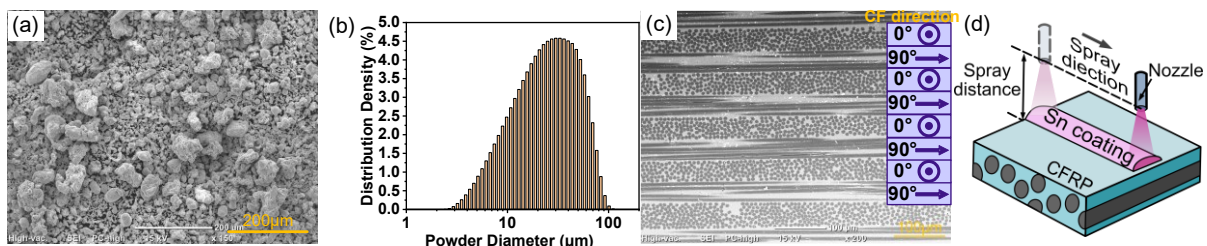
Figure 1. Feedstock powder condition (a) SEM image of powder, (b) particle size distribution of the tin powder, (c) CFRP sample cross-section figure, and (d)

schematic of spray distance.

In this study, water atomized tin powder (Sn-AtW-250, Fukuda Metal Foil & Powder, Japan) was used as a feedstock material with a mean size of 24.28 μ m. The particles were non-spherical, irregular (rod-like) water atomization Sn powder. The particle size distribution was characterized by using Laser light scattering diffraction particle size analyzer (LS230, Beckman Coulter, USA). The morphology and diameter distribution of the tin powder is shown in Fig. 1(a) and 1(b). The CFRP plates, which consisted of epoxy matrix and carbon fiber (CF) reinforcements, were provided by Jamco, Japan. Each laminate was made of 52 plies ([90/0]_{2s}); two adjacent layers had perpendicular fiber directions shown in Fig. 1(c). The plate was cut into small pieces with a dimension of 30 × 30 × 2 mm³. The CFRP samples were degreased with acetone without sandblasting pretreatment before subjected to the cold spray experiments.

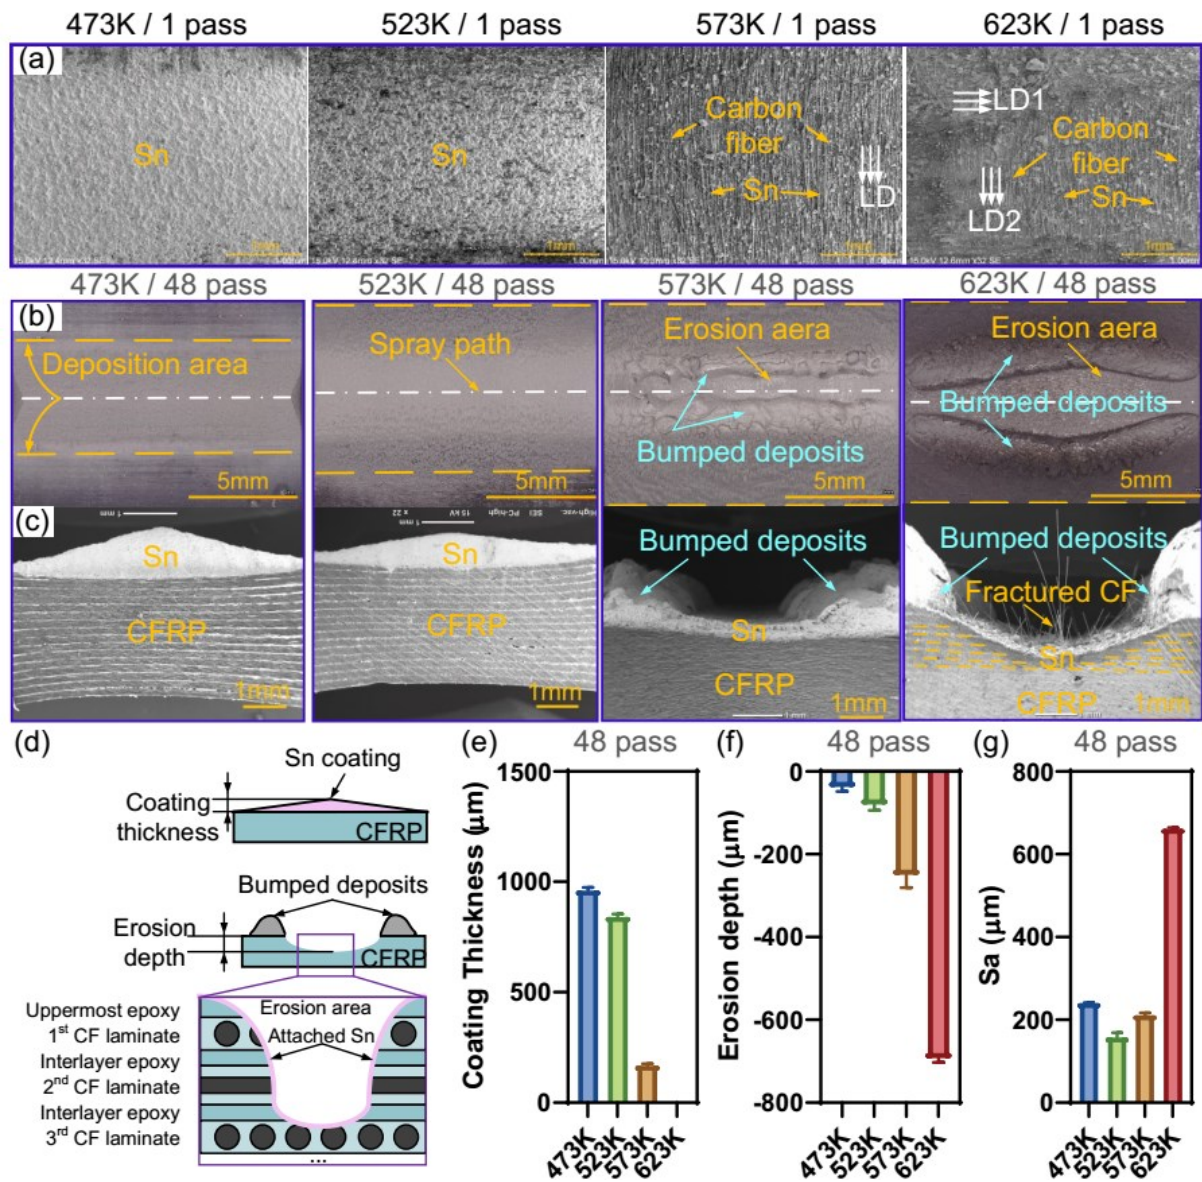
Figure 2. Morphology of coatings under four temperature conditions (a) high magnification SEM observation of the 1-pass samples, (b) surface topography at low magnification of the 48-pass conditions, (c) cross-section figure of the 48-pass conditions, (d) Schematic figure of erosion behavior, (e) coating thickness, (f) erosion depth, and (g) surface roughness (S_a).

Figure 2 (a) and (b) shows the SEM images of the surface morphology of the single-layer Sn coating obtained at various gas temperature conditions. With increasing the gas temperature, the coating becomes sparser, the epoxy matrix degraded and CFs were exposed when the temperature reaches 573K especially; thus, Sn particles directly deposited on the CFs of the exposed first laminate. It is important to note that the whole laminate erosion consists of epoxy degradation and decomposition, CF breakage and fracture. Moreover at 673 K, two continuous CF laminates were exposed by erosion subsequently due to stronger impact effects, the broken and twisted fibers were observed at the interface of two layers. It is easy to identify because CFs in two continuous laminates are mutually perpendicular. According to previous research, the increased pressure and temperature result in increasing particle velocity, the localized melting zone increases; on the contrary, the stored elastic energy decreases.[22,23] As a consequence, even for soften, Sn particles can penetrate the substrate rather than rebound. [24]

The enlarged surface topology characterizations can be investigated in Fig. 2(a). The surface of the Sn layer obtained at 473K exhibits thicker and denser compacted coatings. While the gas temperature increases to 523 K, the sparser coating with

partial epoxy explosion can be identified instead. Moreover, surface erosion condition became severer when increasing the gas temperature from 523K to 573K and 623K. Consequently, the epoxy matrix gradually decomposed, accompanying with CFs of the first laminate exposure and fracture, CFs get a chance to contact with Sn particles directly under 573K. Under 623K condition, more opportunities occur to make it easier to trigger Sn/CF joint rather than Sn/epoxy joint due to the gradually disappearing uppermost epoxy. After the erosion of the first laminate, the epoxy part between the first and second laminates was eroded immediately, then following with the erosion of the second laminates. It is worth mentioning that erosion was observed within two laminates under all gas temperature conditions.

After 48 passes deposition, the surface and cross-section performances were characterized by an Optical microscope shown in Fig. 2(b), with the temperature increasing from 473 K to 523 K, the coatings are gradually getting thinner and sparser. Specifically, the deposition area (marked within two yellow dotted lines) along the spray path (marked by white central line) becomes larger at the same scale, indicates the coating coverage area increases [25,26]. Though the single-pass width is larger than the nozzle diameter theoretically, increased temperature makes the tendency more dramatic with a larger coating width, leading to coating thickness decrease [27]. Apparently, no coating was obtained along with the spray path under 623 K due to severe erosion. However, on the edge of the erosion-formed valley, some bumped deposits formed, probably caused by beam-edge sputtering accompanying by partial particle melting. Figure 3(d) shows the schematic illustration of the coating thickness and erosion depth defined in this study. The coating thickness and erosion thickness were directly determined from the cross-sectional observations by

measuring the height above the initial substrate surface and the depth from the initial substrate surface, respectively. Consequently, as elucidated in Fig. 2(e), 2(f) for the 48-pass condition, with increasing temperature, coating thickness decreases, no coating obtained under 623K; deposition areas increases, erosion depth increases, one laminate was eroded under 573K, two continuous laminates were eroded under 623K. Arithmetical mean height (S_a), which expresses as an absolute value of the height of each measurement point compared to the arithmetical mean height of the surface [28], was used here. The exist of thicker coating at 473 K and bumped deposits at 573 K, and 623 K make the S_a value higher than sparse coating at 523 K, the highest value can be obtained at 623 K.

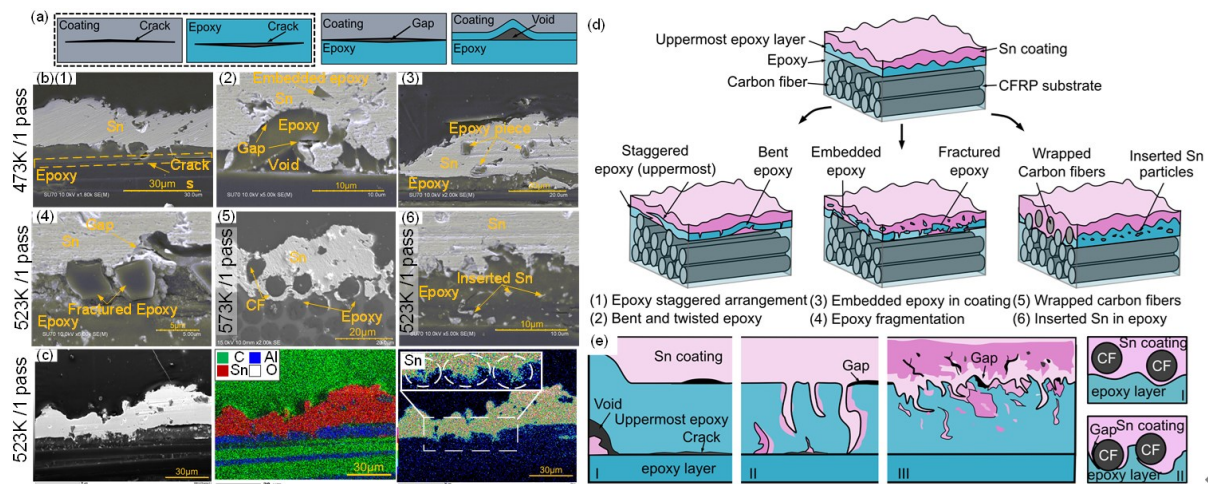
Figure 3. Cross-section figure of the interface performance (a) schematic of classification of defects, (b) interfacial behavior of coating under 473K, 523K, and 573 K, (d) elemental distribution at the interface obtained at 523 K by EDX, (e)

schematic figure of six patterns of the interface, and (b) schematic figure of classification of the interface.

In Fig. 3(a), we define defects into three types. The slits inside the epoxy or coating are regarded as crack, defects located in the interface can be noted as gaps, voids can be regarded as a bigger vacancy.

The interface behaviors between the Sn coating, the uppermost epoxy, and exposure CFs of the CFRP substrate are illustrated in Fig. 3(b). Their corresponding schematic figures are shown in Fig. 3(d). There exist three kinds of interfaces under 473K and 523 K. Specifically, the first one has a distinct and differentiated dividing interface; the other one is an interlocked interface characterized by the staggering performance at the intertwined dividing interface, the last one describes the epoxy pieces embedded in the Sn coating shown in Fig. 3(b-1, 2, 3). Apparently, their common point is clear Sn/epoxy boundaries without involving of CFs. Moreover, these distinct boundaries at the interface of Sn/epoxy are occasionally accompanied by gaps illustrated. Interestingly, the surficial epoxy part bent but not broke under 473K, epoxy experiences fracture, and a vacancy generated. The deposited Sn partially fulfilled such voids, and some Sn penetrated the epoxy part. Also, apparent cracks inside the coating can be seen, which would weaken the bonding strength.

Figure. 3 (b-4, 6) represents the interface characteristics under 523K, while Fig. 3 (b-5) under 573 K. Notably, broken epoxy pieces result from increased temperature can be observed; they emerged in the moment of consolidation of the coating before degradation, some tiny Sn particles embedded inside the epoxy. Figure 3(c) shows the EDX element distribution map; the uppermost epoxy parts show a staggered arrangement with inserted Sn parts. At 573 K, the thinnest coating can be achieved due to erosion occurrence. Exposed CFs get a chance to trigger Sn/CF joint with the features of CFs wrapped and surrounded by Sn coating.

Overall, the interface performances of Sn coating and CFRP substrate can be briefly classified into six patterns illustrated in Fig. 3(d). Also, three types of Sn/epoxy interfaces, two types of Sn/CF and Sn/CF/epoxy interfaces, can be summarized in Fig. 3(e). As for Sn/epoxy joint, the interface has a clear line of demarcation shown in type I, commonly occurs at 473K. Type II describes the uppermost layer of epoxy is inserted vertically by coating; this performance usually can be seen under 523K. Concerning type III, an interlocked boundary can be observed, and the interface jagged and hooked, the coating and substrate staggered and penetrated into each other, similar to the mechanical interlocking bonding mechanism, anchoring effects of the coating can enhance its adhesion strength [4]. With respect to the Sn/CF, fully surrounded CFs is the representative features of type I. Instead, type II shows Sn/CF/epoxy joint with three interfaces lead to a complicated situation.

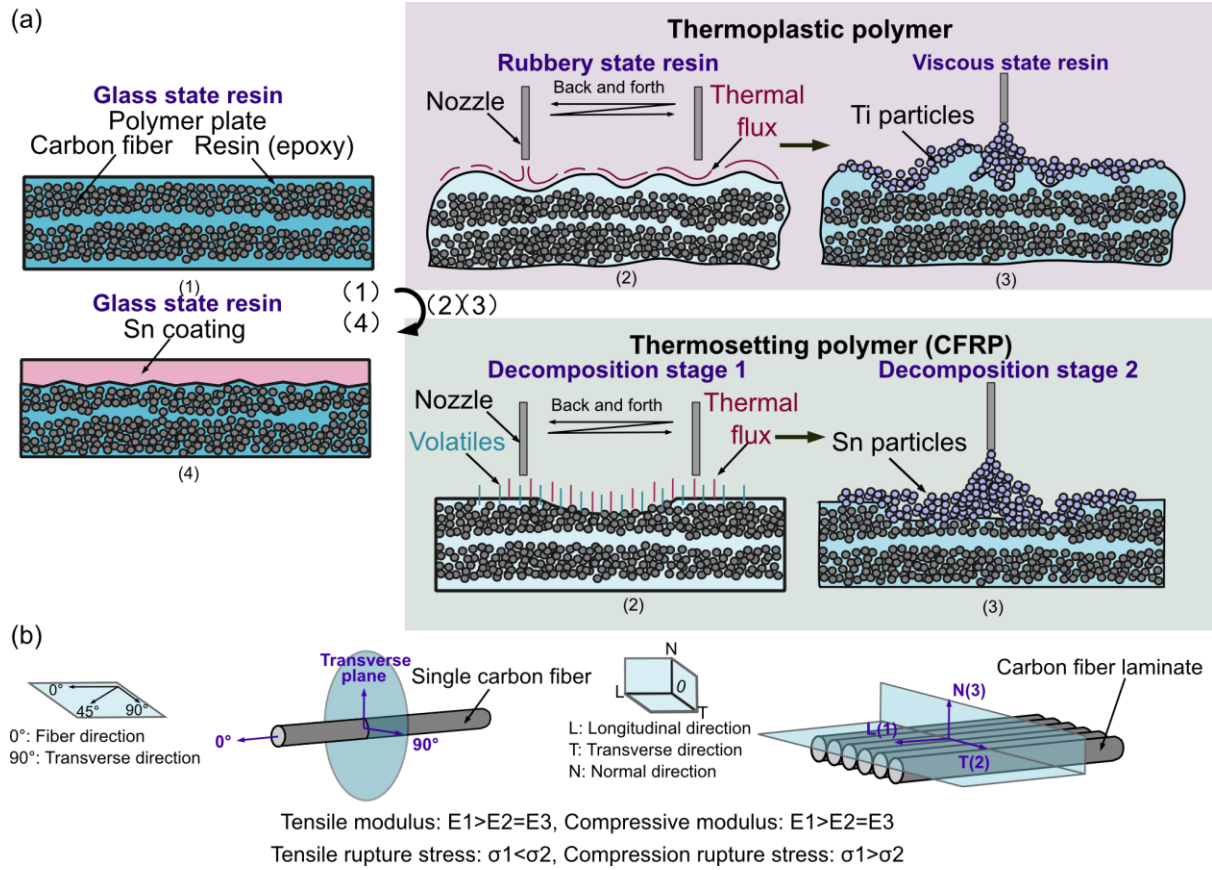
Figure 4. Schematic of epoxy and CF behavior during the process (a) transformation procedure of thermosetting polymer under higher temperature, (b) Force model of single carbon fiber and laminate, and (c) carbon fragment performances.

When the CFRP samples under the high-temperature circumstance such as 573K and 623K, as shown in Fig. 4(a), epoxy role as thermosetting polymer would fracture first, then degrade and decompose during the process, if exclude inserted fractured epoxy, they experience incompletely because insertion in a coating prevents further degradation. Not similar to thermoplastic polymers, such as polyetheretherketone (PEEK) or Poly Phenylene Sulfide Resin (PPS), epoxy does not go through a rubber state after heating. In general, after the degradation of epoxy resin on the uppermost surface, the first CF laminate will be exposed, which provides accessible opportunities for the deposition of Sn particles on CF directly. However, the high impact energy

would directly transfer from particles to fibers and result in CF fracture. As shown in Fig. 4(b), single carbon fiber and one-layer laminate are anisotropic materials [29]. In the fiber direction, it has much higher tensile modulus and compressive modulus, but tensile rupture stress and compression rupture stress are higher along the transverse direction [30,31]. The impact direction of the powder is perpendicular to the CF, coincides with normal direction, fibers are more easily compressed, then fractured into fragments, leading to deformation, crack generation, and fracture [32,33].

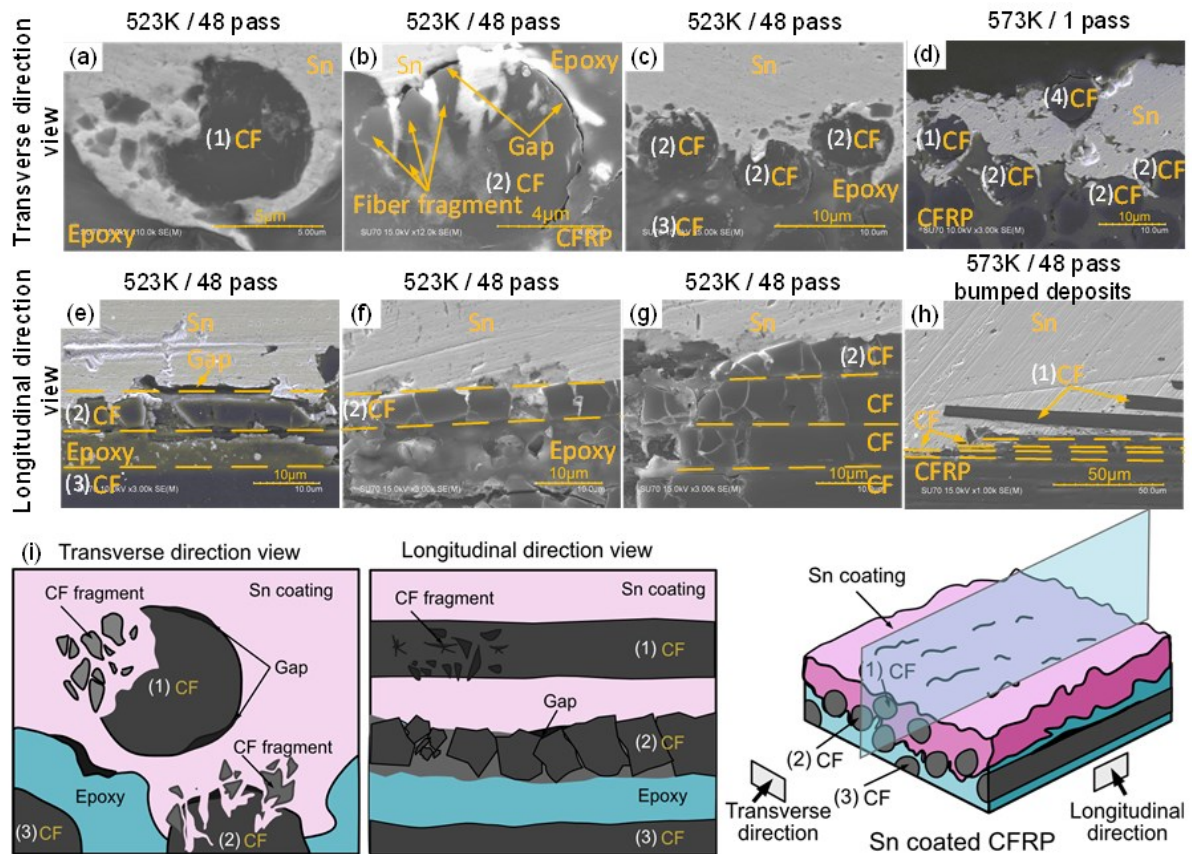
Figure 5. Sn/CF joint can Sn/CF/epoxy joint under 523K and 573K processing conditions (a) - (c) transverse direction view under 523 K/ 48 pass condition, (d) transverse direction view under 523 K/ 1 pass condition, (e) - (f) longitudinal direction of CF breakage performance under 523 K/ 48 pass condition, (h) longitudinal

direction view of bumped deposits under 523 K/ 48 pass condition, and (i) schematic figure of CF performance.

Sn/CF joint and Sn/CF/epoxy joint occasionally occurred at 523 K, but they are main combinations under 573 K case instead. Four carbon fragment performances can be investigated according to their position regarding the interface of joint type, which can be illustrated in Fig. 5(a) - (h). Combining the schematic figure in Fig. 5(i), “(1) CF” means whole CF merged inside the Sn coating, their interface is Sn/CF joint; “(2) CF” represents the upper part of CF embedded in the coating, but bottom part also remains in epoxy; “(3) CF” refers to the whole CF hinged in epoxy, the original state after epoxy cured during the CFRP manufacturing process. In Fig. 5(a), “(1) CF” shows that Sn coating wraps completely whole embedded CFs regardless of them experienced fracture or breakage; its fragments were randomly distributed adjacent to the main part of the broken fiber. In the condition of “(2) CF”, shown in Fig. 5(b) and (c), along the transverse direction, the mixture of Sn and epoxy are inserted into cracks of carbon by subsequent particles, CF contact with epoxy and coating simultaneously. Usually, at the interface of Sn and single fiber, gaps are observed. Moreover, the broken carbon fibers are distributed along the longitudinal direction, the upper surface of the upper CF are bonded with the coating; also coating is investigated filled in the cracks of neighboring pieces, which promotes bonding capability. Fig. 5(e) - (9) shows the longitudinal direction view of “(2) CF”, Sn/CF joint, and Sn/CF/epoxy joint are more common combinations, fractured epoxy and broken CFs compacted at the interface of uppermost substrate and coating. Probably because they were compressed by the Sn coating at the moment of breaking, and their irregular fragments caused the gap (Fig. 5(b, e)). Moreover, we observed the longitudinal view of the bumped deposits

under 573K; severe surface corrosion causes CFs to be inserted inside of the coating. Besides, “(4) CF” represents the CFs exposure in the air passing through the whole coating, usually occur because sparse and thin coating at 573 K cannot completely cover its eroded substrate surface. For further exploring the temperature effects on the interface and assisting us in explaining the bonding mechanism, we analyzed the distribution of the surface temperature.

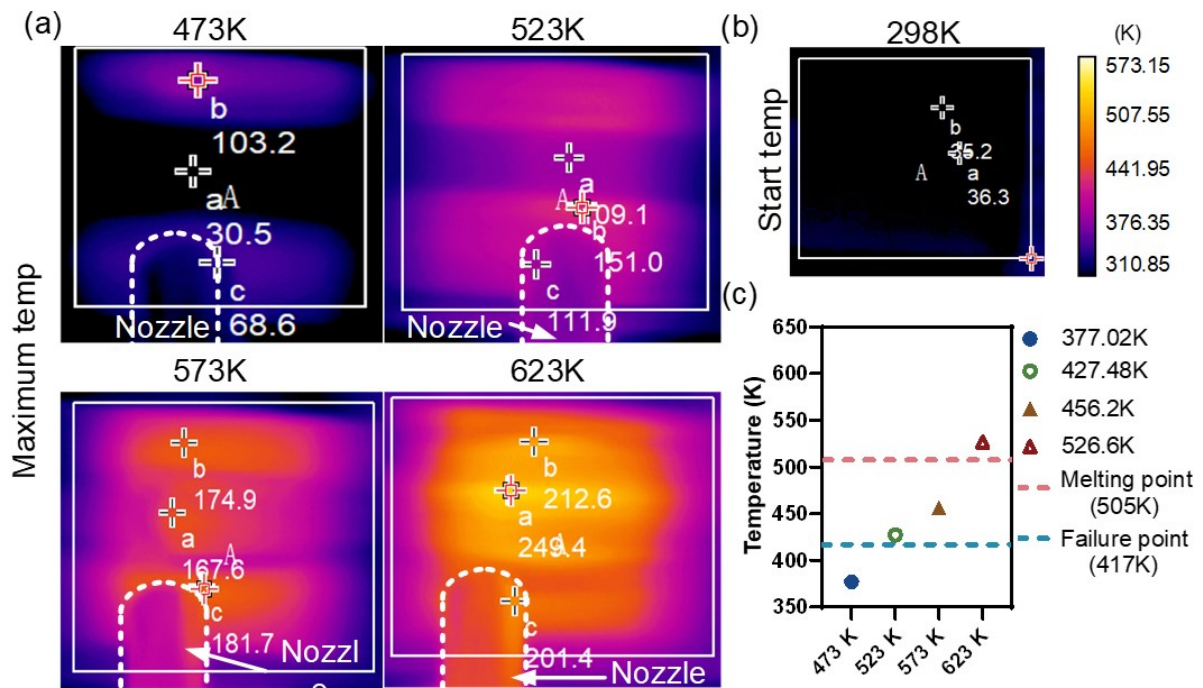
Figure 6. Surface temperature distributions during the spray process (a) temperature distributions where the maximum temperature was obtained, (b) start temperature distributions, and (c) maximum temperature.

Figure 6(b) shows the start temperature of RT before spraying; after spraying, the maximum temperature maps during the whole process under four gas temperatures are shown in Fig. 6(a). It should be noted that the unit of measured temperature marked on the maps is °C; the converted temperature can refer to the color bar in K. In Fig. 6(b), with increasing the gas temperature from 473 K to 623 K, the maximum temperatures increase. The melting temperature of Sn of 505 K and failure temperature of epoxy of 417 K are marked by a red dot line and a blue dot line, respectively, which indicates only the 473 K case did not occur epoxy failure, only the 623 K occurred Sn melting phenomenon [34]. The analyses can provide evidence to verify surface morphology and afterward characterization of coating bottom surface and substrate surface after pulling off the coating.

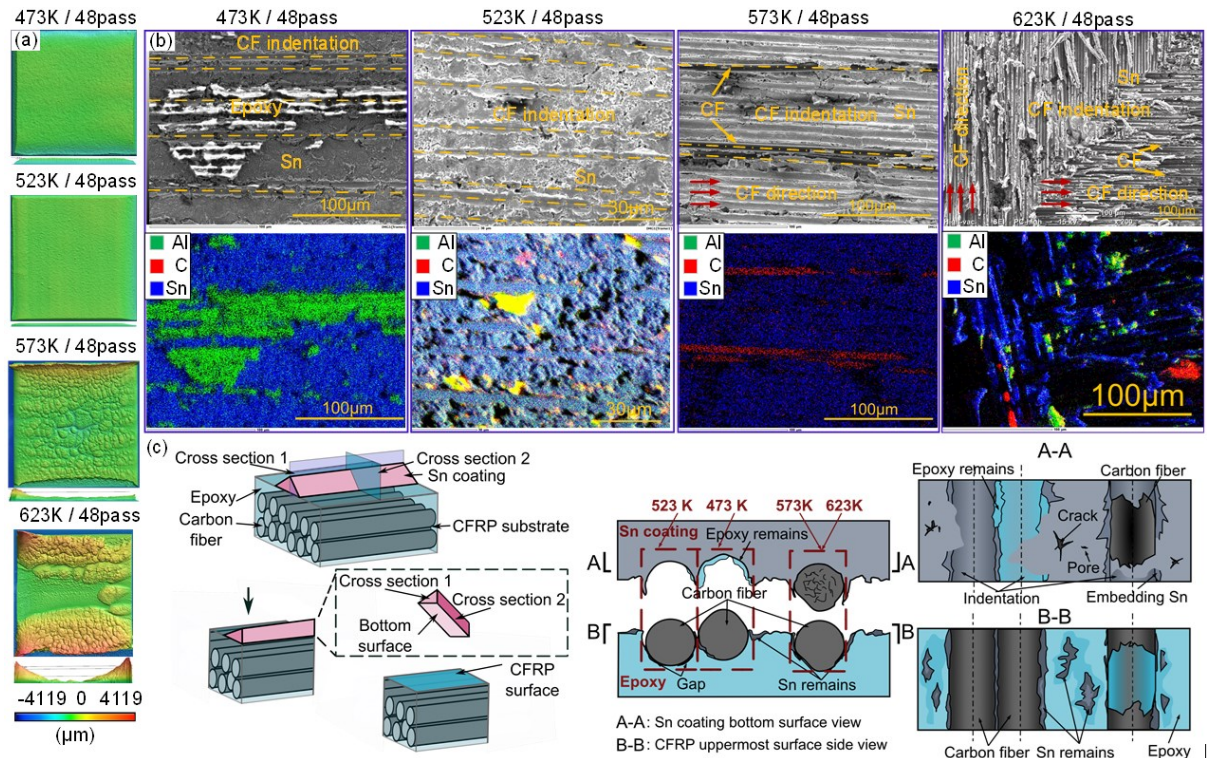
Figure 7. Coating bottom surface characteristics after the pull-off test under four gas temperatures, (a) global coverage samples, (b) coating bottom surface characteristics, (c) schematic figure of the pull-off test.

The pull-off adhesion strength tests of 48 passes multi-layer were conducted to verify the adhesion strength, and the distribution of Sn coating on the CFRP surface can further explicit the bonding mechanism. Under different processing conditions, the morphology of the substrate surfaces after pulling are various; two surface topographies of the bottom surface of the Sn coating and the upper surface of the substrate after puling are investigated in Fig. 7 and Fig. 8. In order to meet the requirement of the pull-off test, global coverage samples are prepared, as shown in Fig. 7(a).

On the one hand, considering the coating surface, the CF indentation and convex performance can be illustrated in the SEM figure and corresponding schematic image in Fig. 7(b) and (c). On the condition of the gas temperature change from 473 K to 623 K, Sn particles plastically deformed, compressed, deposited, only melt at 623 K. Under 473 K case, epoxy resin remains and embeds in the bottom surface of Sn coating because 473 K cannot cause epoxy failure, which is consistent with surface temperature shown in Fig. 6(c). Hence, the indentations of carbon fibers marked by dotted lines can be observed both in the coating area and epoxy area. Almost no uppermost epoxy can be seen at 523 K and 573 K because epoxy began to degrade and decompose, driven by thermal effects. Meanwhile, more CF indentations shown may be indicated by two possible reasons. The one is , Sn/CF direct contact results

from epoxy degradation; another is temperature increment. At 573 K and 623 K, unusual performance occurs: broken CFs attached and embedded in the Sn coating bottom surface. First, higher impact energy derived from higher temperature leads to CF fracture; afterward, the tighter combinations of coating and CFs or inserted CFs obtain higher adhesion strength, causing stronger sticking of CFs with Sn coating when pulling. When the temperature reaches 623 K, two continuous eroded laminates can be observed with very impacted and dense indentation, the warped part derives from CF-nether coating after the pull-off test. CFs drew out from surrounded coating, leaves one part connected, one part suspended. The schematic of this mechanism is illustrated in Fig. 7 (c).

It should be noted that the strip indentations are derived from upper compression of CFs, and flake convexes result from embedding coating in the vacancy of two adjacent CFs, and both sides of a single CF. Moreover, for any single fiber, the indentations and convexes are discontinuously located, the discontinuous areas can be regarded as the not tamping parts. Moreover, besides the fiber indentation area, another flat area was analyzed direct bonded with epoxy. The indentation has a smooth inner surface, which verifies carbon fiber cannot bond with Sn coating tightly, which indicates monarchical interlocking is weak. However, the flat area is rough and uneven, which means epoxy and Sn has a stronger binding force. Overall, a potential bonding mechanism can be investigated that with the increasing gas temperature, epoxy disappears, Sn gets more chance to deposit directly on the CF surface. Also, a higher temperature provides stronger adhesion strength seen in Fig. 7(d).

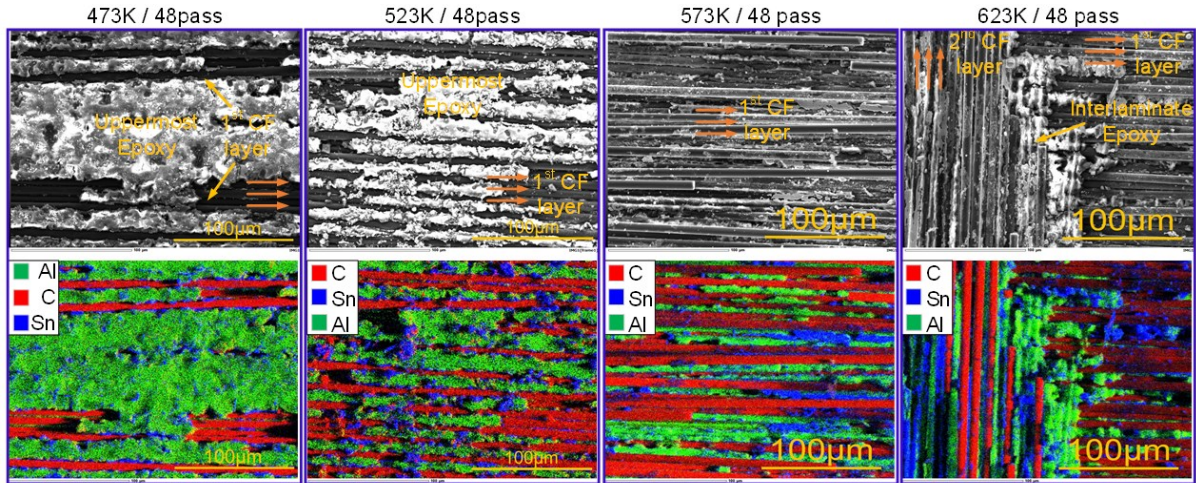
Figure 8. Substrate surface performance after the pull-off test

On the other hand, the substrate surfaces under various gas conditions after the pull-off test are observed shown in Fig. 8. When the gas temperature is 473 K, Sn coating residual epoxy and exposure CFs mainly distribute; exposure CFs showed because their epoxy cover layer is attached on the coating bottom surface corresponding with Fig. 7(b). Apparently, Sn coatings mainly distribute on the epoxy clusters or locate in vacancies between evenly arranged CFs. When increasing the temperature from 473K to 523K, epoxy gradually disappears, accompanying by more CFs exposure. Sn coating is distributed around the fiber, mainly scattered on the epoxy surface and embedded in the interface of fiber and epoxy; rare Sn coating locates on the fiber distribution area. Notably, comparing the probability occurrence of Sn/epoxy and Sn/CF joint, Sn/epoxy joint occupies more circumstances, which proves Sn particles are easier to bond with epoxy than CF. At 573 K, fully CF exposure and occasional breakage can be observed; while at 623 K, multi-laminates erosion occurs, at least two perpendicular CF directions of two laminates proves the serve erosion condition.

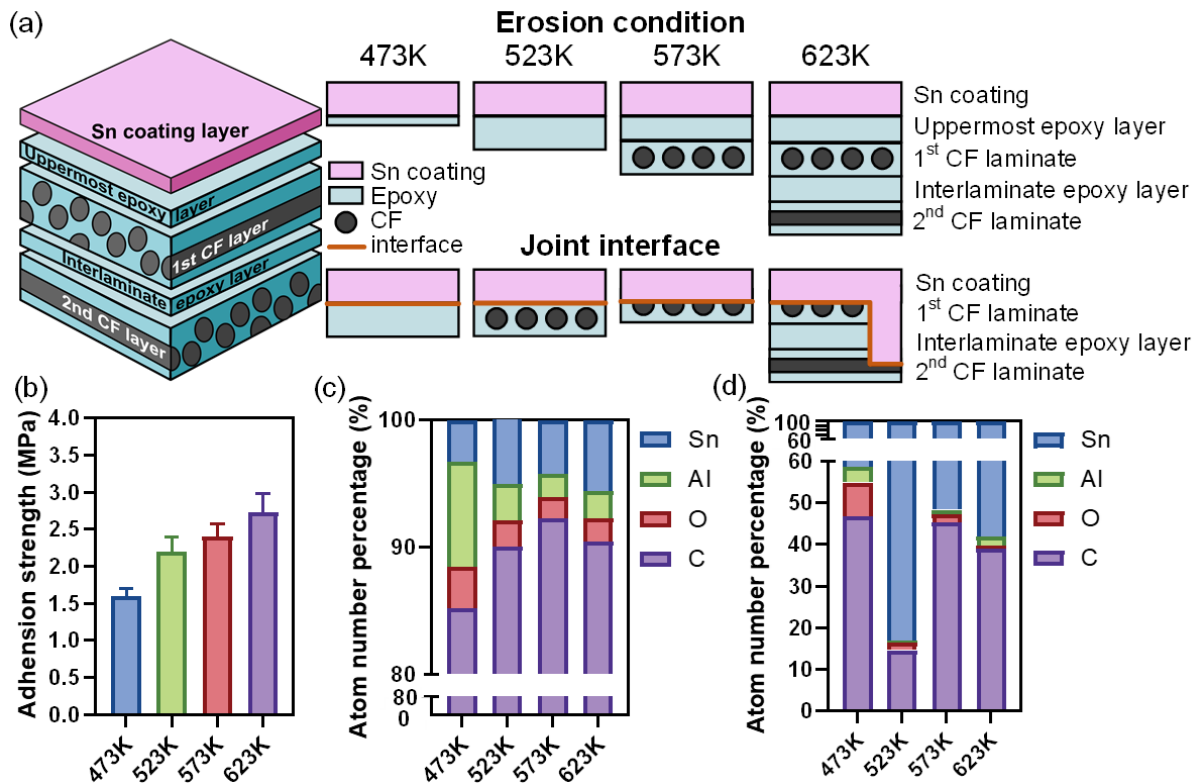
Figure 9. Erosion condition (a) CFRP structure, erosion condition and joint interface under various conditions, (b) adhesion strength, (c) atom number percentage of the substrate upper surface from EDX observation (d) atom number percentage of the coating bottom surface from EDX observation

From the microstructure observation of the two-side surface after the pull-off test, some interesting conclusions can be drawn. First, the structure of the coating bottom surface and the substrate upper surface correspond to each other. In Fig. 9(a), we specifically explain the structure of the CFRP sample again. Summarily, under 473 K, almost no erosion of the first epoxy layer occurs, the interface observed is Sn/epoxy joint; under 523 K, erosion happens in the first epoxy layer with Sn/CF laminate interface; under 573 K, erosion also occurs in the first epoxy layer involving the first CF laminate, while the interface is mainly Sn/CF interface, different from the situation

of 523 K, direct contact of Sn/CF occupies the main part of combination; under 623K, above the second CF laminate are all the erosion regions, the interface consists of Sn/CF (longitudinal direction), Sn/epoxy (second layer) and Sn/CF (transverse direction). Second, the adhesion strength is shown in Fig. 9 (b); with the increasing temperature, the adhesion strength increases. These characteristics summarised under various temperatures illustrate when we only considering physical bonding, which is mechanical interlocking, but the bonding strength under 623K is the highest owing to metal melting. Actually, Sn particles can penetrate and embed into epoxy more easily than CF, fractured epoxy generates a rough surface, and various cracks and gaps help regardless of melted or solid Sn particles fill in. Meanwhile, more contact areas result from CF fragments, gaps between CF and epoxy, and even cracks inside the CF can further increase combined opportunity, enhance bonding effectiveness further promote deposition performance because the adhesion strength in the interface of Sn coating and CFRP substrate is weak [8,35]. Interestingly, Sn particles deform upon impact on the surface due to its softness nature, results in the jet formation and ensuing bond formation with the substrate via mechanical anchoring. Plastic deformation may disrupt thin surface films, provide intimate conformal contact under high local pressure permitting bonding to occur. Figure 9(c) and (d) are the figures of the ingredient percentage of atom number distribution measured by the EDX method after the pull-off test. Figure 9(c) shows the distribution of CFRP surface; the Carbon element (C) is mainly distributed in CF; Oxygen (O) and Aluminum element (Al) exist in epoxy, while Sn mainly represents the remained Sn coatings. Under 473 K, epoxy is not degraded so much, CFs is buried in epoxy resin. That's the reason for the minimum value of C and the maximum value of the O and Al element. The adhesion strength of Sn coating is worst in this condition, so the value of Sn is the

minimum one among four circumstances. Increasing the temperature from 473 K to 523 K and 573 K, the distribution of carbon increases due to CF exposure, the representation of epoxy by O and Al decreases due to erosion and epoxy degradation. Sn increases under 523 K due to epoxy erosion but decreases due to CF exposure because Sn can better deposit on epoxy than CF surface. At 623 K, C decrease and Sn increase because the second CF laminate had been eroded accompanying with exposure of the second epoxy layer, resulting in an epoxy increment. Similarly, Figure 9(d) shows the element distribution of the coating bottom surface. Sn element occupies the main part, C element ranked second. Under 473 K, we obtain the most C element because we have the most epoxy (O and Al element). However, different from 473K, under 573K, C element is ranked second because of CF exposure; meanwhile, the value of epoxy is the minimum one. Under 523K, epoxy is almost gone with the lowest value of O and Al element, as well as the lowest C value. Under 623K, the second epoxy layer shows then increases the value of O and Al element.

As mentioned aforehand in Fig. 9(a), interfacial morphologies are various corresponding to different processing conditions. Figure 10(a) represents three kinds of CF-related interface: Sn/epoxy interface is marked by a green dot line, Sn/CF interface is denoted by the red color, and CF/epoxy interfaces are presented by blue color. CFs circled by them are (1)CF, (2)CF, and (3)CF, respectively. Figure 10(b) illustrates the bonding mechanism under 573 K and 623 K occurring (1)CF feature. As shown, the original CFRP samples contain some degree of CF exposure due to low humidity resistance of epoxy. After spraying, epoxy erodes, CF exposes, the upper CF partially warp and partially break, melting Sn flows beneath the warped CF then consolidates; while, unmelted particles are impacted, deformed then fill in the gap and cracks, finally coating forms.

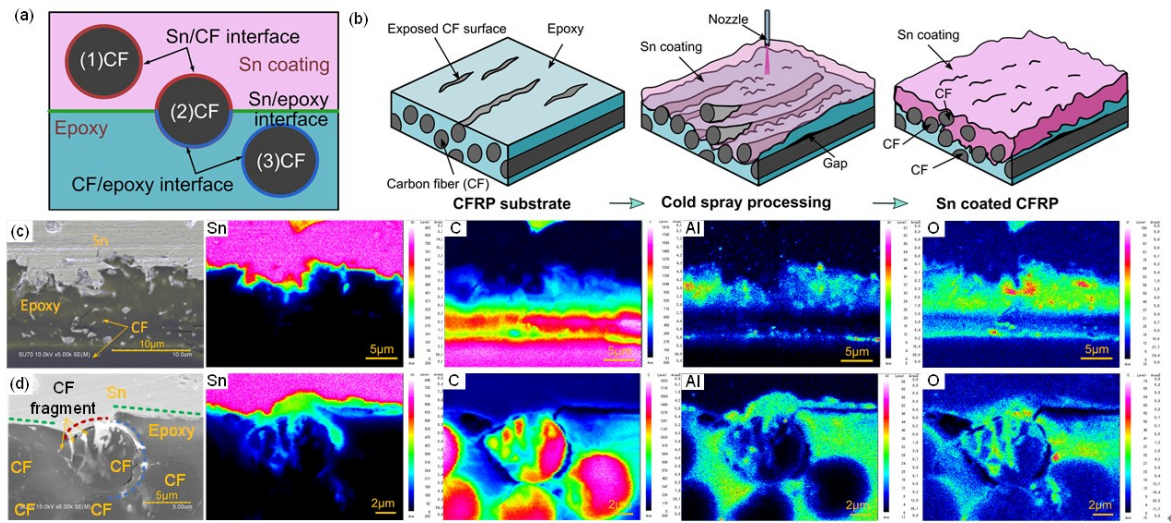
Figure 10. Interfacial element distribution and bonding mechanism explication (a) three kinds of CF-related interfaces, (b) schematic of deposition under the temperature higher than 523 K Interfacial (c) Sn/epoxy interlocked interface under 523 K condition (d) Sn/CF/epoxy interface under 523K condition

Figure 10(c) shows the Sn/epoxy interlocked interface obtained under the gas temperature of 523 K. There happens Sn atoms diffusion in the interfacial region towards epoxy. Further, Fig. 10(d) shows a complicated Sn/CF/epoxy joint circumstance contains three kinds of interfaces simultaneously. In this case, Sn coating inserted in the broken CF and contact with epoxy and CF to form Sn/epoxy and Sn/CF joint simultaneously. In Fig. 10(d), obvious gaps can be recognized in the Sn/CF interface (marked in red) rather than Sn/epoxy (marked in green) interface from the EMPA observation, indicates Sn/epoxy is tighter and stronger. It again indicates that Sn has better adhesion conditions with epoxy rather than CF.
