Aircraft Skin Inspections: Towards a New Model for Dent Evaluation

Pasquale Lafiosca^{*}, Ip-Shing Fan[†]and Nicolas P. Avdelidis[‡] Integrated Vehicle Health Management Centre Cranfield University United Kingdom

Abstract

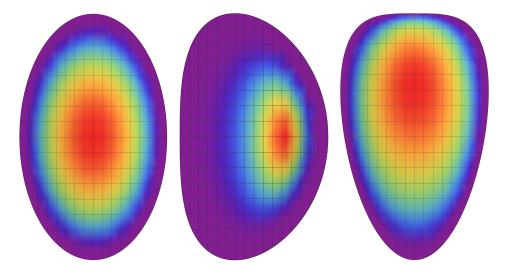
Figure 3: These three illustrative dents have all the same length and width and depth (as heatmap) and are thus classified in the same way by the SRM. However, they have evidently different shapes.

Consider, for example, the three illustrative dents represented in Fig. 3. By following the SRM to the letter, these dents should be classified in the

exact same way, yet they have completely different shapes. In all likelihood, also their structural characteristics are different.

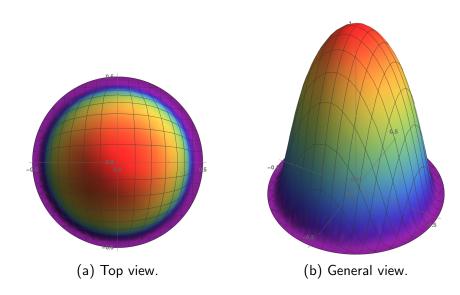
Figure 4: Reference dent function refDent(x, y) with unitary xyz dimensions, p = 1, $s_x = s_y = 0$ and b = e.

The reference function refDent(x, y) showed in Fig. 4 has unitary dimensions along the three axis and can be easily rescaled to produce a general dent:

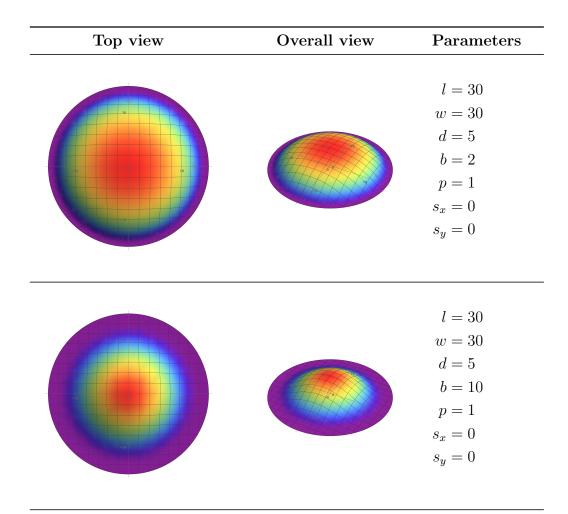
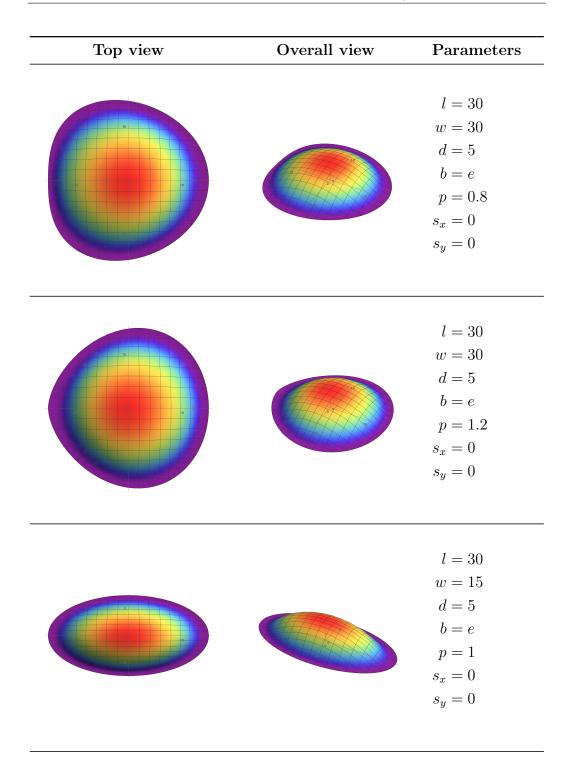
Top view	Overall view	Parameters
		$l = 30$ $w = 15$ $d = 5$ $b = e$ $p = 1$ $s_x = 0.2$ $s_y = 0$
		$l = 30$ $w = 15$ $d = 5$ $b = e$ $p = 1$ $s_x = 0$ $s_y = 0.2$
		$l = 30$ $w = 30$ $d = 5$ $b = e$ $p = 0.7$ $s_x = -0.2$ $s_y = -0.1$

Table 1: Examples of the proposed dent model for different parameter values, where e stands for the Euler's number.

Before discussing the possible applications in the following section, some shapes obtained with the proposed model are shown in Table 1, accompanied by their corresponding parameters. Depth values have been intentionally exaggerated for visualisation purposes.

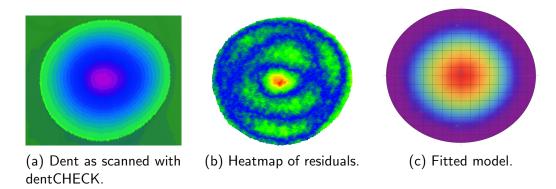
Figure 11: Evaluation on the first dent. The MAE was $0.02 \,\mathrm{mm}$.

After fitting the model, the first dent had l = 59.76 mm, w = 53.42 mm, d = 0.82 mm, p = 0.99, $s_x = 0.01$, $s_y = 0.00$ and b = 10.00, with a MAE of 0.02 mm. The isolated dent and its corresponding model are shown in Fig. 11.
